2006 Master Plan Update

SUNY ORANGE

Master Plan Update

Orange County Community College

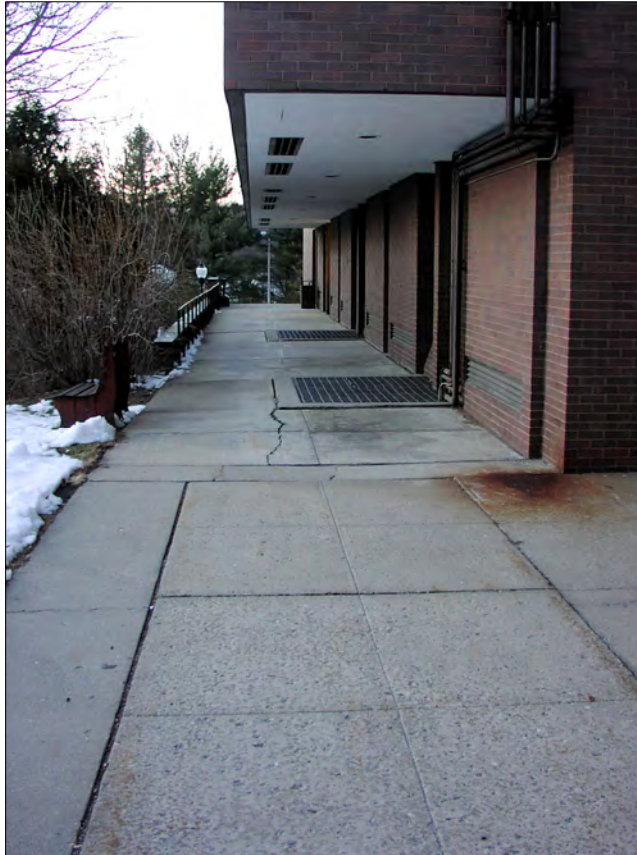
The sidewalk northwest of the Bio-Tech Building is in poor condition and should be replaced.

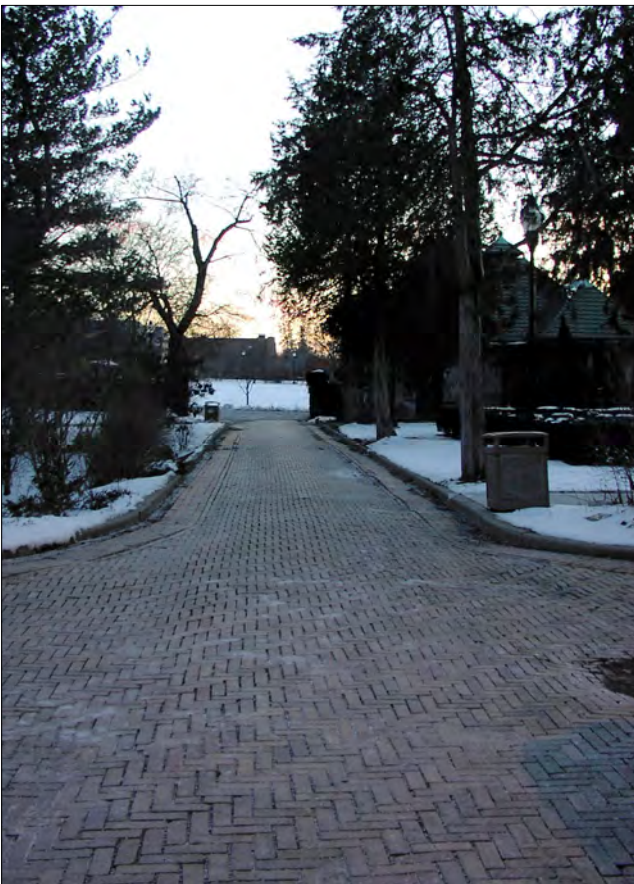
The paved road west of Horton Hall has settled above the utility tunnel that runs between Horton Hall and the Ice House. The pavers should be removed; the area should be regraded; and the pavers should be reinstalled.

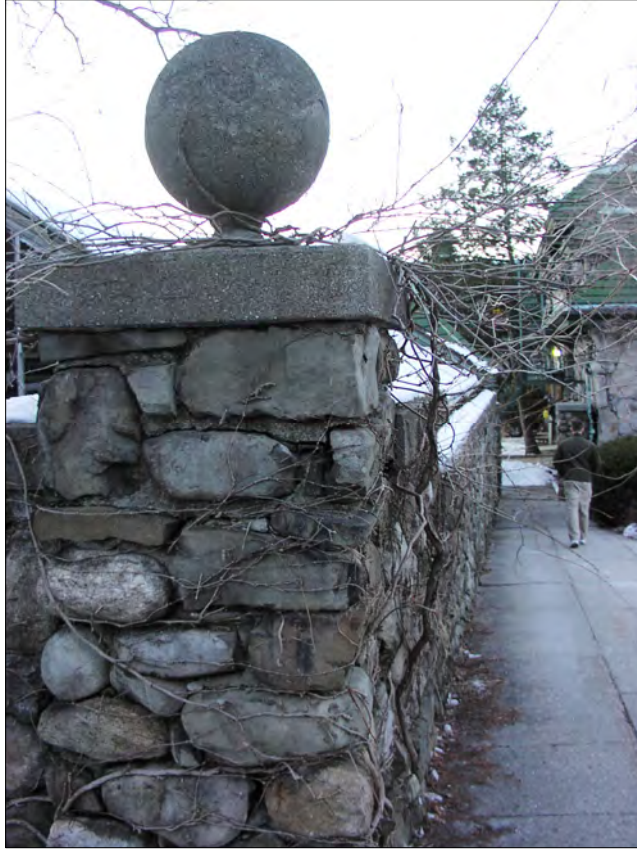
The stone site wall, a portion of which serves as the east wall of Greenhouse A, should be repointed.

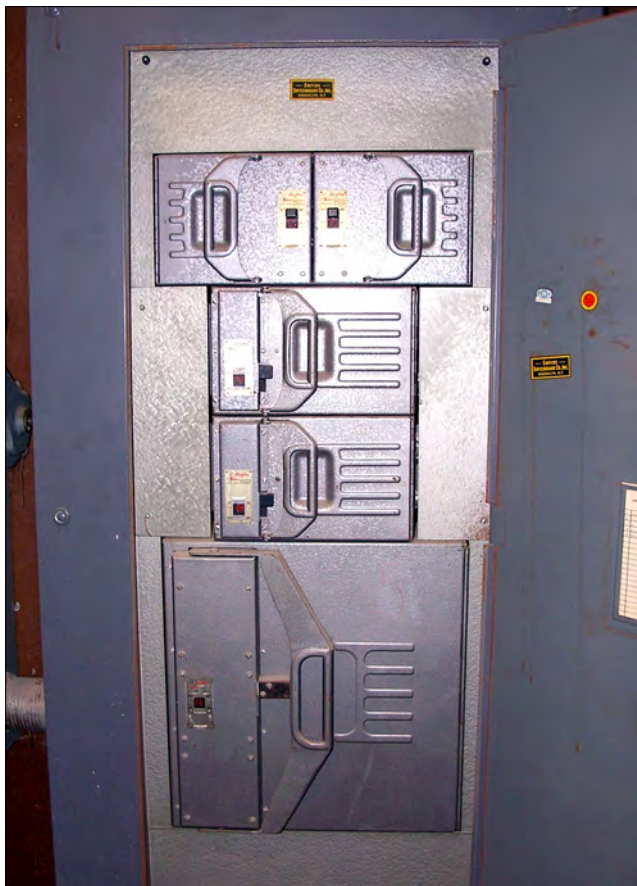
The distribution switch gear and main disconnect switch for the campus are located in the basement of Hudson Hall. The draw-out fuse boxes (shown below) can be pulled out while still under a live electrical load, presenting a possibly hazardous condition. The distribution equipment should be replaced.

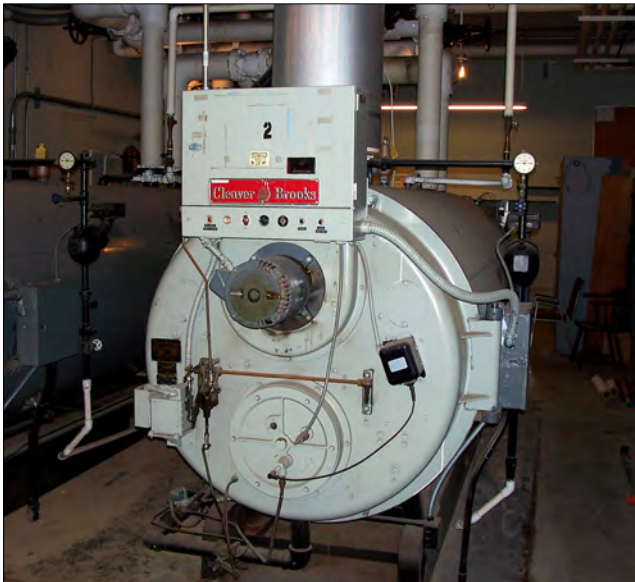
The old boiler in Harriman Hall should be replaced within the next ten years.

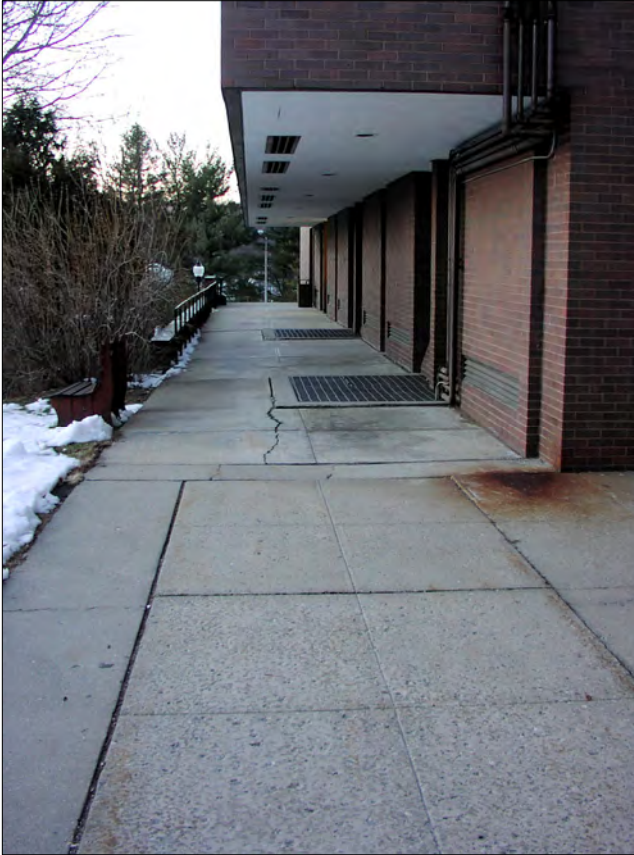
Deteriorating plazas to the north/northeast of the building should be repaired. The retaining wall at the southeast site stair (below) is also in need of repair.

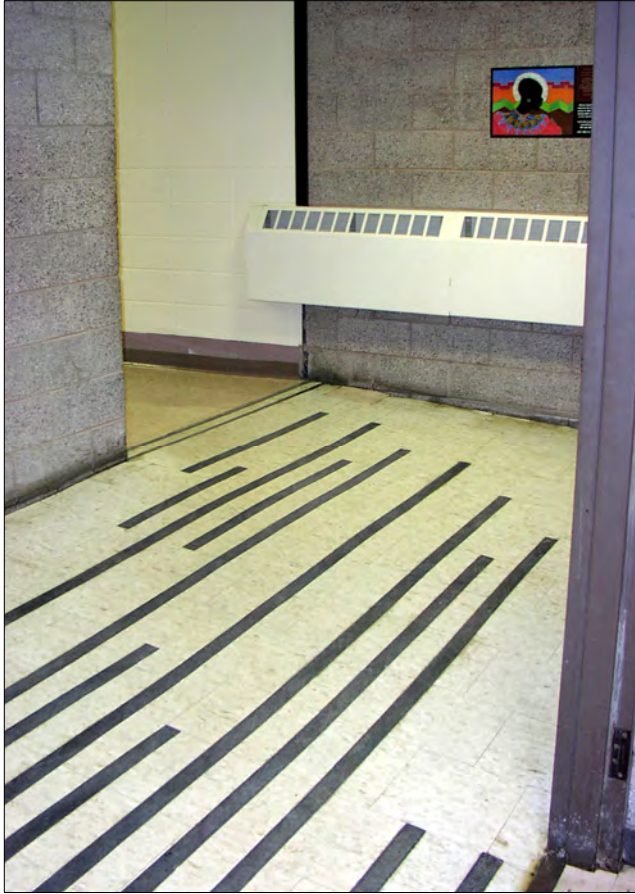
Disability Services reports that several disabled individuals have fallen at the cross ramp in the connector between the Bio-Technology Building and Hudson Hall. Hand rails should be provided to improve accessibility in this area.

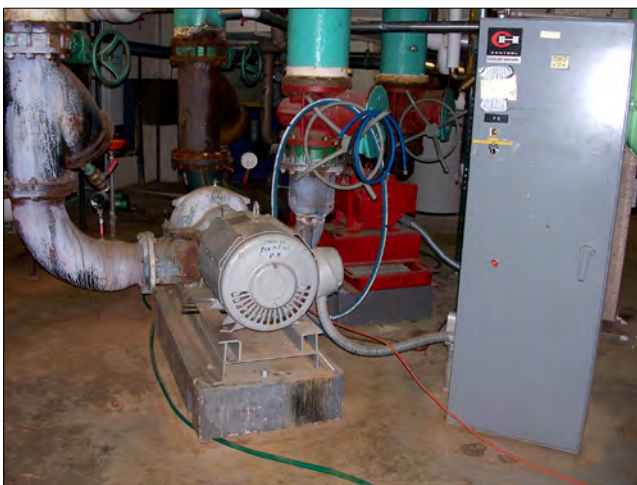
The existing tower pumps should be replaced.

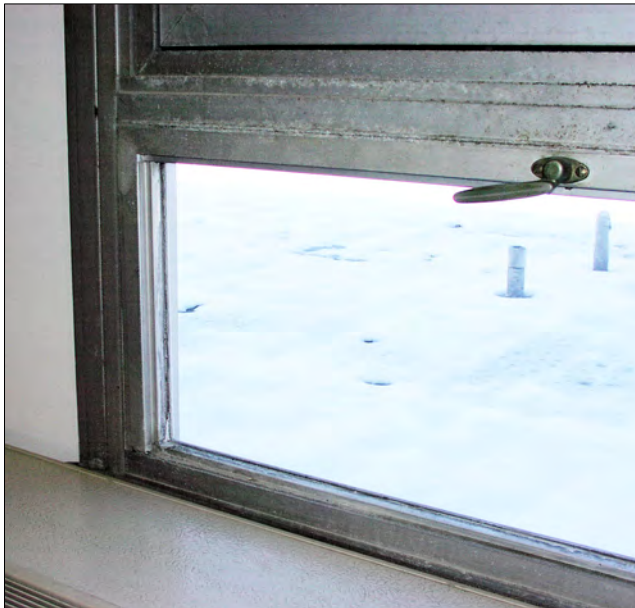
The building's windows are in poor condition and they are not energy-efficient. The College should replace the curtainwall system.

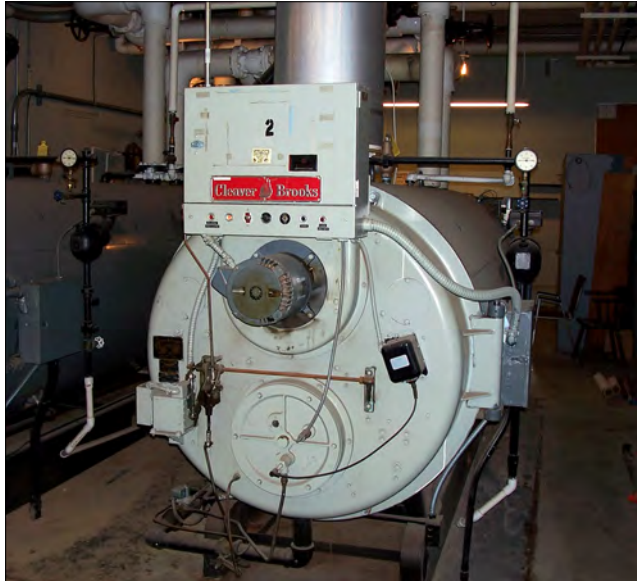
The original boilers are past their useful life and should be replaced within the next ten years.

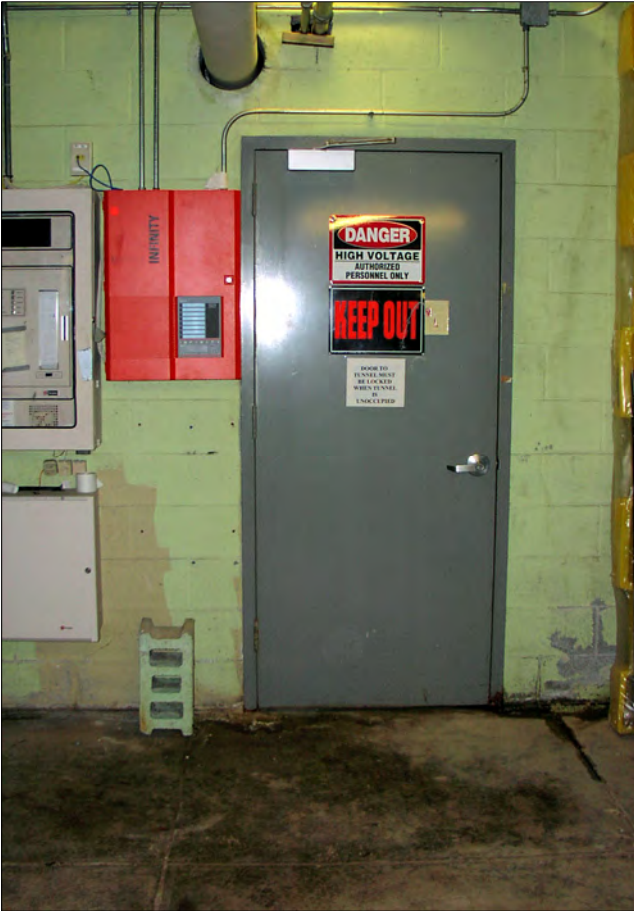
Water can be seen seeping into the basement of Horton Hall at the base of the service tunnel door, shown above. Water infiltration also occurs at the base of the basement wall, as shown below.

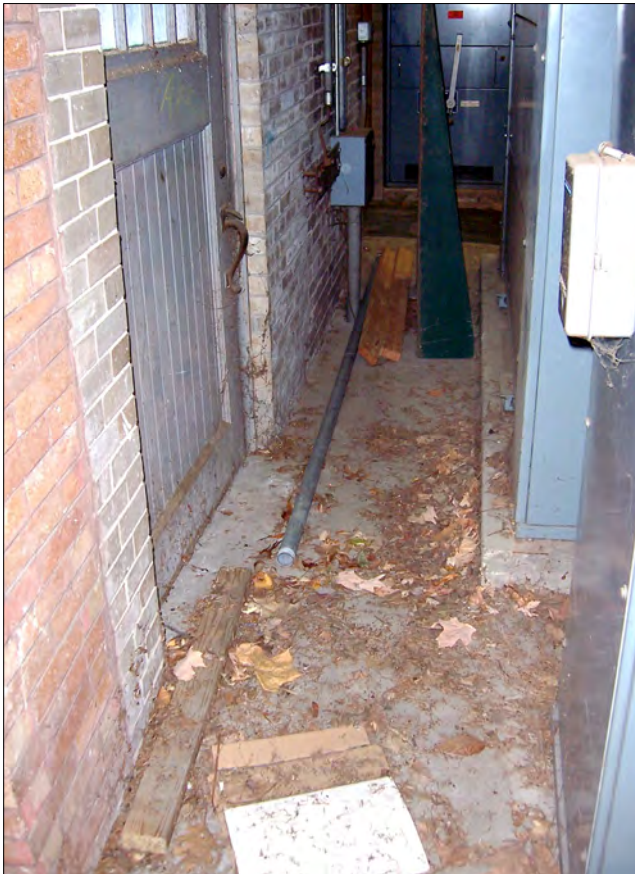
Dirt, leaves and other debris found throughout the upper floor of the building can infiltrate the transformers as there are no filters on these older units.

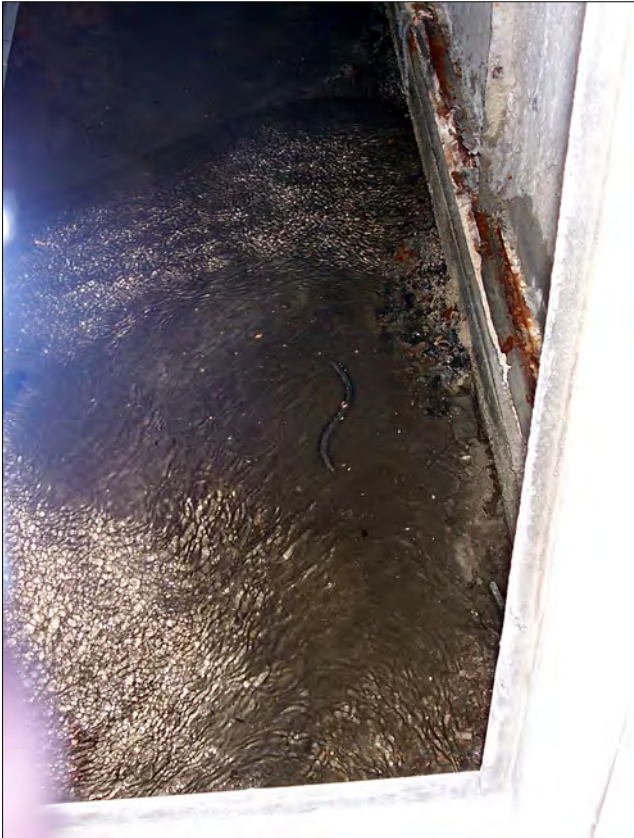
The source of the standing water in the cooling pan of the air-handling unit should be found and eliminated. This moisture source has added to the deterioration of the building's electrical distribution system.

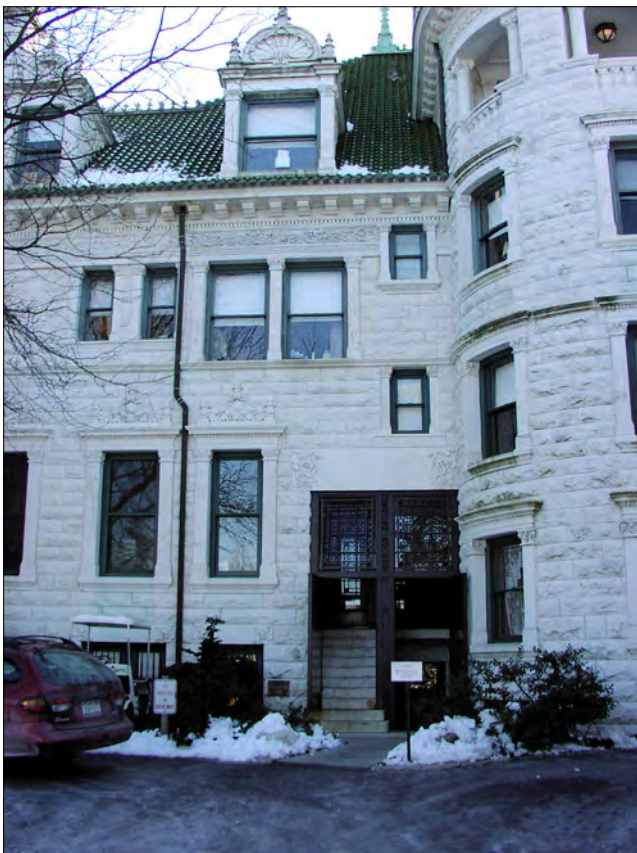
Snow and ice falling from the roof pose a potential hazard to pedestrians below.

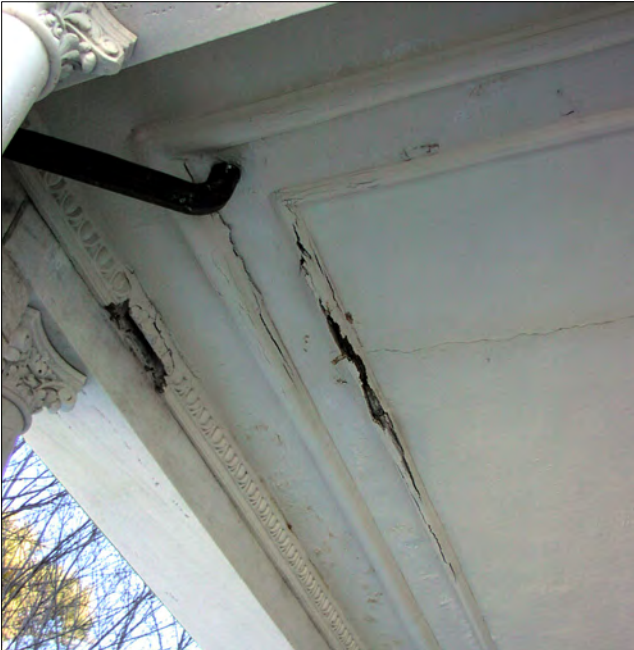
Damage to flat roof sections has affected the ceilings below.

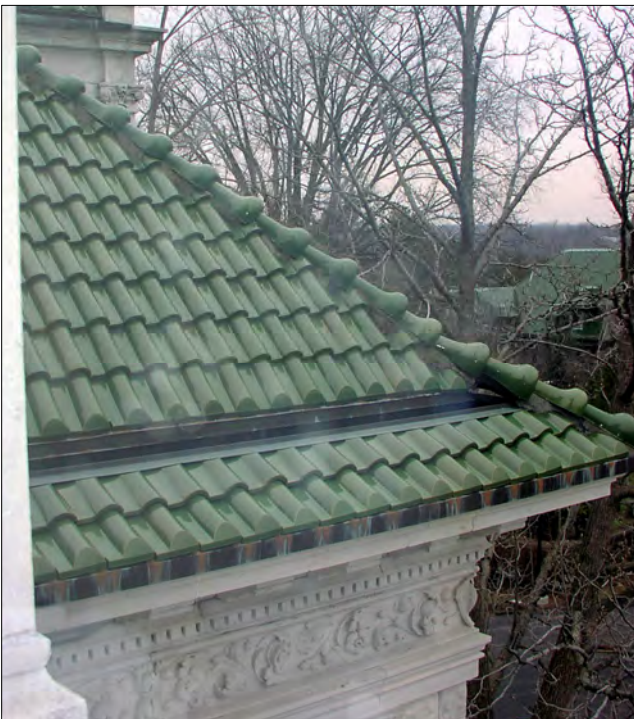
Gutters originally used steam to help melt snow and ice on the roof. This system was not duplicated when the new clay roof was installed.

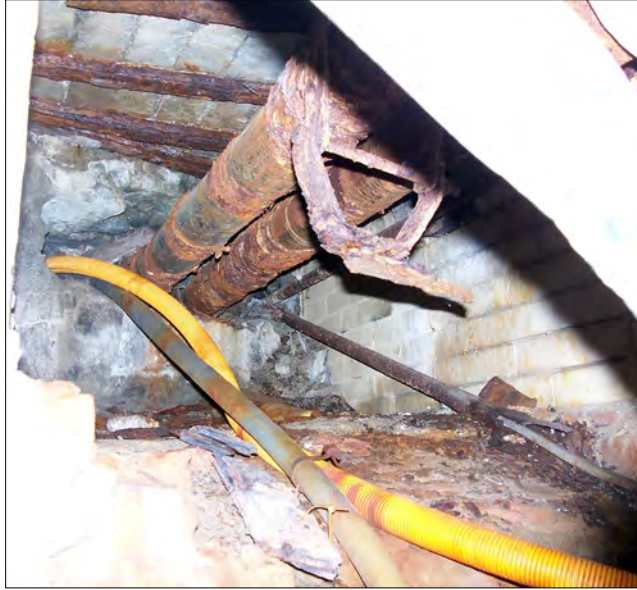
Deteriorating cooling tower piping in the service tunnel.

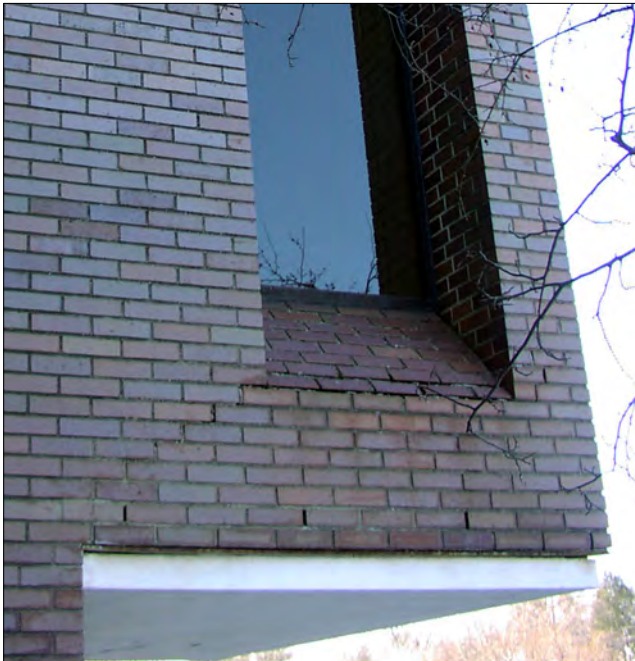
Deteriorating mortar joints should be raked and repointed to prevent further damage to the wall system.

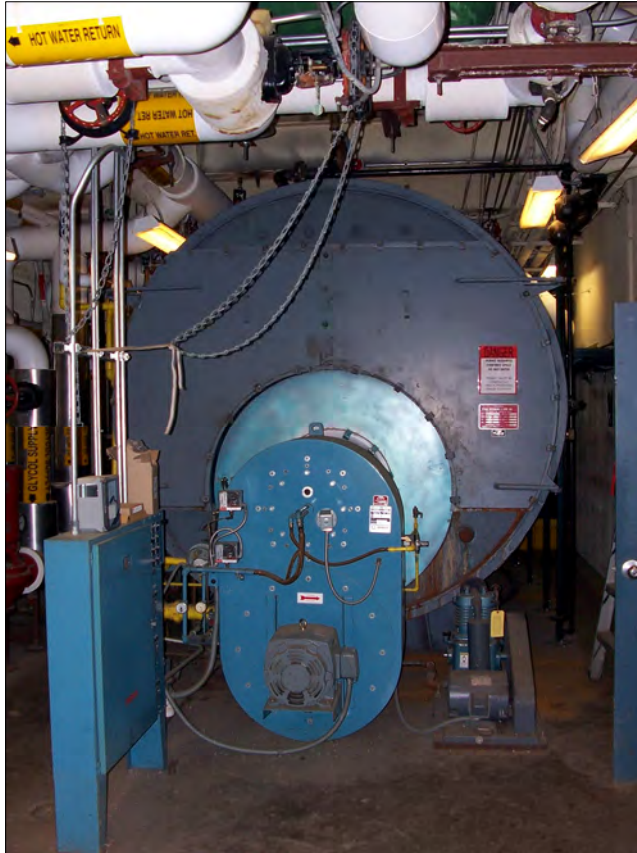
A small boiler should be installed for summer use so the large 600-Hp boiler shown above does not have to be used during summer months.

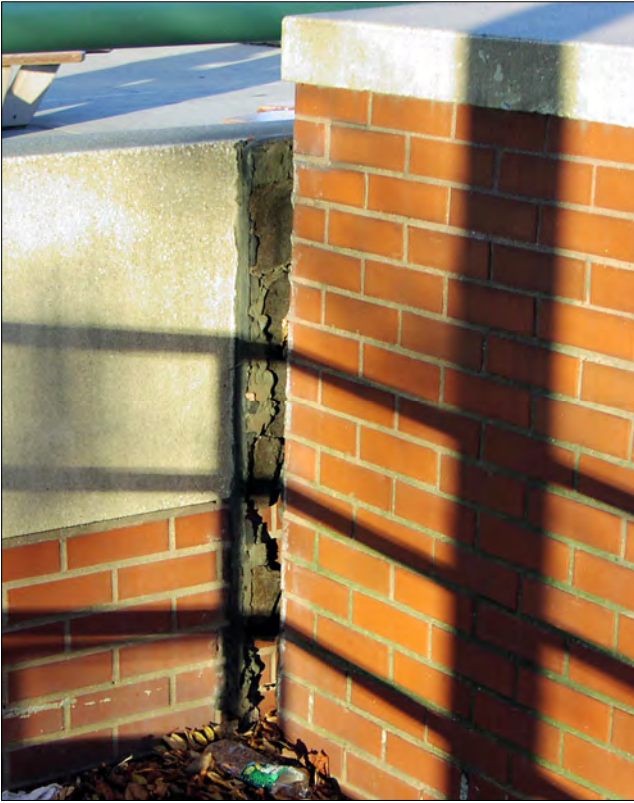
One of the site walls appears to have settled, resulting in cracks in brick mortar joints and separation from another site wall.

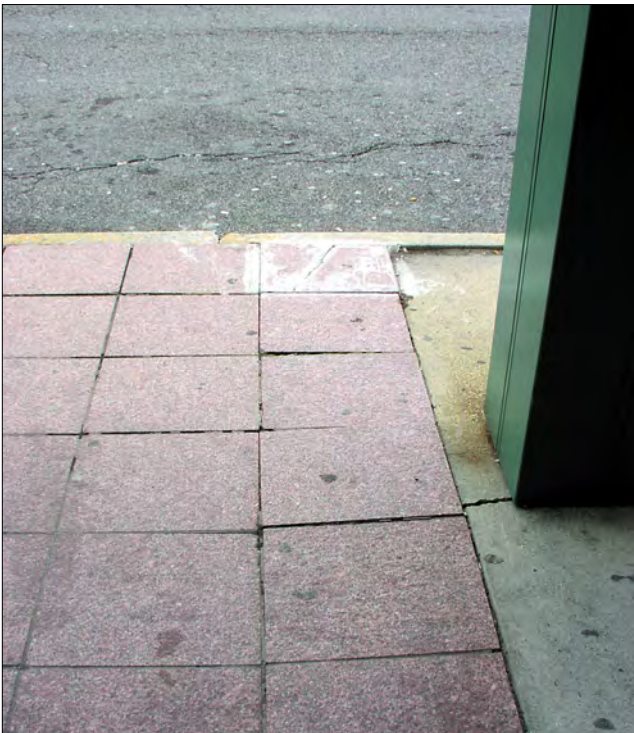
Damaged and heaving sidewalks and curbing should be repaired or replaced, as needed.

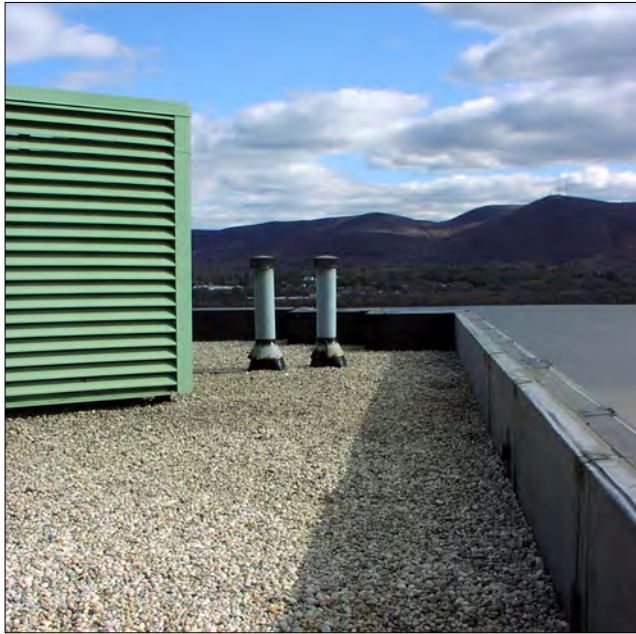
A new ballasted membrane room system will be needed and the standing-seam metal roof needs repairs.

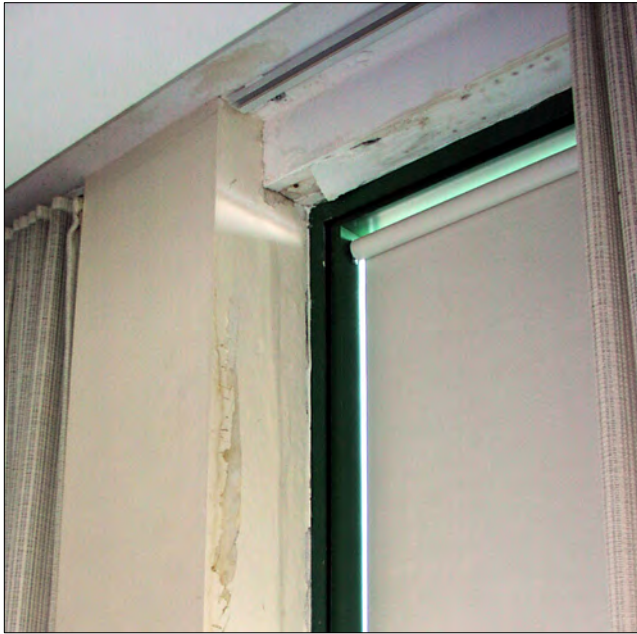
Interior water damage appears to be the result of improperly placed wall flashing and weep holes above windows.

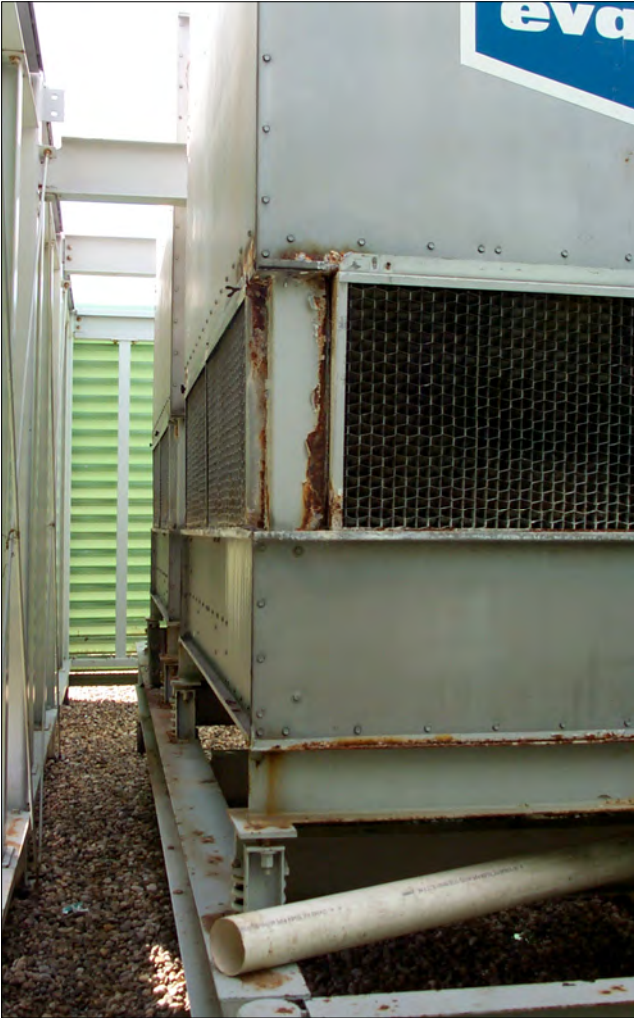
The two open cooling towers should be replaced.

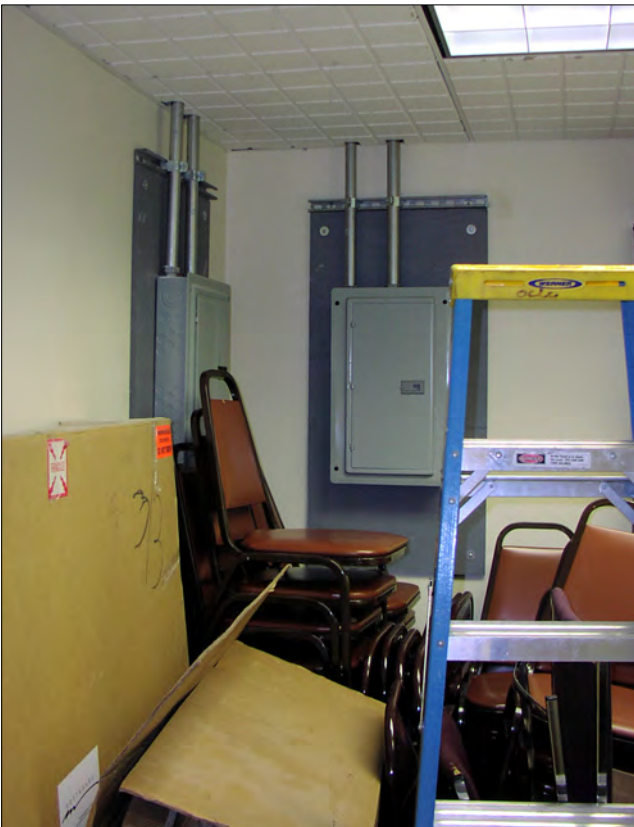
Access to electrical panels should not be blocked by stored items.

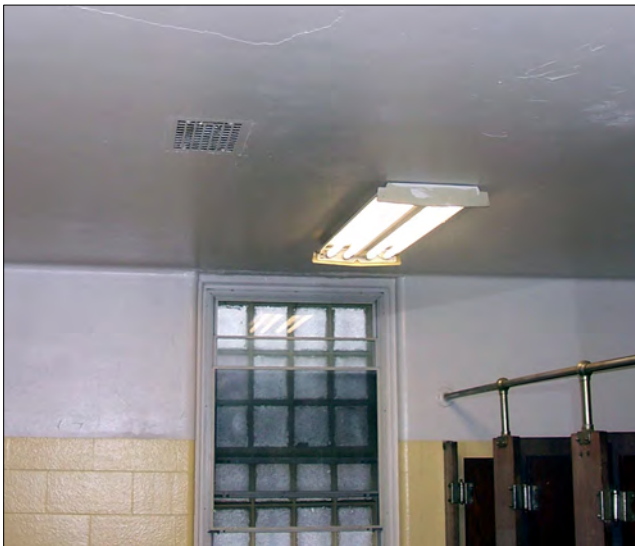
Gravity exhaust opening, located in some of the toilet rooms, would need to be replaced with exhaust fans.

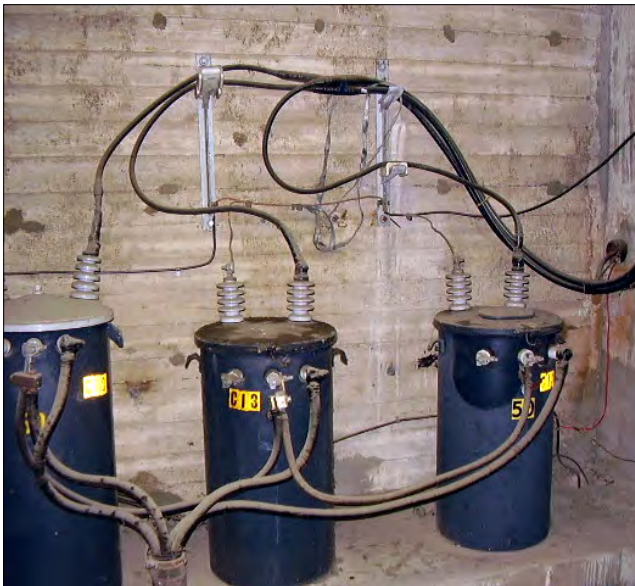
The building's transformers are old and in poor condition.

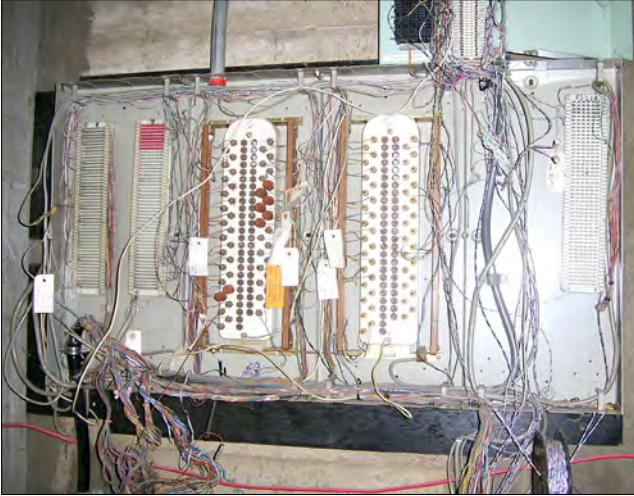
The existing telephone and data distribution system would need to be replaced.
