## 2006 Master Plan Update

# SUNY ORANGE

# Master Plan Update

Presented to the OCCC Board of Trustees on 8 May 2006

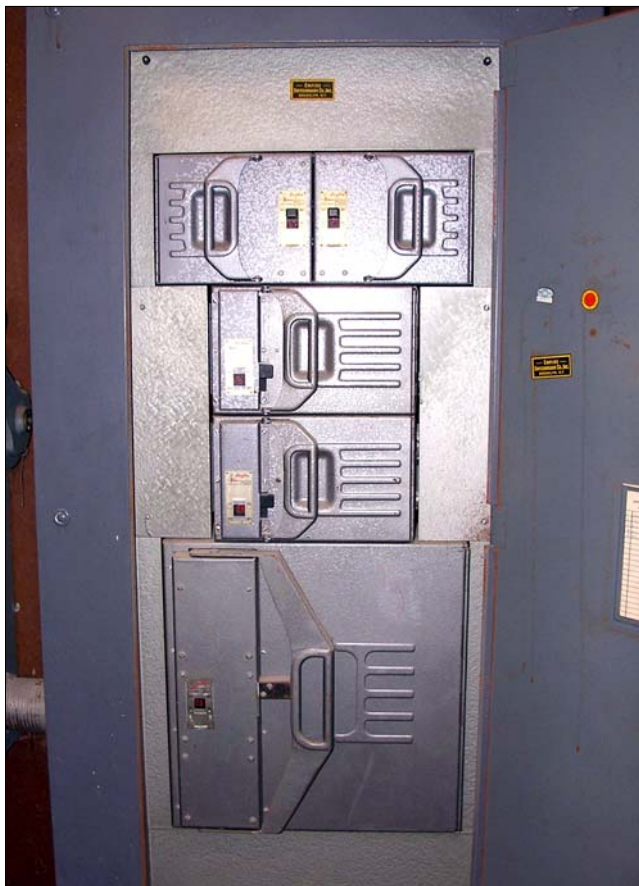
The distribution switch gear and main disconnect switch for the campus are located in the basement of Hudson Hall. The draw-out fuse boxes (shown below) can be pulled out while still under a live electrical load, presenting a possibly hazardous condition. The distribution equipment should be replaced.

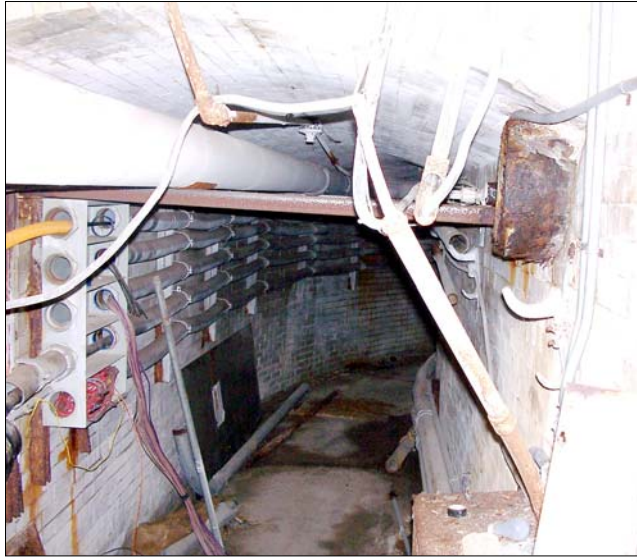
View of the underground service tunnel.

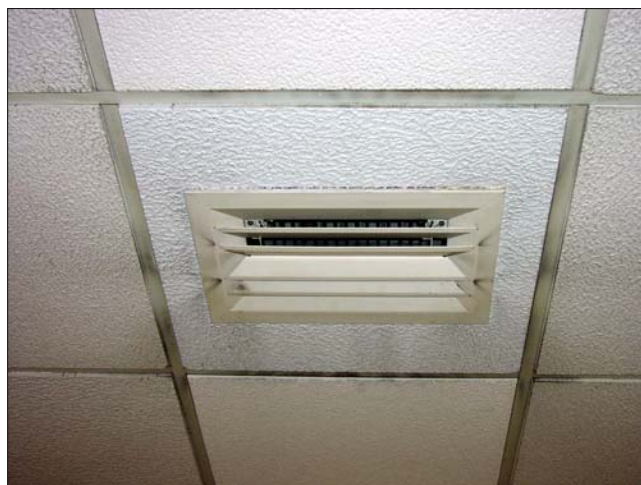
Black dirt can be seen at many air supply diffusers.

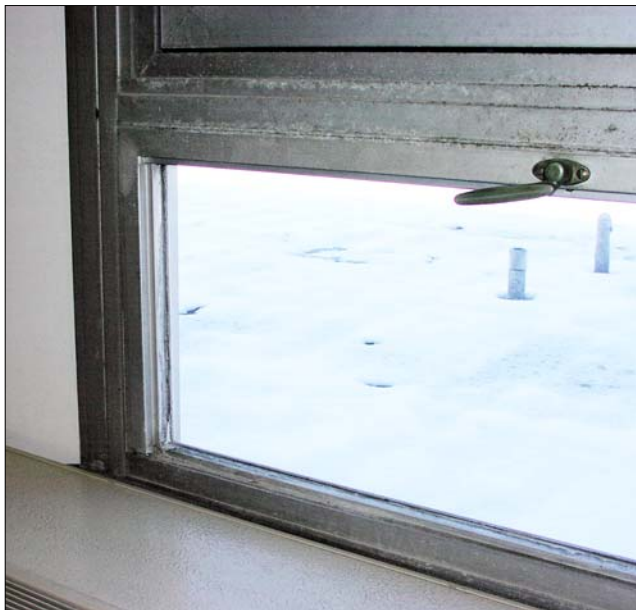
The building's windows are in poor condition and they are not energy-efficient. The College should replace the curtainwall system.

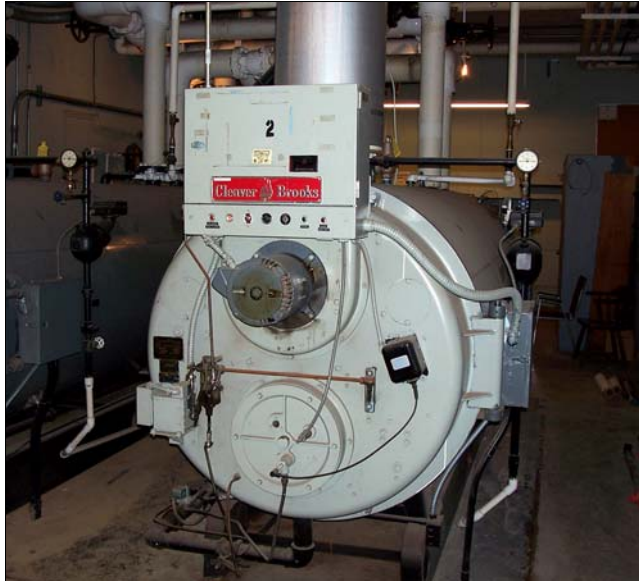
The original boilers are past their useful life and should be replaced within the next ten years.

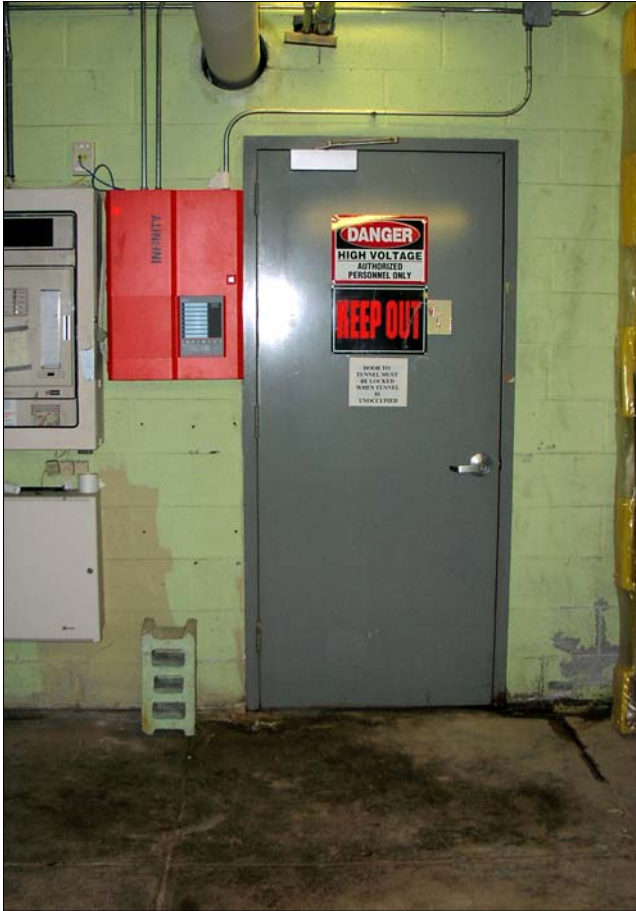
Water can be seen seeping into the basement of Horton Hall at the base of the service tunnel door, shown above. Water infiltration also occurs at the base of the basement wall, as shown below.

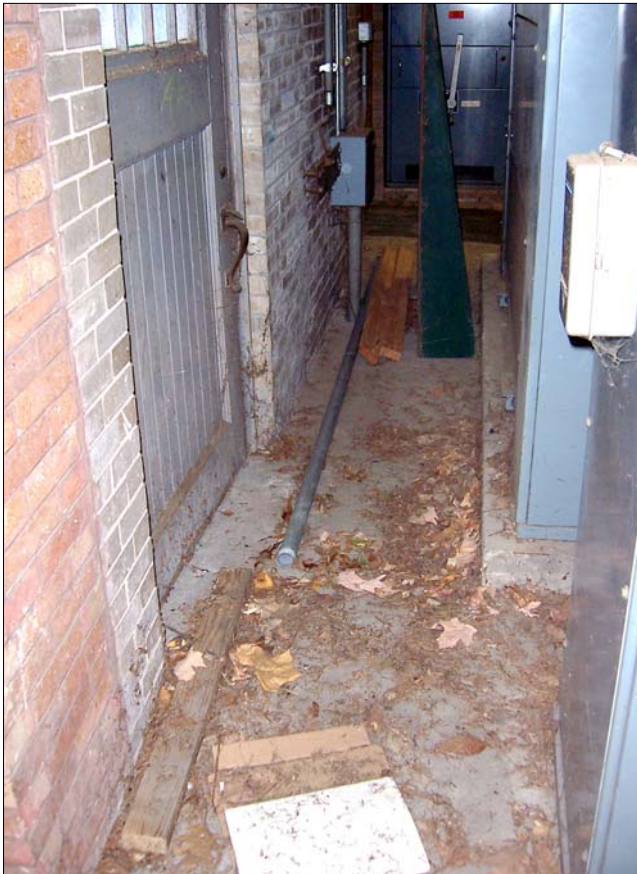
Dirt, leaves and other debris found throughout the upper floor of the building can infiltrate the transformers as there are no filters on these older units.

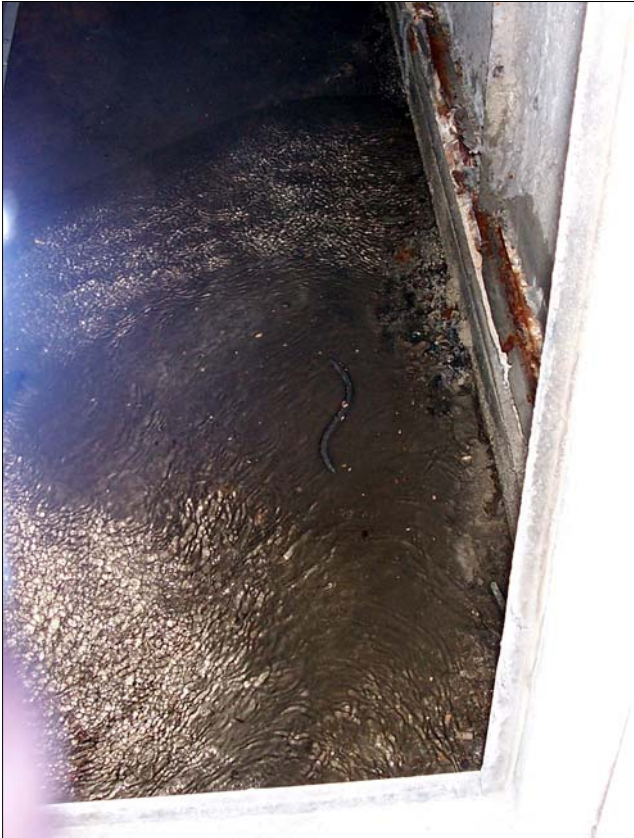
The source of the standing water in the cooling pan of the air-handling unit should be found and eliminated. This moisture source has added to the deterioration of the building's electrical distribution system.

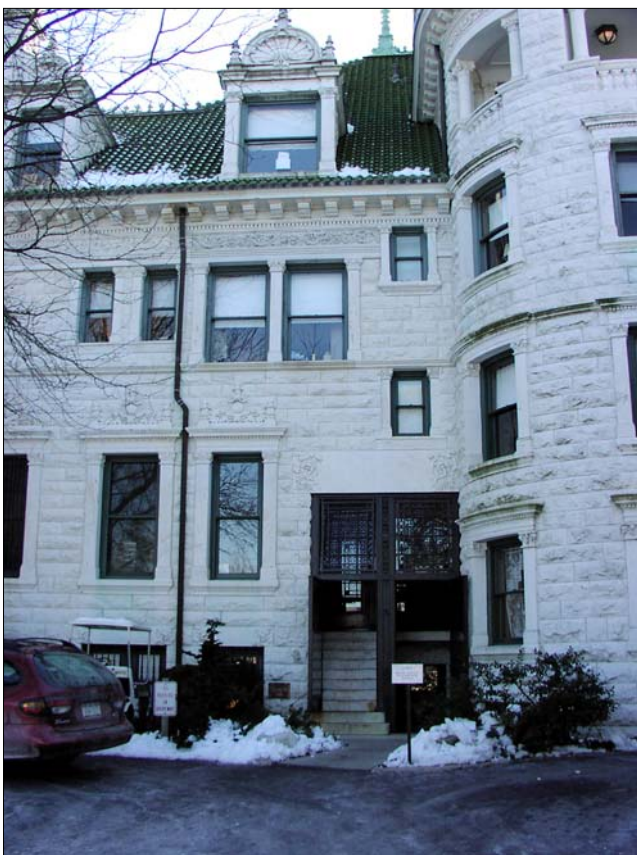
Snow and ice falling from the roof pose a potential hazard to pedestrians below.

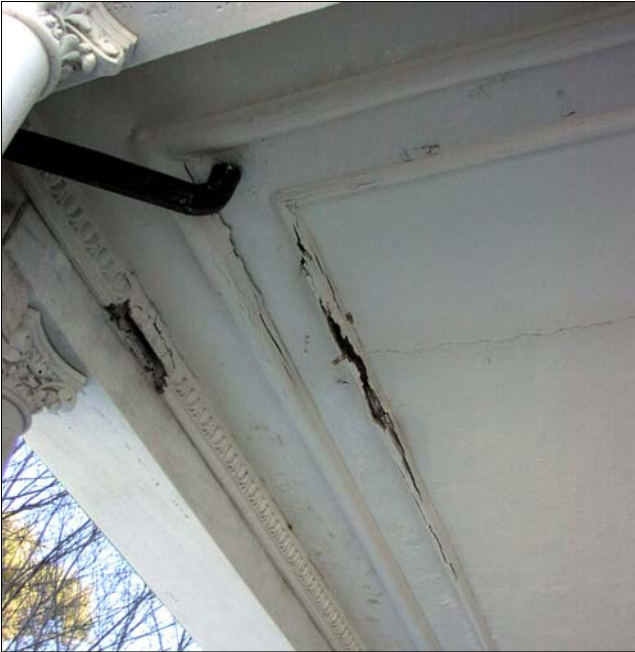
Damage to flat roof sections has affected the ceilings below.

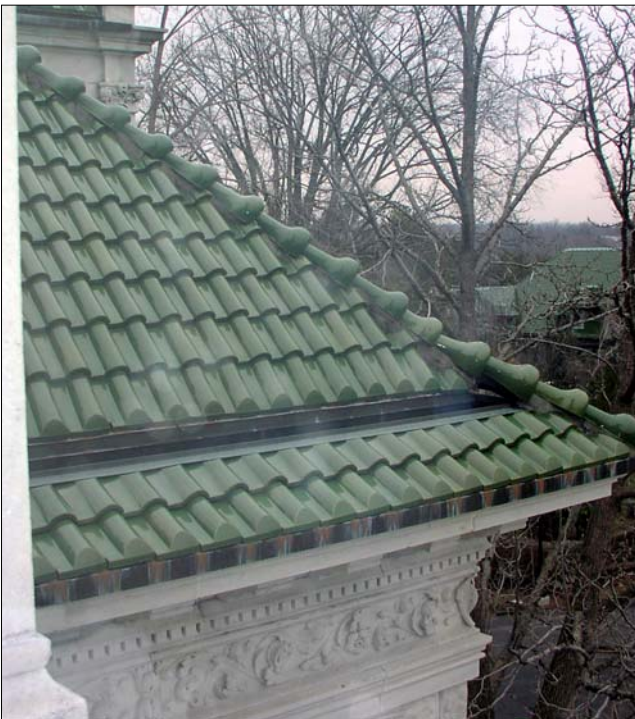
Gutters originally used steam to help melt snow and ice on the roof. This system was not duplicated when the new clay roof was installed.

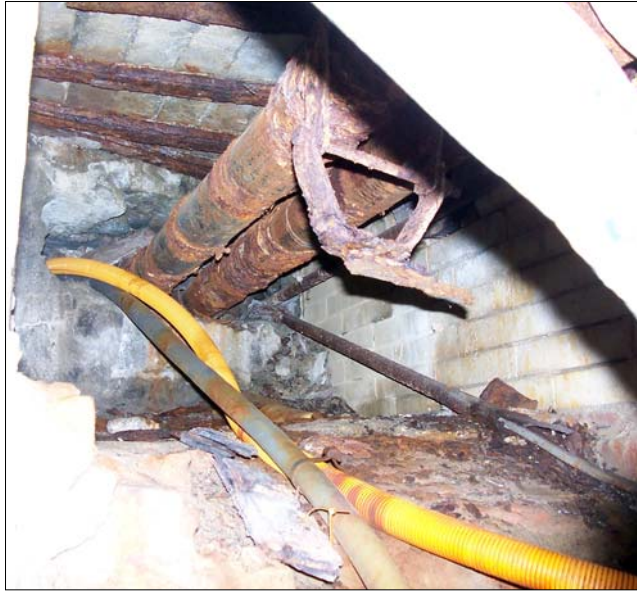
Deteriorating cooling tower piping in the service tunnel.

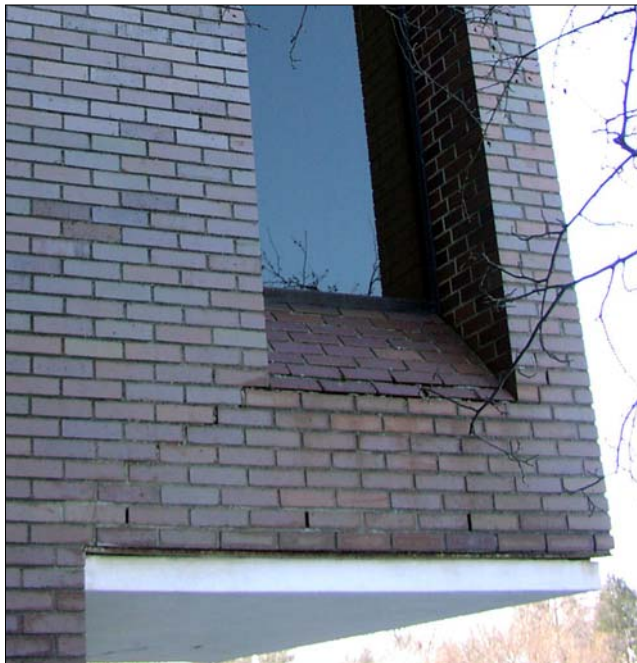
Deteriorating mortar joints should be raked and repointed to prevent further damage to the wall system.

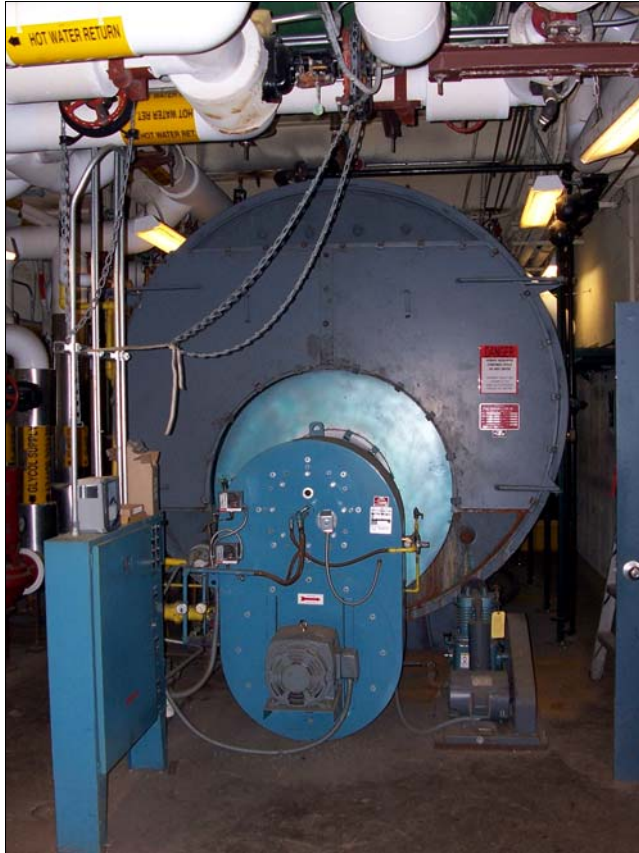
A small boiler should be installed for summer use so the large 600-Hp boiler shown above does not have to be used during summer months.

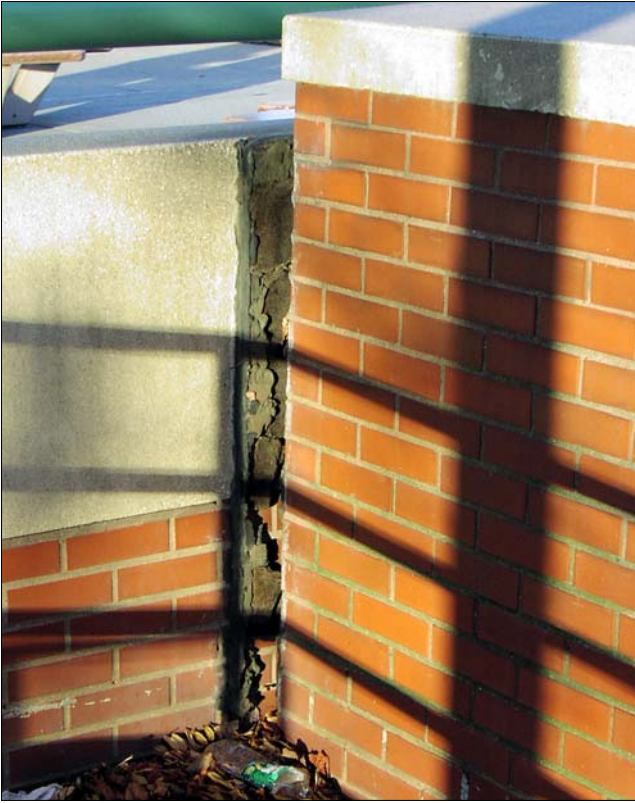
One of the site walls appears to have settled, resulting in cracks in brick mortar joints and separation from another site wall.

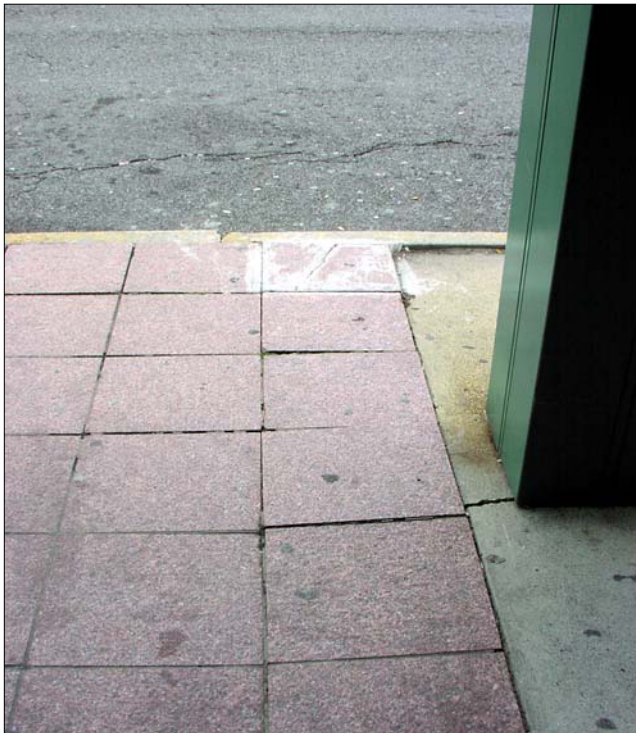
Damaged and heaving sidewalks and curbing should be repaired or replaced, as needed.

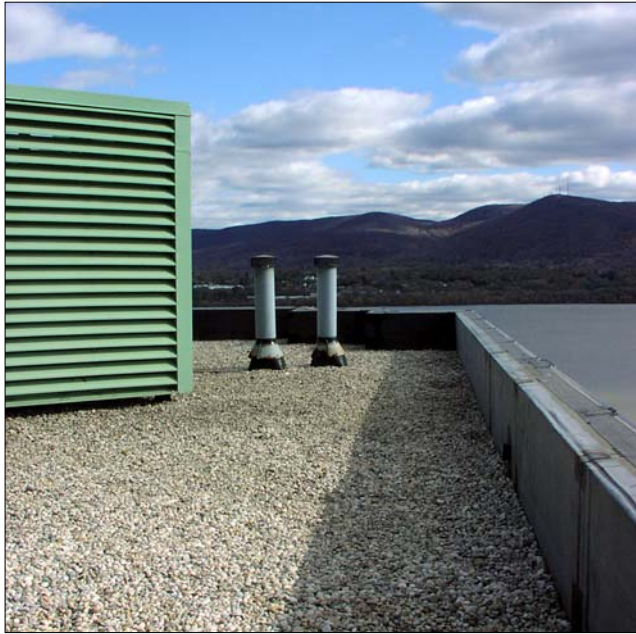
A new ballasted membrane room system will be needed and the standing-seam metal roof needs repairs.

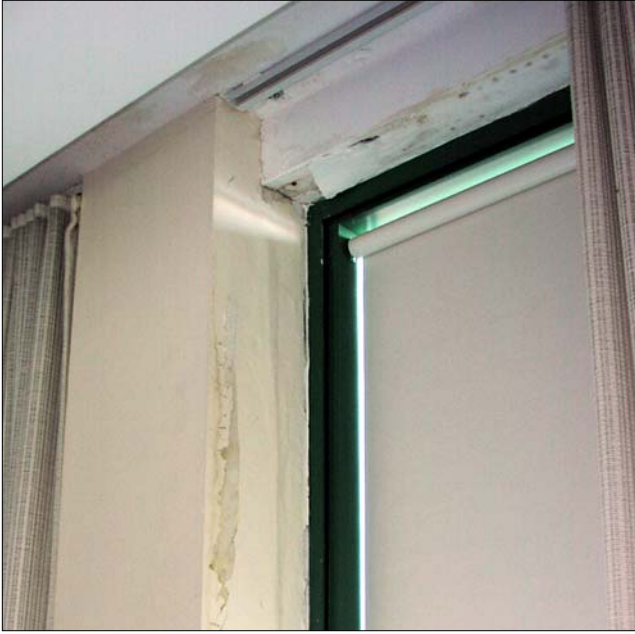
Interior water damage appears to be the result of improperly placed wall flashing and weep holes above windows.

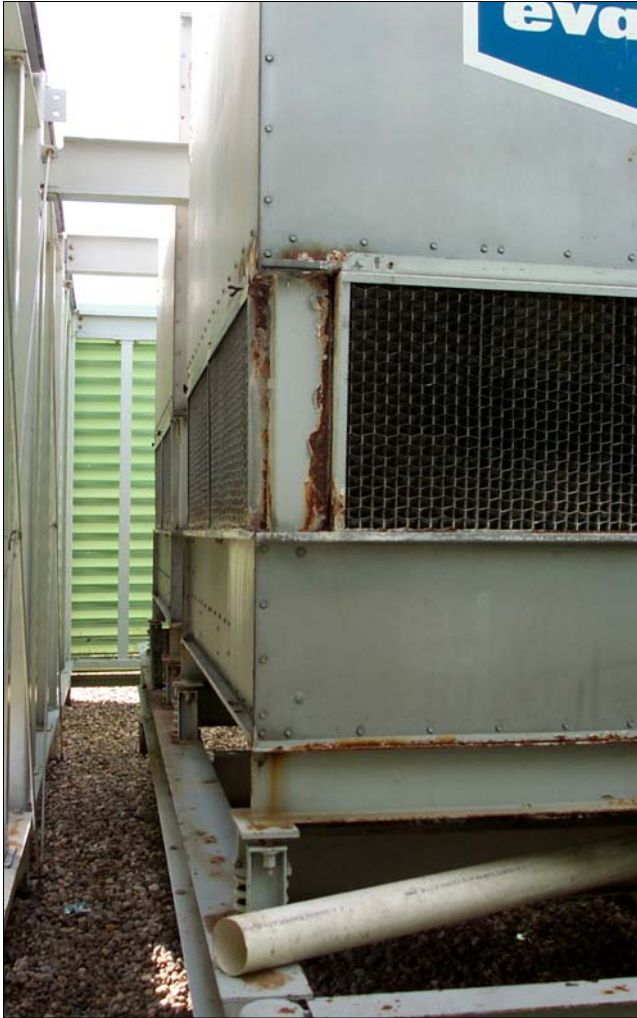
The two open cooling towers should be replaced.

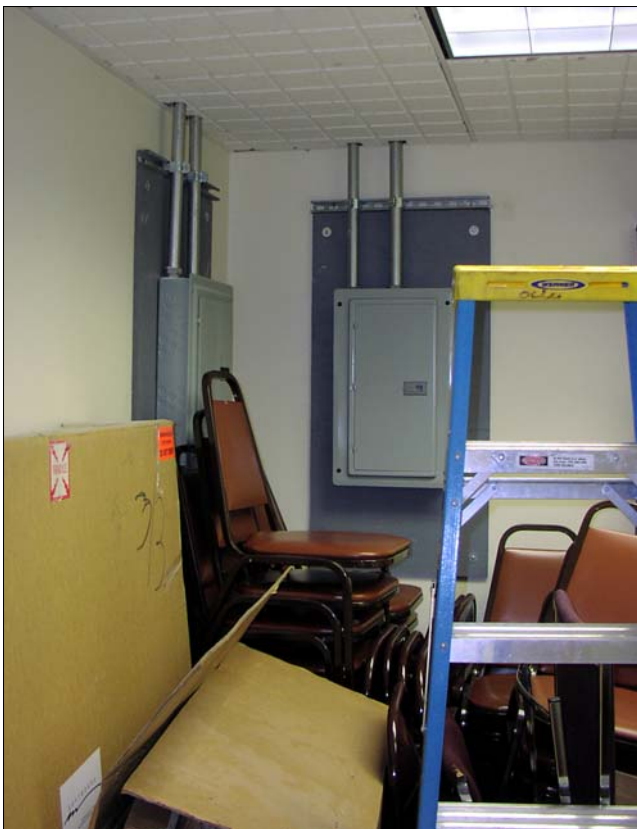
Access to electrical panels should not be blocked by stored items.

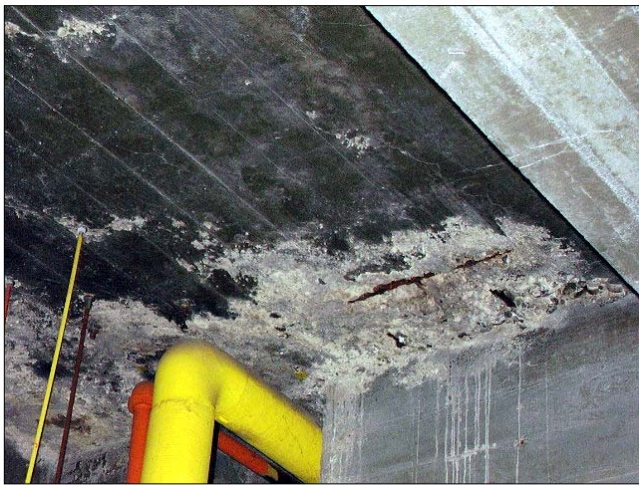
Water infiltration in basement below the ramp is resulting in deterioration of the concrete structure.

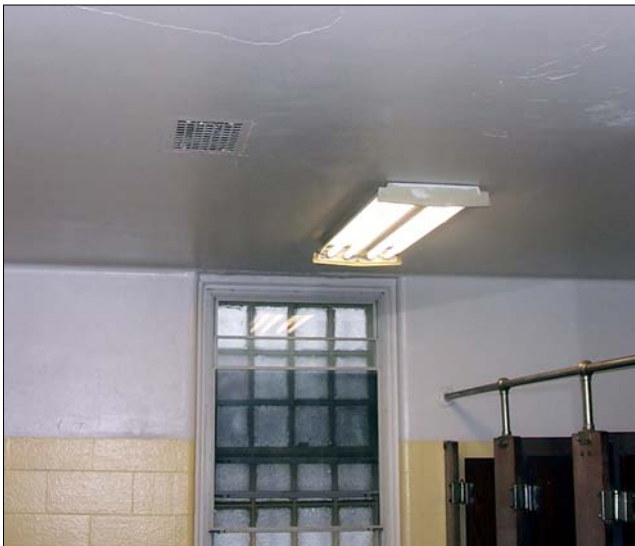
Gravity exhaust opening, located in some of the toilet rooms, would need to be replaced with exhaust fans.

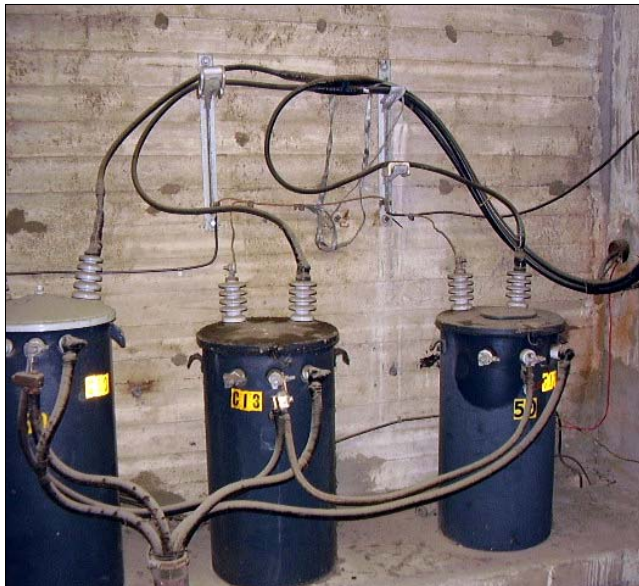
The building's transformers are old and in poor condition.
