2006 Master Plan Update

SUNY ORANGE

Master Plan Update

Orange County Community College

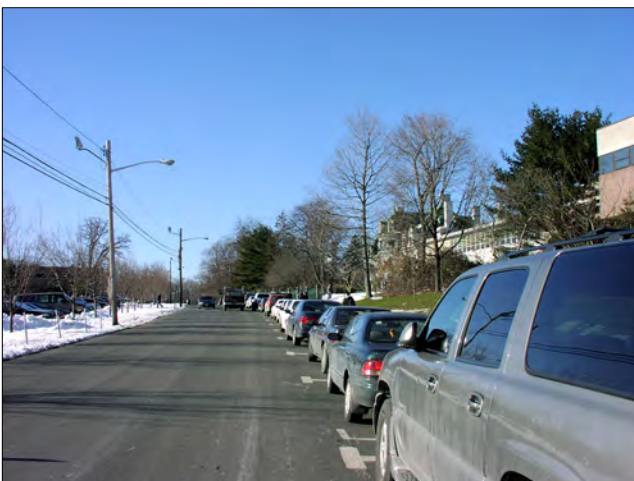
College personnel report that several times a year students are hit by cars on South Street.

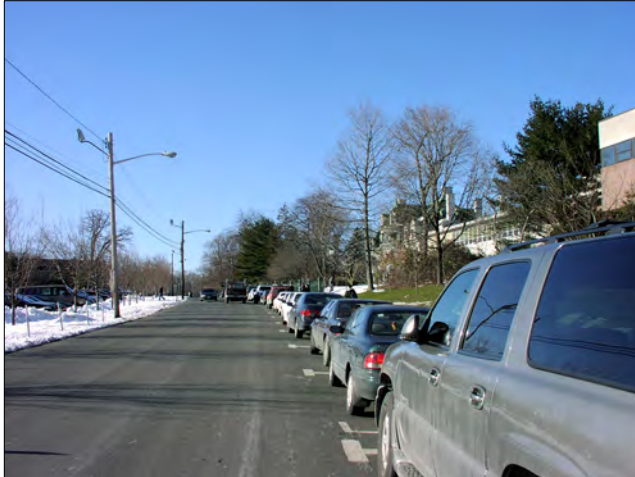
Reportedly, several students are hit by cars each year as they cross South Street.

South Street also presents a hazard as several students are reportedly hit by cars each year as they cross the street. This appears to be due, in part, to vehicle speed but also because the crosswalks are poorly defined. Closing a portion of South Street to through traffic would connect the two sides of the campus and eliminate these dangerous vehicular/pedestrian conflicts. South Street is a busy thoroughfare, however, and this may be difficult to accomplish.

- **Improvements to South Street.** The pedestrian/vehicular conflicts that occur along South Street are a significant issue that will be addressed by this Master Plan. While improvements such as creating well-defined crosswalks and road edges, improving site lighting and signage, burying overhead wiring and introducing trees, banners, and raised planters would all help to “calm” traffic and reduce the number of accidents, additional issues must be addressed. For example, the main pedestrian entry route to the campus is also used by vehicles. This Master Plan will examine ways to separate these two to improve pedestrian safety. In addition, there is a need to create a better connection between the two sides of the campus and clearly signal to drivers that they have arrived on the Middletown Campus.

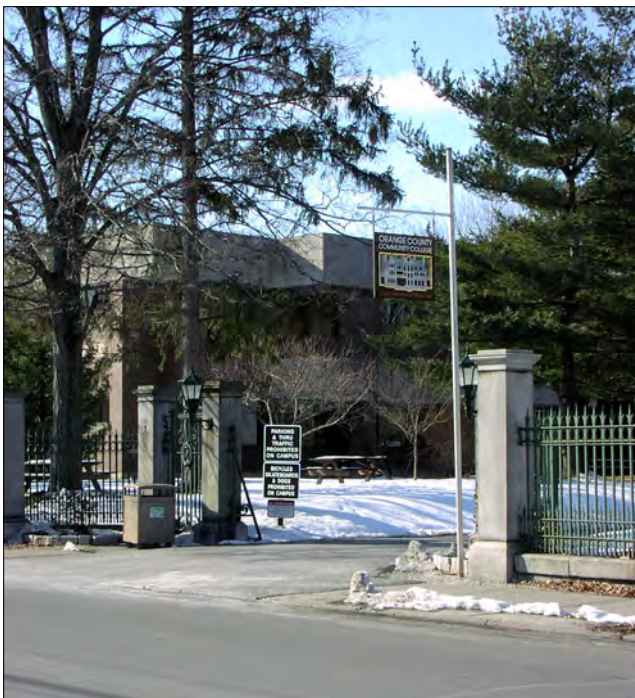
The primary vehicle entry to the campus core is also the primary pedestrian entry point. These two should be separated from each other.

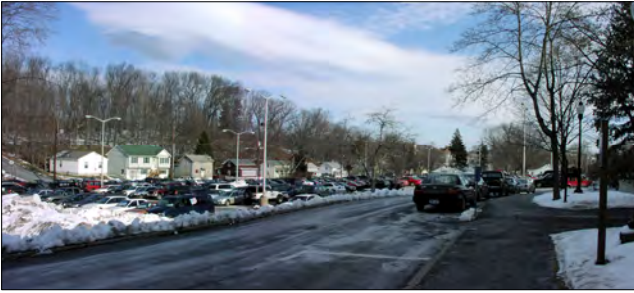
An additional entry to the Orange Hall parking lot should be constructed from Wawayanda Avenue.

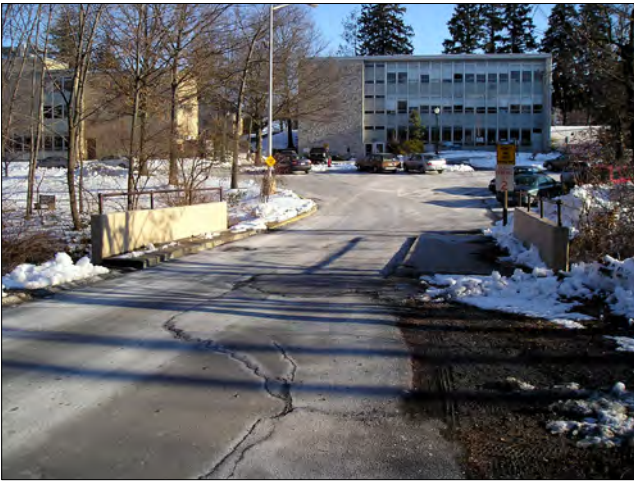
The College should consider widening the road and bridge at the entry to the Harriman Hall parking lot.

- **Widen the entrance road and bridge at the Harriman Hall parking lot.** The existing entry road and bridge are quite narrow, making it tight for two cars to cross the bridge at the same time. The College should consider widening the roadway to improve traffic flow in this area.

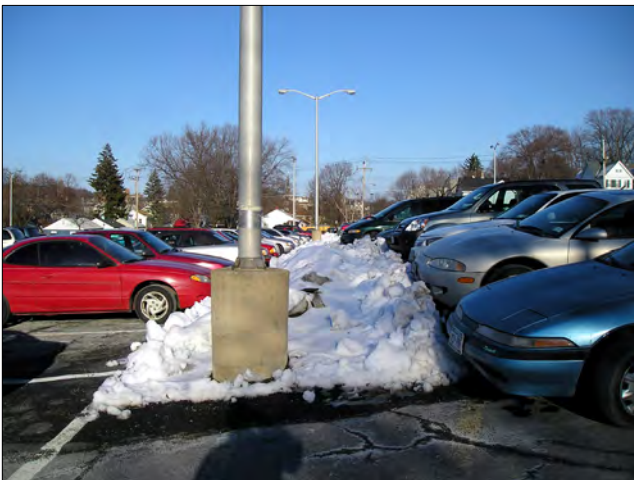
Regrading and reconfiguring the Orange Hall parking lot could result in the creation of additional parking capacity.

- **Reconfigure the Orange Hall parking lot.** The College plans to resurface the Orange Hall parking lot in 2006. The lot currently contains some awkwardly positioned parking spaces. In addition, grade changes between parking rows consume a fair amount of space. Additional spaces may be created by regrading and reconfiguring the entire lot in conjunction with the planned repaving and restriping project.
- **Resurface the tennis court parking lot.** The parking lot adjacent to the tennis courts is in poor condition and should be resurfaced.

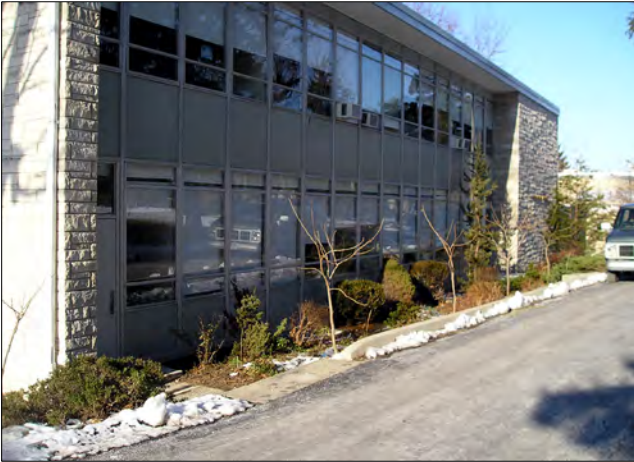
An access ramp is needed at Sarah Wells to make at least the quad level floor accessible.

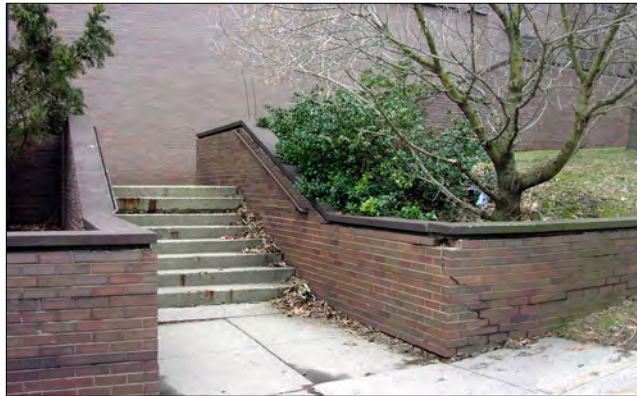
The site wall and stair at the southeast corner of the Bio-Technology Building are beginning to deteriorate.

- **Redesign the plaza and walkways north/northwest of the Bio-Technology Building.** As mentioned previously, the plaza and sidewalks north/northwest of the Bio-Technology Building are in poor condition. The College should consider redesigning the area and reducing the amount of paved surface around the building. A portion of the concrete plaza could be replaced with landscaped beds to improve the appearance of this well-traveled area.

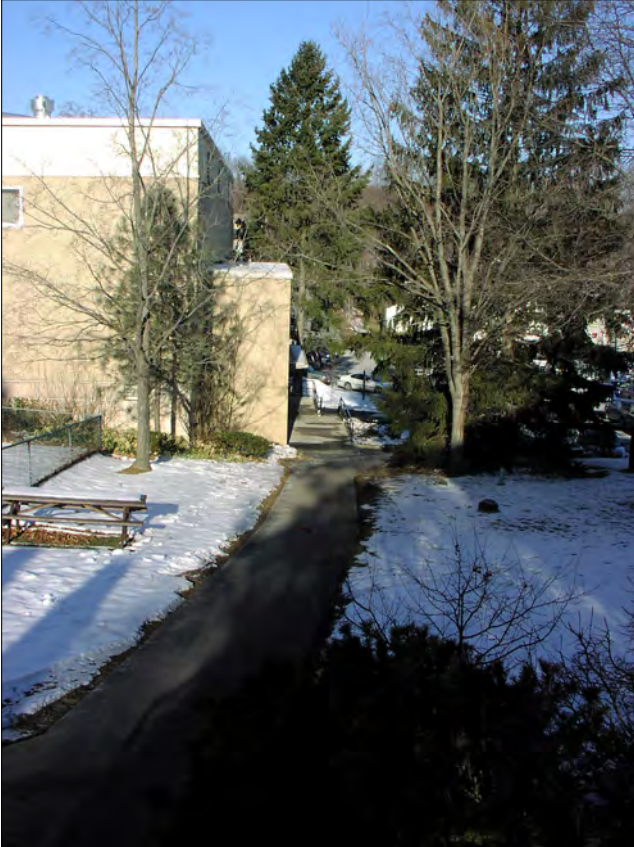
Additional site lighting should be installed along the walkway between Orange and Horton Halls.

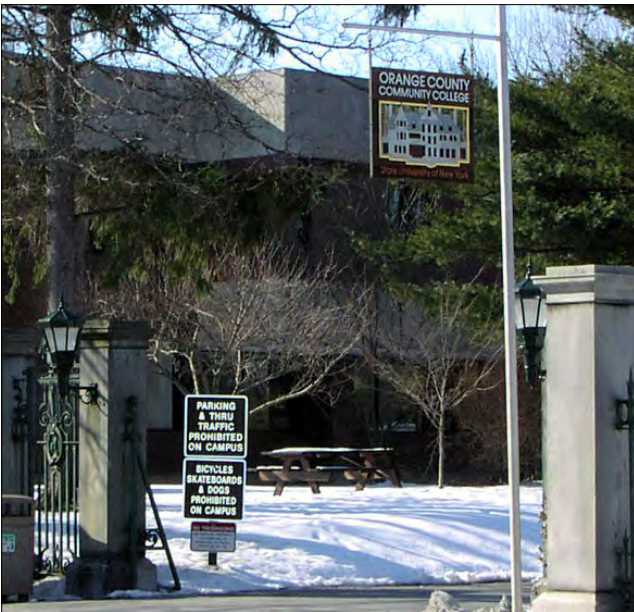
A comprehensive campus signage plan should be developed to improve exterior wayfinding and informational signage throughout the campus.

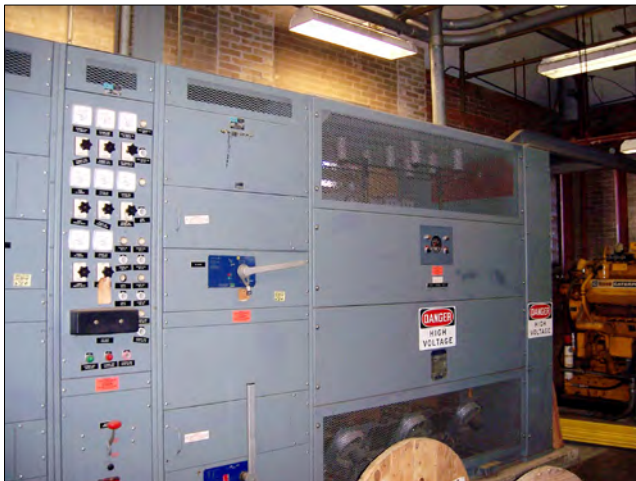
The main switchgear equipment and transformer in the Ice House are past their useful life and should be replaced.

- **Replace the main switchgear equipment.** The 13.2 kV switchgear is over 40 years old and past its useful life. The switchgear equipment and the transformer should be replaced. Prior to the replacement of the switchgear. A study should be completed to determine the most appropriate switchgear and distribution system for the College. The study should evaluate reliability, constructability, first cost and maintenance costs. The design will need to be compatible with the new emergency generator system installed approximately five years ago.

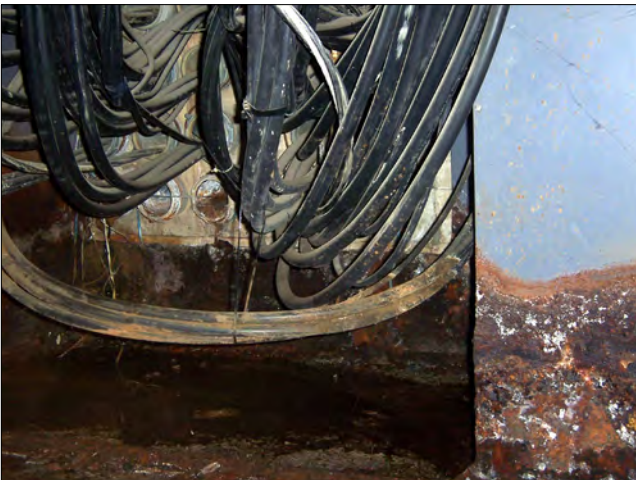
The tunnels beneath the Ice House expose the existing secondary distribution system to a deleterious environment for electrical equipment and conductors. The tunnel/basement area beneath the Ice House is constantly infiltrated with flowing

ground water. This has resulted in extensive damage to the existing junction boxes and conduit, exposing conductors to possible water damage, as well. If allowed to continue, this condition could lead to an electrical failure.

The electrical junction box in the basement of the Ice House is severely deteriorated because of water infiltration through the conduits.

This extensive project is recommended because all of the secondary power for the campus passes through the tunnel area under the Ice House. Here, the condition of the raceways is very poor and the cabling is openly exposed to excessive ground water. The underground feeders to the campus buildings are of the same vintage as the switchgear in the Ice House. In the event of a catastrophic electrical failure at this location, a significant portion of the campus would be without power for an extended period of time. The new ductbank system could also accommodate telephone and data lines.

- **Construct a new underground ductbank system.** Install a new 480 volt secondary underground ductbank electrical distribution system to serve the entire campus. The ductbank should originate either from the Ice House, or from wherever the new switchgear equipment is located. The ductbank should run to all campus buildings on the north side of South Street. Underdrains should be installed to prevent water infiltration in the new ductbank.

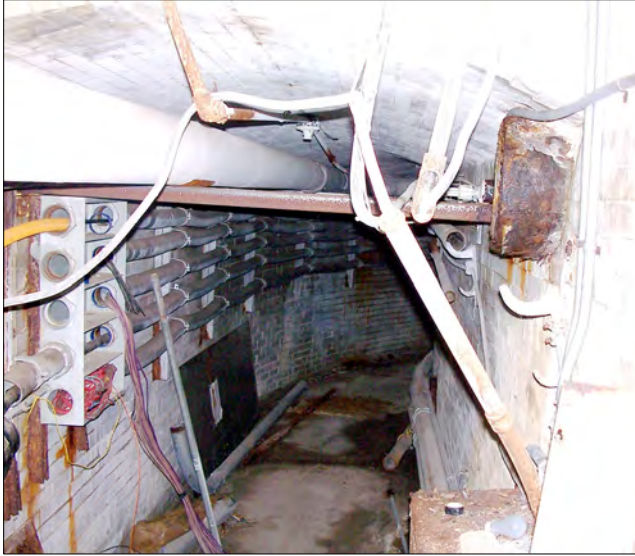
View of the underground service tunnel.

- **Replace lighting fixtures in the service tunnels.**
The existing lighting in the service tunnels is in extremely poor condition due to excessive corrosion. Once the new ductbank and electrical distribution system is in place, the deteriorating lighting fixtures and the abandoned electrical cabling should be removed from the service tunnels. If the College wishes to maintain the tunnels for their historical value, a new lighting system designed for wet locations and controllable from all three tunnel end locations should be installed.

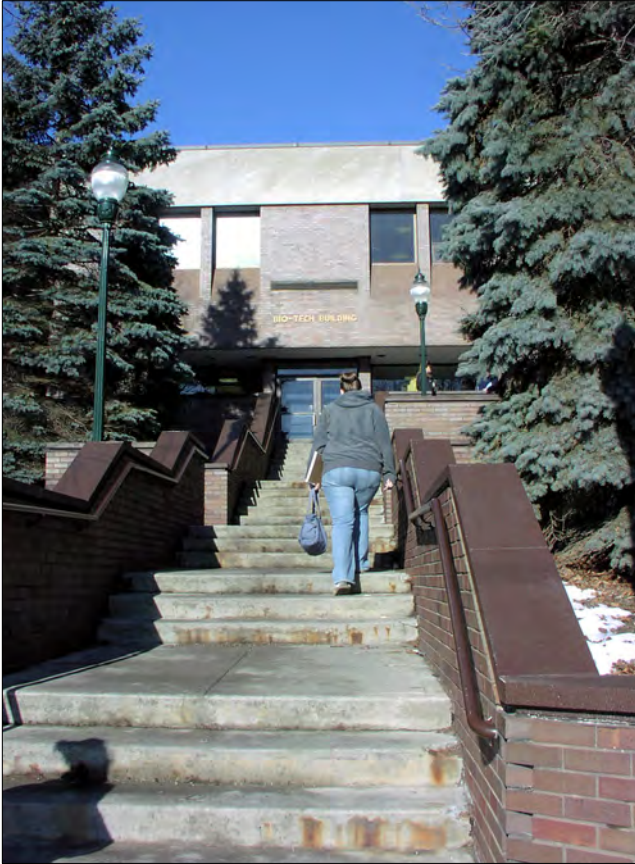
The exterior south stair to the Bio-Tech Building.

- **Repair southeast exterior stair and site wall.** The exterior stair and site wall at the southeast corner of the building is beginning to deteriorate. Repairs should be made to prevent further deterioration.

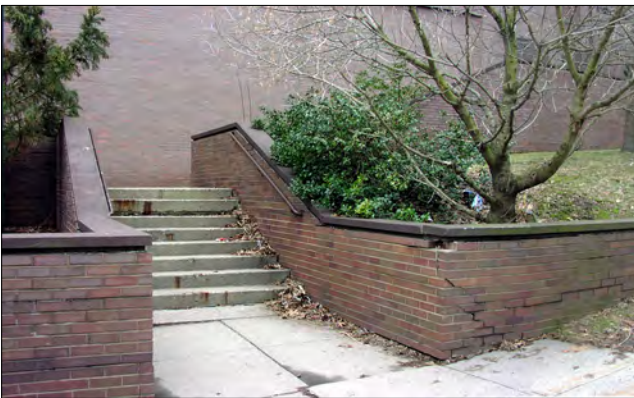
Deteriorating plazas to the north/northeast of the building should be repaired. The retaining wall at the southeast site stair (below) is also in need of repair.

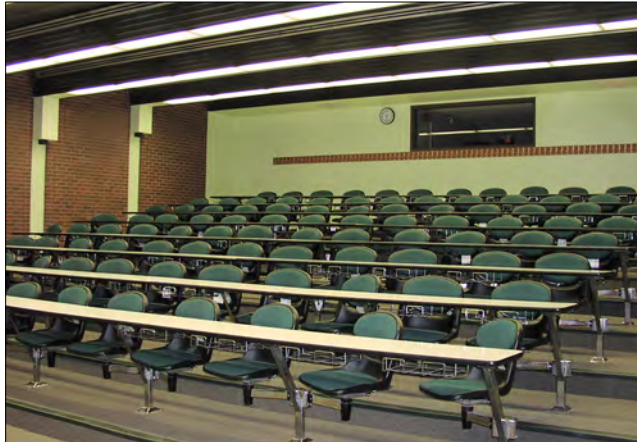
New seats were installed in BT311.

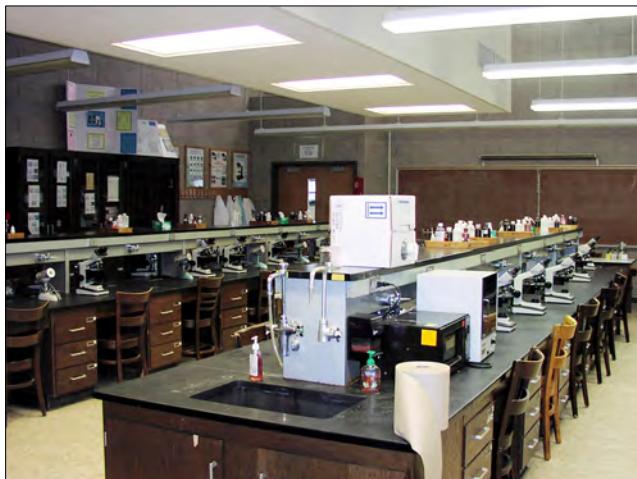
Faculty report that the risers on the lab tables in BT315 interfere with teaching.

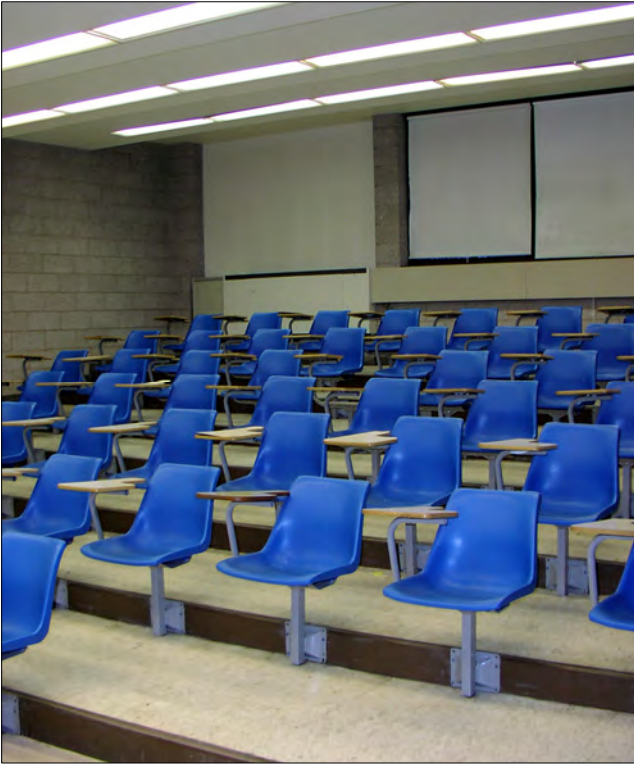
Tiered classrooms should be updated with seating that is more appropriate for today's students.

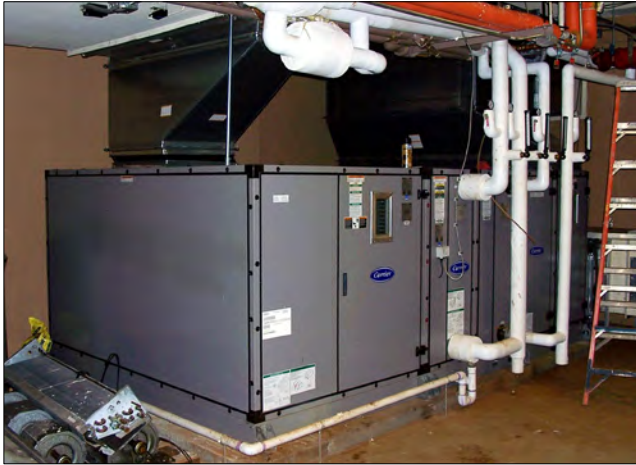
New air-handling unit located in the basement.

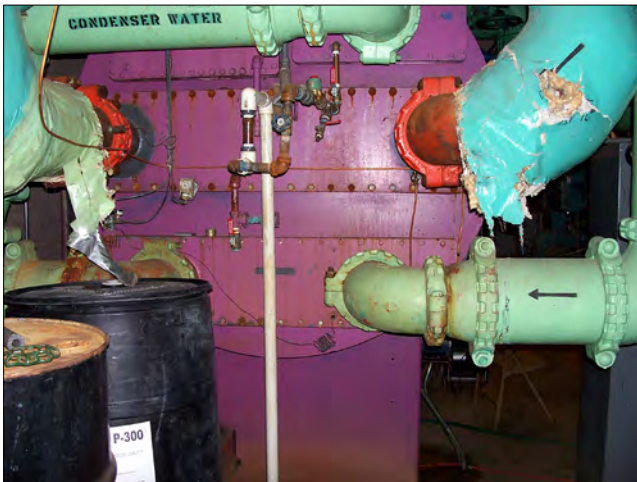
The existing absorption chiller is being replaced.

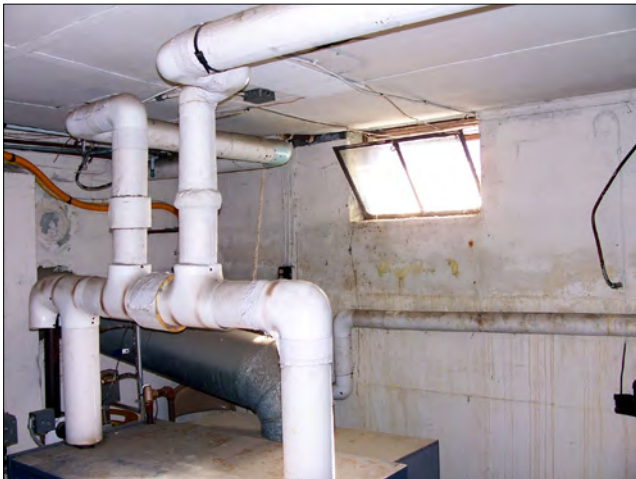
The boiler piping should be reworked to comply with manufacturer's recommendations.

- **Provide a dedicated outdoor air/ventilation system.** The house currently does not have a ventilation system that delivers fresh air to occupied spaces, as required by the NYS Building Code. A dedicated outdoor air system should be installed.
- **Modify the boiler piping.** The steam boiler should be re-piped so the piping is in accordance with manufacturer's recommendations. Also install a reduced-pressure zone backflow preventer.
- **Provide adequate combustion air for the boiler.**
- **Update the fire alarm system.**
- **Install public address and master clock systems.**

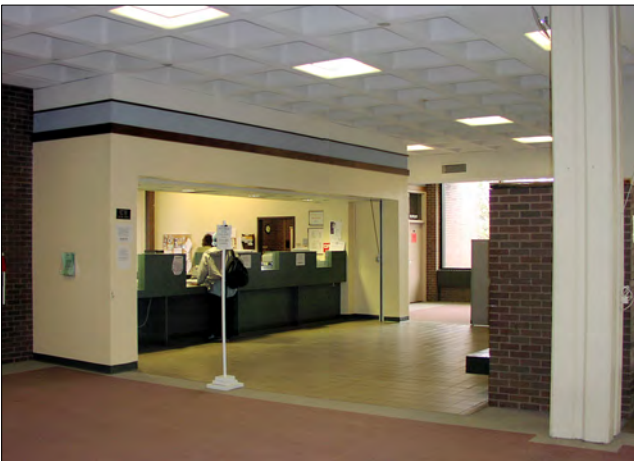
A roll-down fire shutter was installed at the Bursar's counter, located in the main lounge on the second floor.

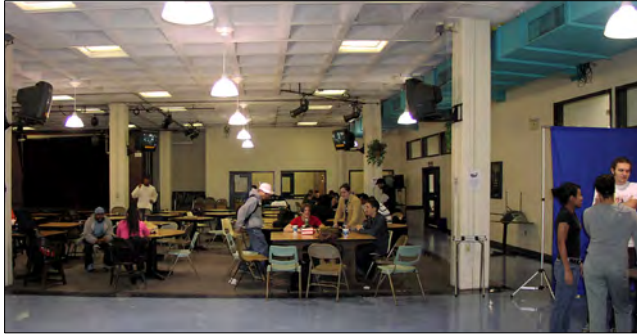
The cafeteria should be renovated to make it more appealing to students and the rest of the College community.

- **Upgrade interior finishes and improve lighting.** Upgrade the interior finishes and lighting throughout the building in conjunction with a Master Plan project to reconfigure and renovate the Commons.
- **Renovate the cafeteria.** The high school-type cafeteria should be updated. The existing kitchen equipment is 32 years old and should be replaced. Instead of duplicating the existing cafeteria set-up, however, the College should consider creating a food court where the cooking is done in front of the customers, not hidden in the kitchen. Many of OCCC's peers have moved

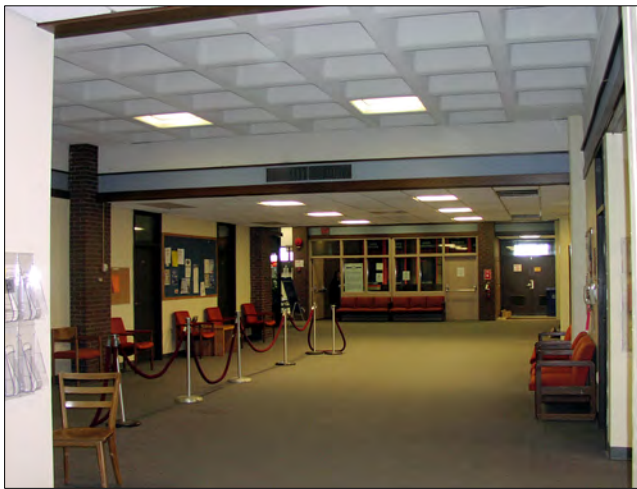
The third floor of the building should be completely renovated and reconfigured to streamline the delivery of student services to students.

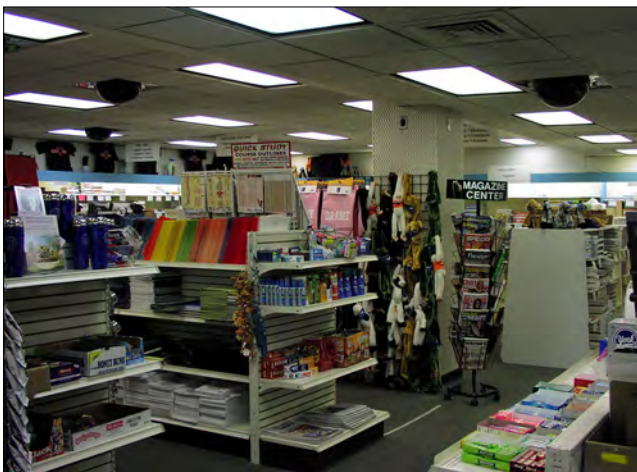
The bookstore should be updated.

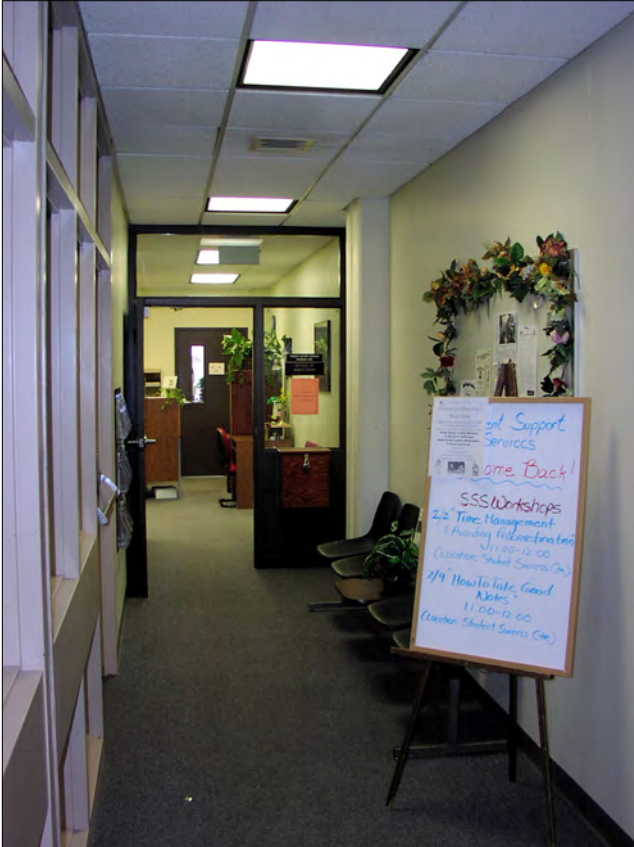
Staff report that some disabled students have had difficulty maneuvering around the cramped Disability Services office area.

part of the renovation of the third floor, improve accessibility to the office of Disability Services. Staff report that disabled individuals have had difficulty moving around the existing office.

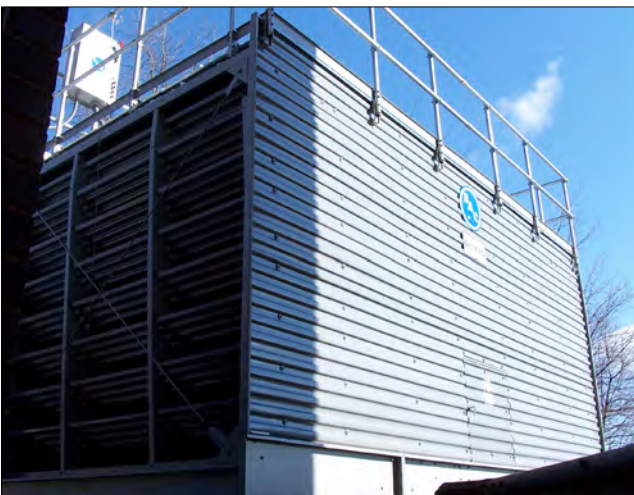
The new cooling tower is scheduled to come online in spring 2006.

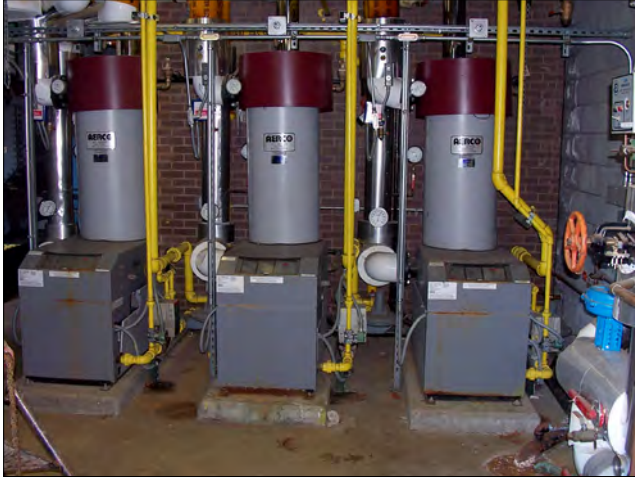
The boilers were recently replaced.

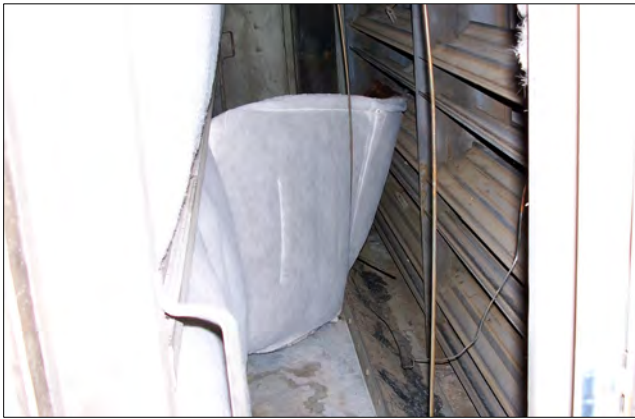
A displaced filter on an air-handling unit should be put back in place to improve indoor air quality in the Commons.

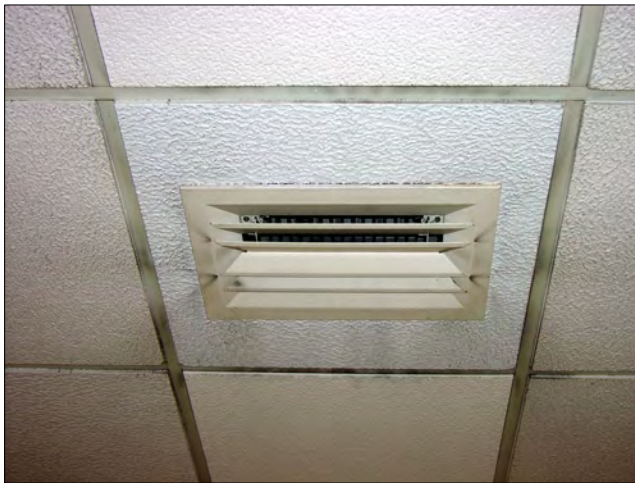
Black dirt can be seen at many air supply diffusers.

- **Clean the supply and return air ducts.** There is evidence of black dirt on the ceilings beside supply diffusers. This Master Plan recommends cleaning the supply and return ducts, and the air-handling units, including coils and outdoor air intakes. The cause of this streaking should be investigated. If the filters are torn or the air is bypassing the filters, this should be corrected. If deemed necessary, an electrostatic air precipitator could be installed to remove dirt from the building air system.

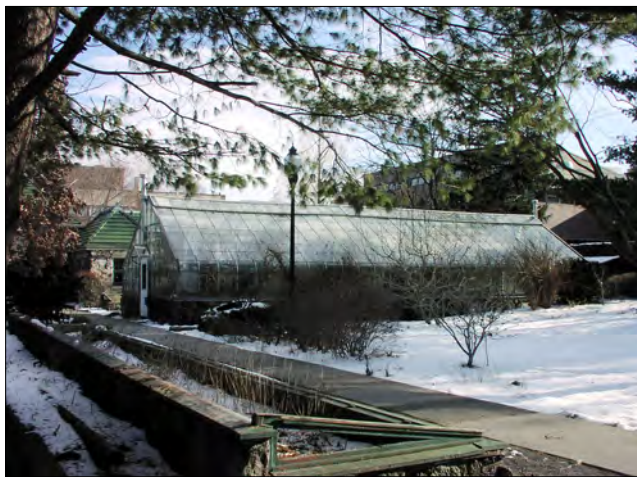
Built in 1908, both greenhouses are in need of repair. The front portion of Greenhouse A received a new clay tile roof in 1995, but the remaining roof and all of the glazing is in poor condition and should be replaced. In addition, its stone walls need to be repointed. Greenhouse B's wood frame and glazing are also in poor condition and should be replaced.

- **Restore Greenhouse A for use as a laboratory/classroom:** In the past, both greenhouses were used for science courses. Faculty would like to be able to use them for this purpose again. To make this possible, the metal roof, all of the glazing, and the entry door should be replaced. The stone walls should be repointed.
- **Replace Greenhouse B's frame and glazing:** Greenhouse B is a working greenhouse that is home to OCCC's extensive tropical plant collection. The existing glazing and frame are in poor condition. While it would be preferable to restore the greenhouse, it would less costly to replace the existing frame and glazing system with a prefabricated cap with either tempered glass or polycarbonate sheathing. The entry door should also be replaced.

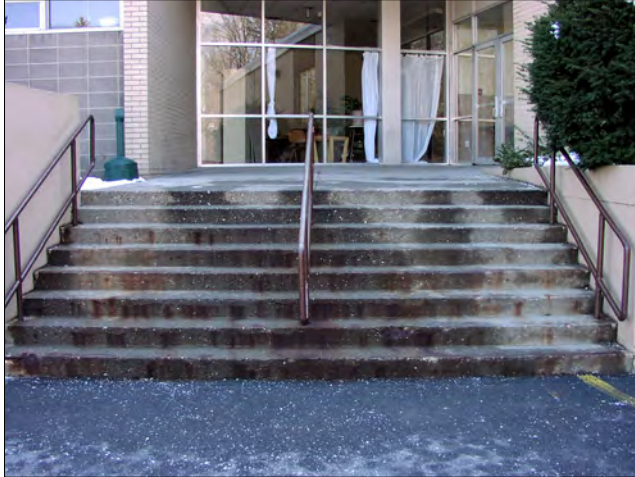
The exterior north stair is beginning to deteriorate and should be monitored.

- The exterior concrete stair at the north entrance plaza is showing signs of deterioration. It should be monitored and repaired, when necessary.

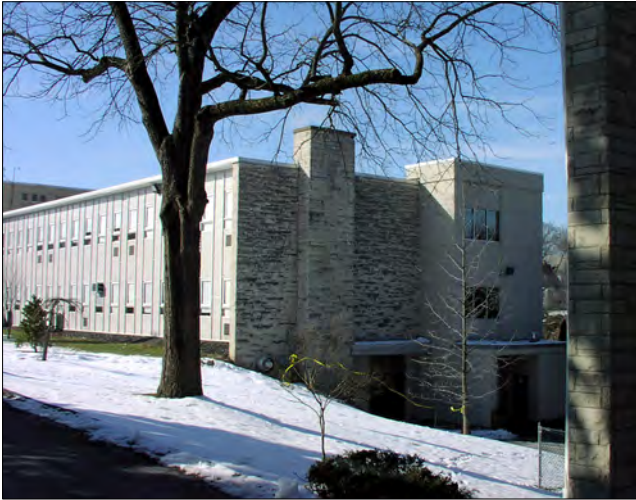
The building's windows are in poor condition and they are not energy-efficient. The College should replace the curtainwall system.

- **Replace the curtainwall system.** The building's skin is a combination of stone and brick veneer and an aluminum curtainwall system. The single-pane operable windows are set in anodized aluminum frames. The windows and the poorly insulated infill panels are not energy efficient and occupants report problems with cold drafts. In addition, the window operators in some rooms don't function well. The system should be replaced to reduce energy costs and improve occupant comfort.
- **Recoat/resurface the roof.** While the roof has recently been recoated, the College should be prepared to recoat the roof after the warranty expires in 2011.

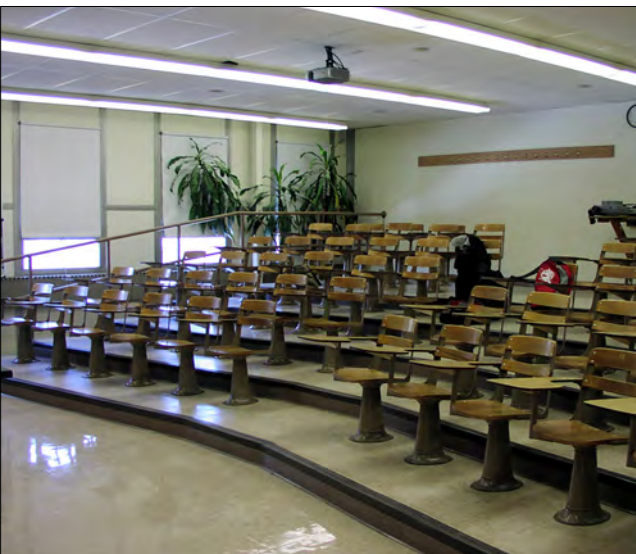
Science labs and lecture halls should be updated.

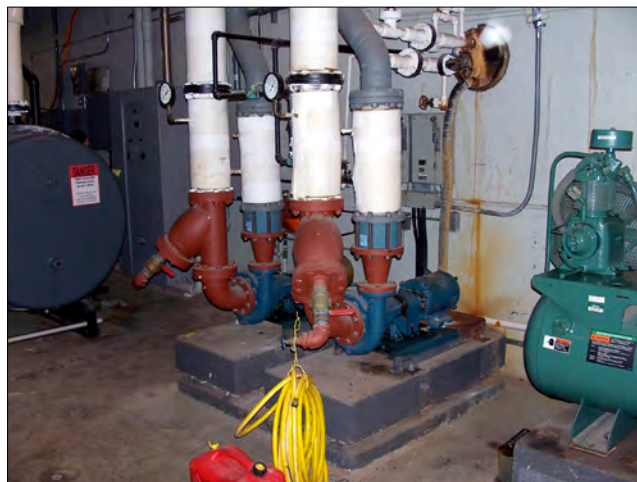
The original boilers are past their useful life and should be replaced within the next ten years.

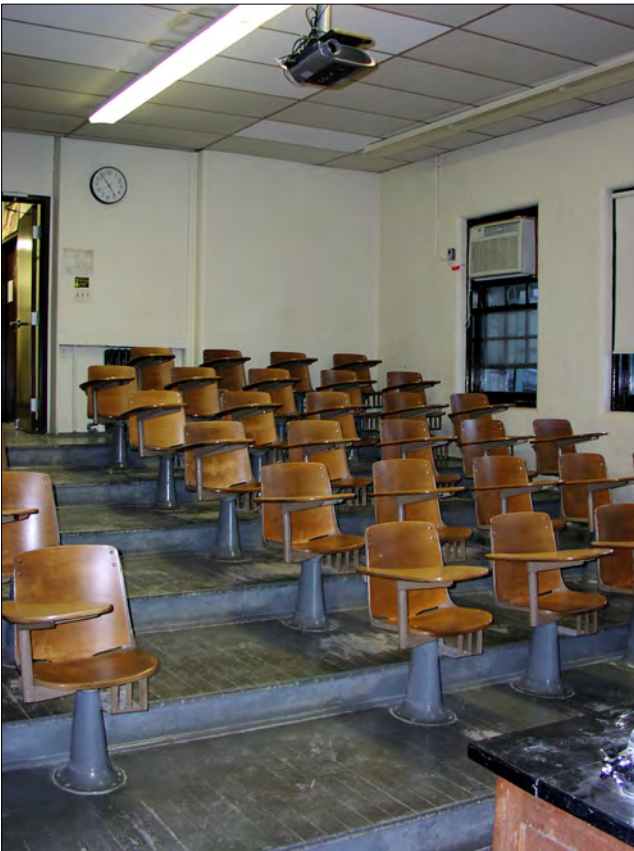
The science labs and tiered lecture hall should be completely renovated to provide more appropriate learning environments.

- **Renovate science labs.** Completely renovate labs HO102, 107, 108, 112 and 113. Install new furnishings and provide new technology to transform these spaces into smart classrooms.

- **Upgrade tiered classroom HO101.** The swivel, tablet-arm seating does not comfortably accommodate many of today's students. The College should consider replacing the rooms furnishings with seats and tables similar to those found in BT311.

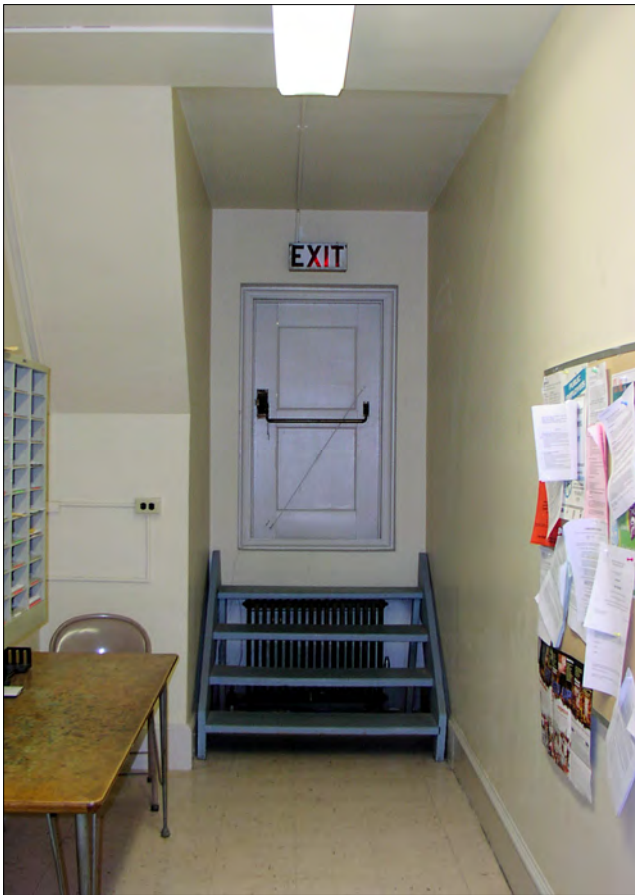
This space is used as a faculty office and for storage.

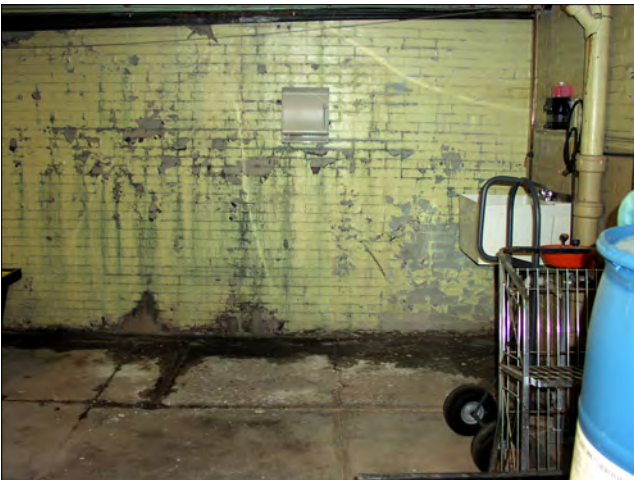
Water can be seen seeping into the basement of Horton Hall at the base of the service tunnel door, shown above. Water infiltration also occurs at the base of the basement wall, as shown below.

- **Renovate faculty offices.** Some faculty offices are in former storage rooms which may lack proper ventilation and lighting.
- **Address water infiltration issue in the basement.** A portion of the basement is currently being used for storage, but only certain items can be kept in this space due to the continuing water infiltration problem. Water enters the basement via the service tunnel. (See a discussion of the tunnel in the Site and Campus Infrastructure section of this report.) Water also weeps up from around the floor in some areas. Once the water infiltration in the tunnel has been eliminated, the basement should be monitored carefully to determine whether the problem continues. If it does, a site drainage system may need to be installed around the building to eliminate the water problem.

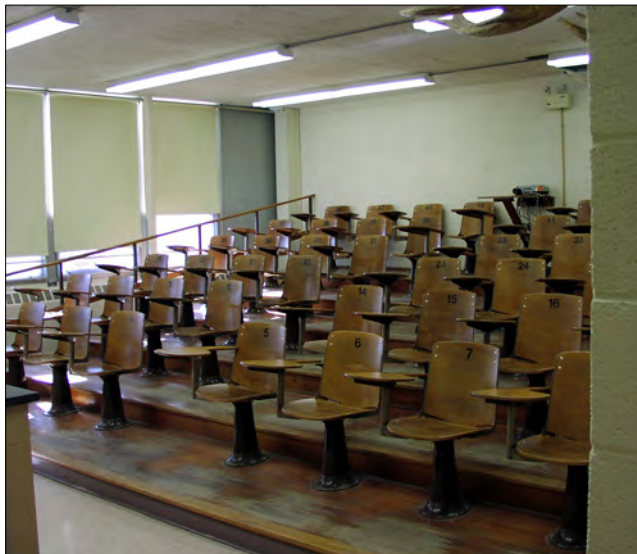
All four science labs should be renovated.

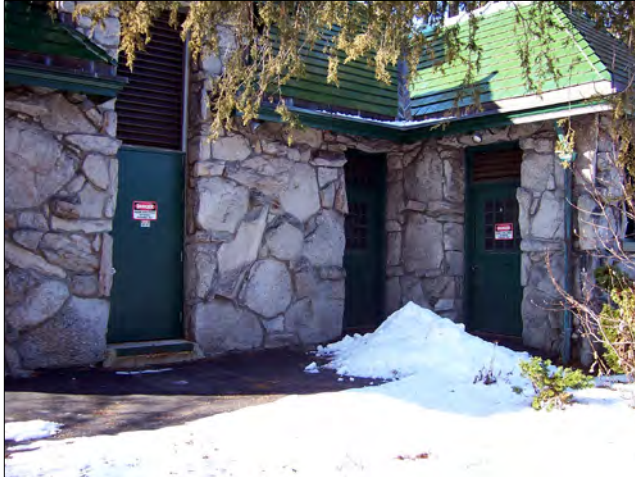
Snow falls from the roof and piles up in front of the building's two secondary doors. The main door to the upper floor is seen on the left.

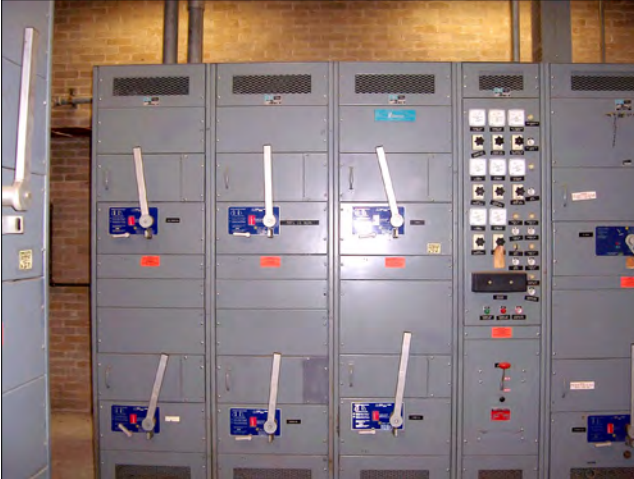
The switchgear equipment is well past its useful life and should be replaced.

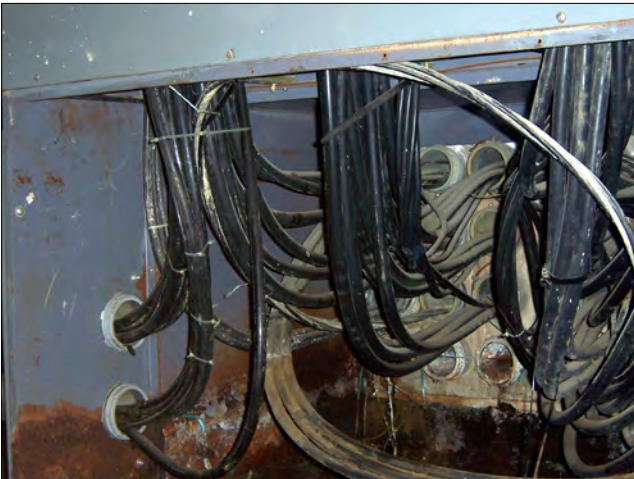
There is no internal connection between the upper floor and the basement. Electrical cables run from the switchgear equipment through the floor to a junction box in the basement. From there the cables run underground in conduits to the various campus buildings. There is an ongoing problem with water infiltration in the basement that has caused extensive damage to the junction box.

Water infiltration in the basement has caused the junction box to deteriorate. See the Site and Campus Infrastructure section of this report for a more detailed discussion of this problem.

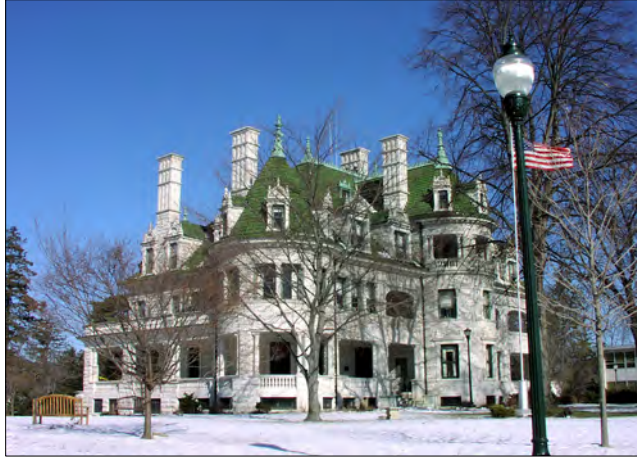
Snow and ice falling from the roof pose a potential hazard to pedestrians below.

- **Repair the flat roofs and exterior ceilings.** Repair the two flat roofs and install pavers to protect the roof membranes from falling snow and ice. Repair the damaged plaster ceilings below the flat roofs at the porte-cochere and rear porch.

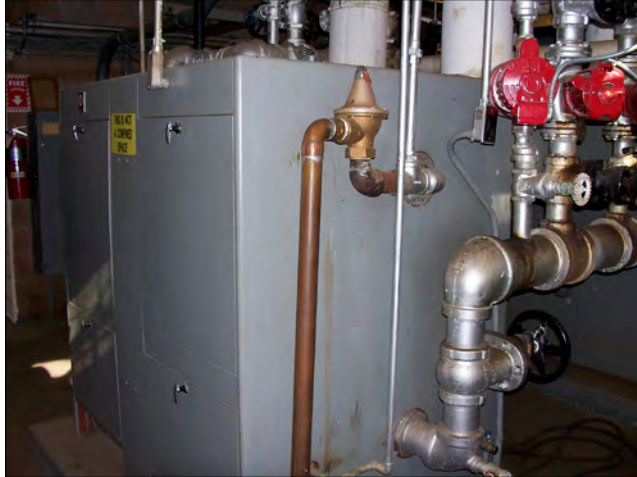
The two old boilers should be replaced.

- **Install two new boilers.** The two older boilers should be replaced.
- **Provide air conditioning in all areas of the building.** Air conditioning should be installed in all portions of the building that are not currently air conditioned.
- **The copy room exhaust fan should be used.** The exhaust fan in the copy room should be left on, preferably all the time and at a minimum when the space is occupied. Removing air-borne particulates is essential to maintaining acceptable indoor air quality levels.

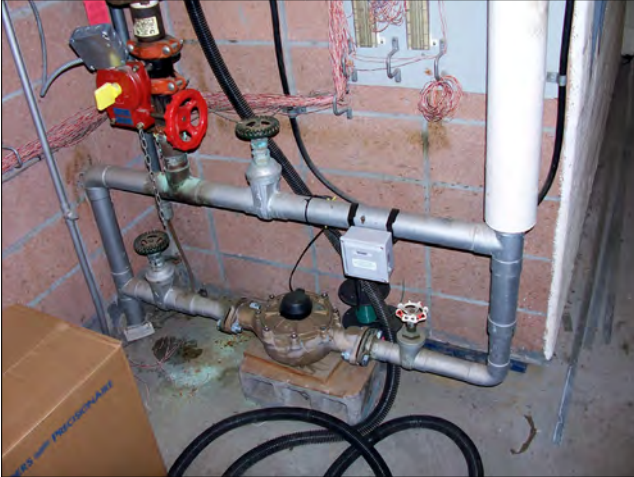
A backflow preventer should be installed at the boiler connection to protect the domestic cold water system.

- **Replace deteriorating pipes.** Oxidation of the copper and galvanized cold water piping and the galvanized drainage piping has caused many leaks in the system. Deteriorating pipes should be replaced, as needed.
- **Install a backflow preventer.**

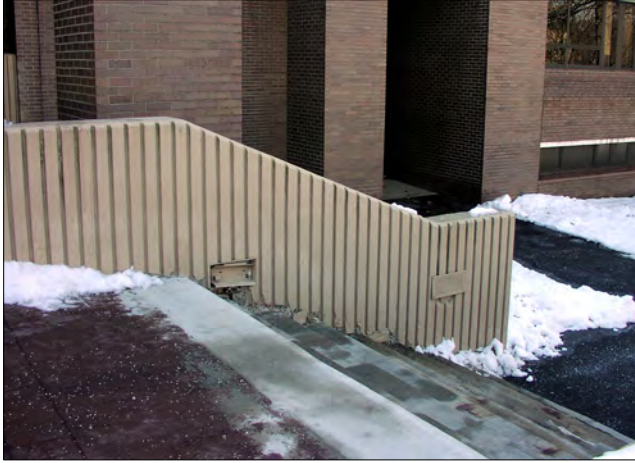
Damaged site stair lighting fixtures should be replaced.

- **Replace site stair lighting fixtures.** The lighting fixtures in the site wall north of the main entrance stair to the upper level are broken and should be replaced.

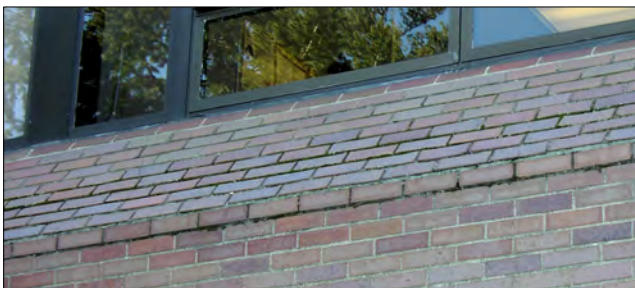
- **Repoint deteriorating mortar joints.** Mortar joints are showing signs of deterioration at several locations around the building, particularly at the sloped sills beneath windows. All deteriorating joints should be raked and repointed to prevent further deterioration of the exterior wall system.
- **Recoat/resurface the roof.** The roof warranty expires in 2009. Therefore, the College should be prepared to recoat the roof within the next ten years.

Deteriorating mortar joints should be raked and repointed to prevent further damage to the wall system.

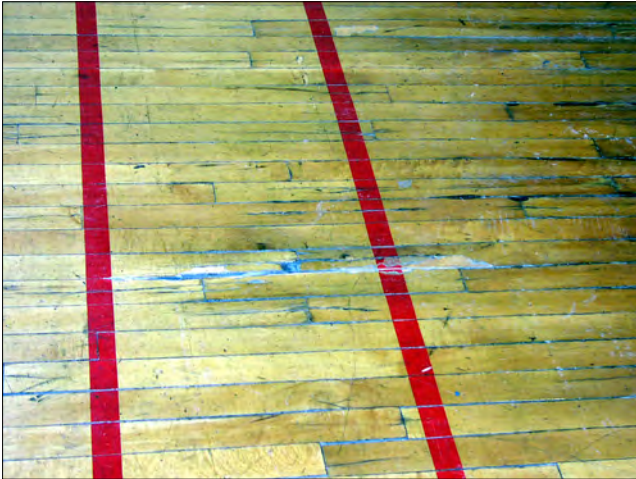
- **Replace the gymnasium floor, bleachers and partitions.** The existing floor is in poor condition. Some areas are badly damaged and present a

The gymnasium floor is in poor condition. It should be replaced and new bleachers and partitions should be installed.

potential tripping hazard. The bleachers are in failing condition and they damage the gym floor when opened and closed. The partitions do not work properly. The flooring, bleachers and partitions should all be replaced. Faculty would like to maintain at least one solid partition in the gym. The second partition could be replaced with netting.

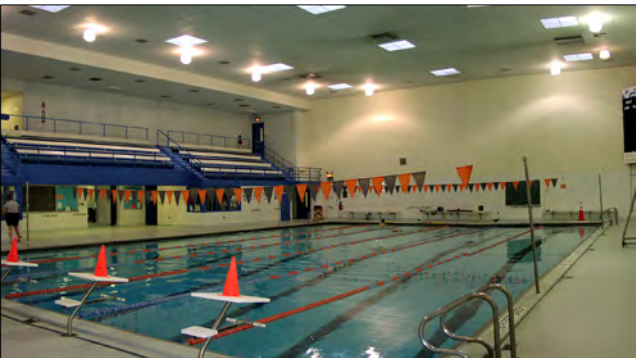
The suspended ceiling above the pool should be removed and the lighting fixtures should be replaced.

- **Remove the suspended ceiling system and replace the lighting fixtures above the pool.** The ceiling in the pool area appears to be in poor condition and should be removed to eliminate the possibility of it falling into the pool. The building framing and floor structure above should be exposed, cleaned and coated with an epoxy finish to prevent deterioration. Perforated co-polymer covered acoustic panels should be installed to control noise in the natatorium. New lighting fixtures designed for high humidity environments should be installed.

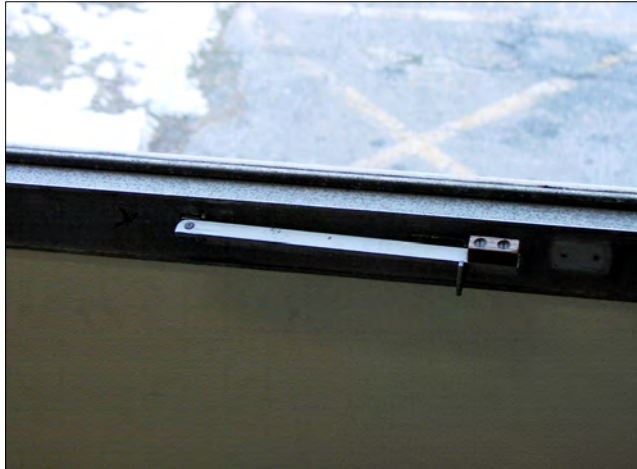
The College has devised a mechanism to replace damaged window operators, but the entire curtainwall system is in poor condition and should be replaced.

- **Install a new curtainwall system.** The curtainwall system, composed of single-glazed windows and uninsulated panels, is in poor condition and should be replaced.
- **Recoat the roof.** The roof warranty expired in 2002, but there are no reported problems at this time. The College plans to recoat the roof in 2007.
- **Replace all entry doors.** The heavy exterior doors are in poor condition and should be replaced.

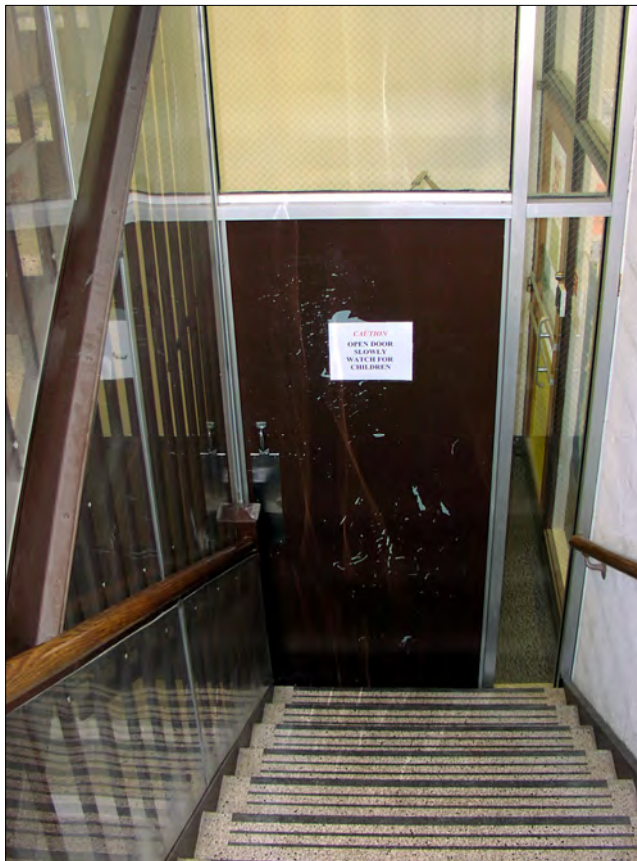
If the Kinder College remains in Sarah Wells, the entry should be reconfigured to provide code compliant space in front of the entry door.

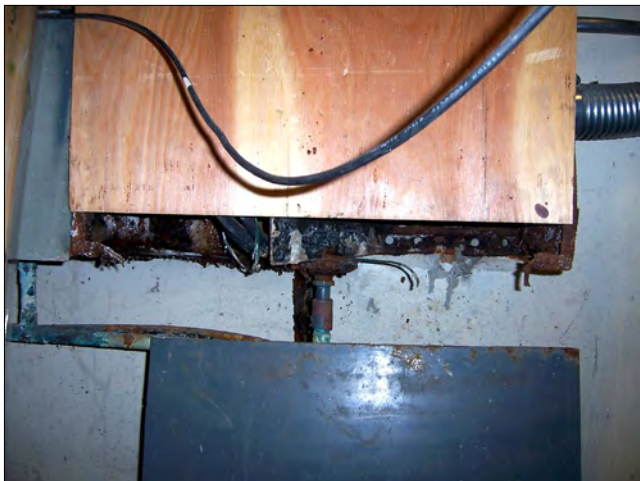
The rusted cover of an electrical panel has been replaced with a piece of wood. The building's entire electrical distribution system should be replaced.

- **Installation of a new electrical distribution system.** This Master Plan recommends the replacement of the entire electrical distribution system to provide both 480/277 and 120/208 volts.
- **Upgrade the lighting system.** Replace the existing lighting system with new energy efficient lighting fixtures that use T-8 fluorescent lamps or compact fluorescent lamps and electronic ballasts and a 277 volt system. Many of the existing fixtures are old and are not energy efficient.
- **Update the fire alarm system.**
- **Install public address and master clock systems.**
