2006 Master Plan Update

SUNY ORANGE

Master Plan Update

Orange County Community College

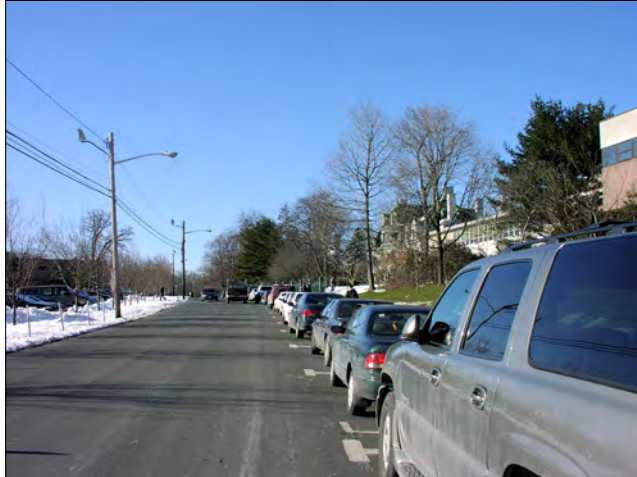
Reportedly, South Street is the site of several pedestrian/vehicle accidents each year.

South Street is a busy thoroughfare that divides the Middletown Campus, positioning the College Commons and a large college parking lot on the south side of the street and the remainder of the campus to the north. Parked cars along one side of the road and the speed at which vehicles travel create a potentially dangerous situation. Each year several students are reportedly hit by cars as they cross South Street at designated crosswalks. In addition to creating an unsafe condition for pedestrians, South Street creates a physical and psychological barrier between academic and student life components of the College. It also undercuts the viability of constructing a new academic building on the land currently used for parking.

This Master Plan recommends that South Street be closed to all but emergency vehicles between East Conkling Avenue and Grandview Avenue. The road in this area should be narrowed and textured paving should be installed to create a recognizable pedestrian zone. Overhead utilities should be buried, and new trees, site lighting and banners should be installed to create one the sense of being on a college campus.

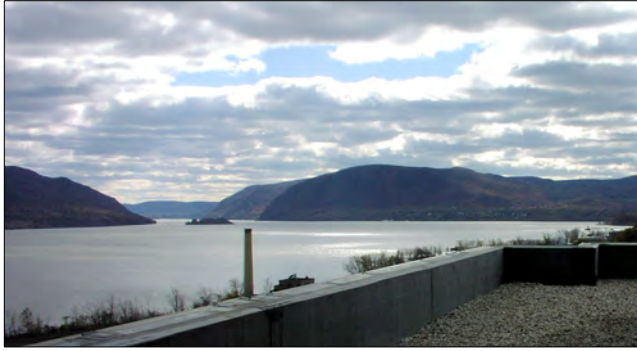
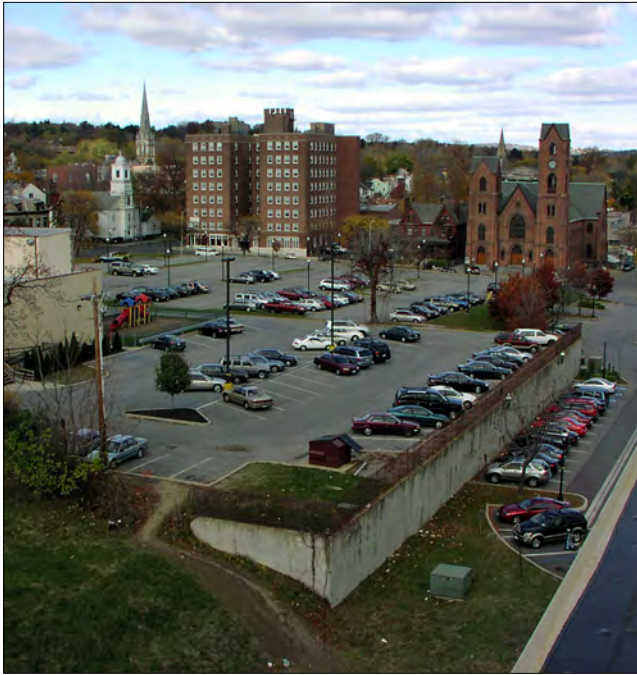
View of the elevated YMCA Parking Lot with the Maple Building Parking Lot in the distance. Metered parking for the Key Bank Building is located at the lower left of the picture, adjacent to the concrete retaining wall.

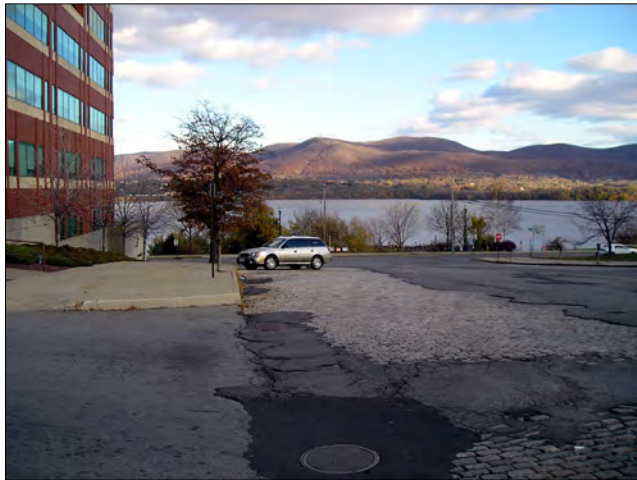
Site vegetation is sparse.

There is very little site vegetation. The strip of land along Broadway contains Maple trees with a low Juniper ground cover. The planting presented a lackluster appearance during the November site visit, and one of the Maples appears to be dead. The planted strip along Colden Street only extends to the service entrance and contains two Maple trees and some low Yews. The landscape here is also nondescript. The most heavily planted area on or near the campus is at the stairway located between the Key Bank and Maple Buildings that connects the upper campus entrance drive with the Colden Street sidewalk below. The area adjacent to the stairway is planted with trees and shrubs but does not offer a place to sit. Campus officials report that the area collects a good deal of wind-blown trash and leaves and that it is difficult to maintain.

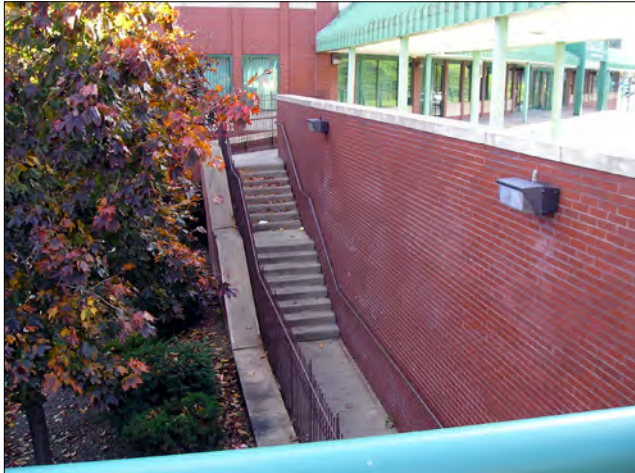
The site stair between the Key Bank and Maple Buildings collects wind-blown trash and leaves and is difficult to maintain.

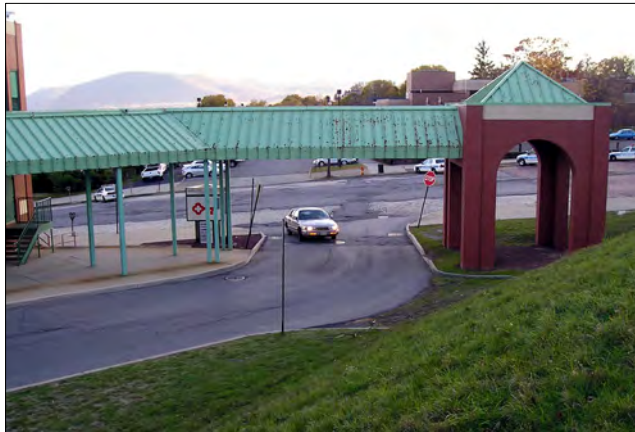
Widening the narrow main entry drive would involve reworking the entry canopy.

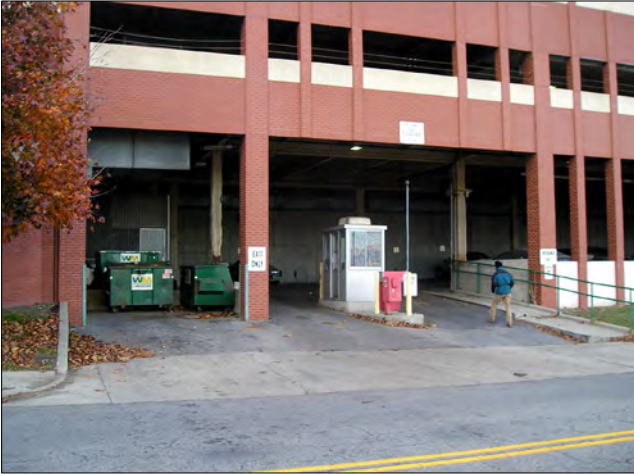
Refuse containers located adjacent to the garage entrance are an eyesore.

Campus trash receptacles are located adjacent to the garage entrance in plain view from the street, which is an eyesore.

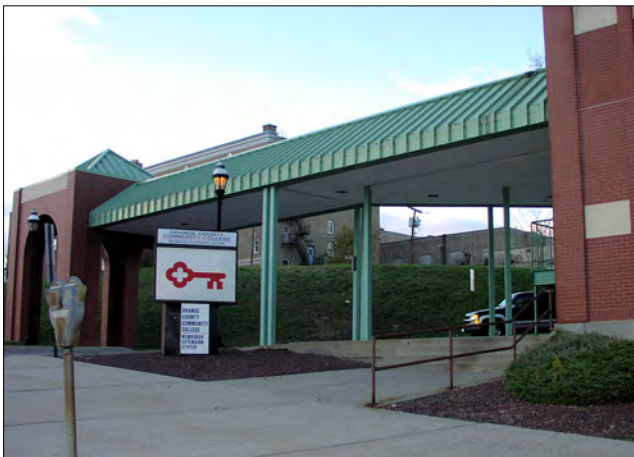
The College's name should be featured more prominently on the main entry sign.

The only vehicular signage observed on campus is located at the corner of Broadway and the main entrance drive. The most prominent feature of the sign is the Key Bank symbol. Orange County Community College lettering appears to have been added to the existing Key Bank sign and is somewhat difficult to read. There is no other signage to direct vehicles to parking or service areas and, consequently, it is difficult for drivers to tell where they are allowed to park.

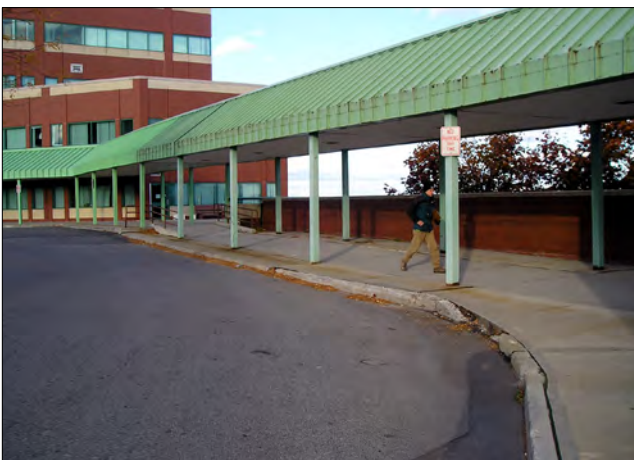
Signage should be installed to direct pedestrians to the College entrance at the Key Bank Building. Additional curb cuts should be created, especially at the main building entrance.

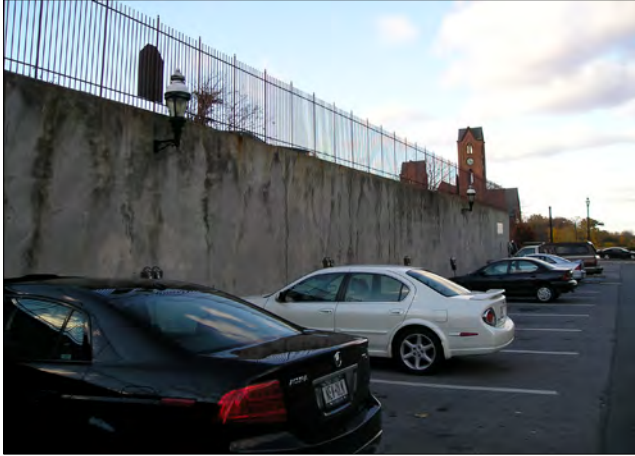
Metered parking, limited to 2 hours, is available along the service drive.

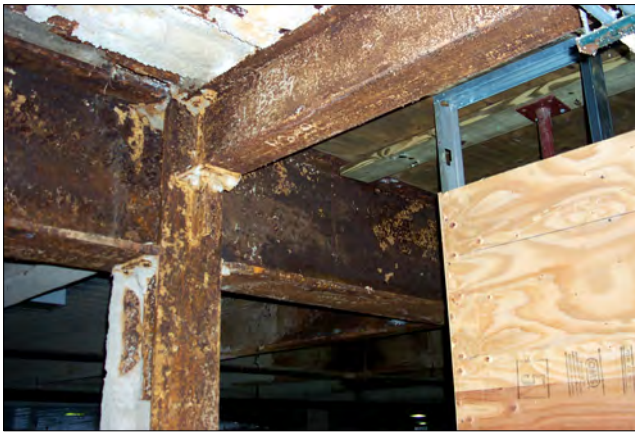
Water damage is evident in the parking garage beneath the Maple Building.

As previously mentioned, 75 parking spaces are available to the College in the public parking garage located under the Maple Building. At the time of the consultant’s site visit it appeared work was in progress to deal with water damage. College personnel report that security issues keep many people from taking advantage of the garage.

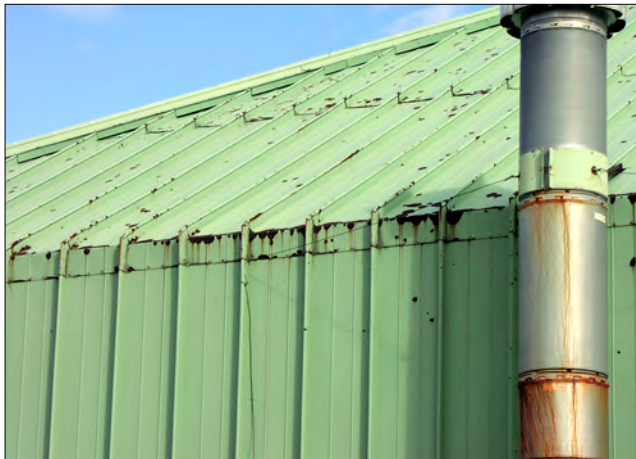
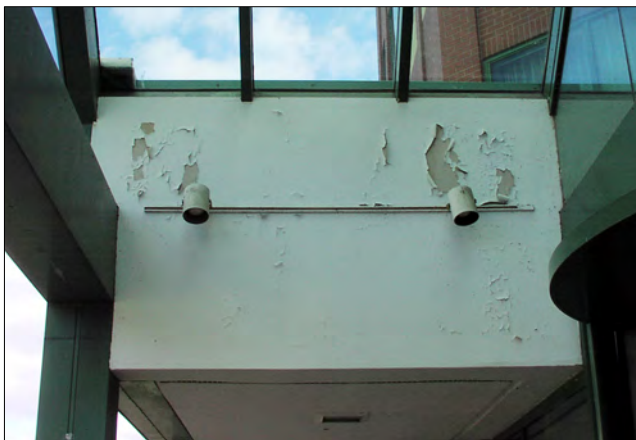
Exterior soffits need to be repainted.

- The ballasted, single-membrane roof underwent some repairs in August 2005. Occupants report, however, that leaks continue. In addition, there are some areas of the sixteen-year old roof where water is ponding. Given the fact that recent repairs have not eliminated the leaks and that it is the original roof system, the College should anticipate the need to replace the roof within the next five years.
- The standing-seam metal roof is marked with rust spots over its entire surface. The rust should be removed and the entire metal roof system should be properly prepared and repainted.
- Paint on the exterior soffits along the front of the building is deteriorating. All of these surfaces should be scraped, properly prepared and repainted.

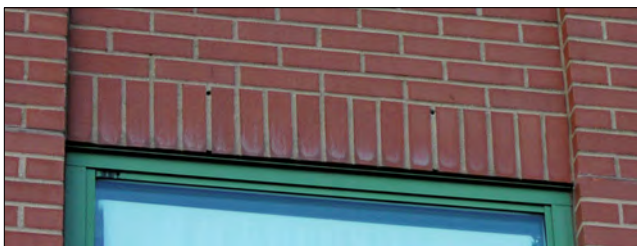
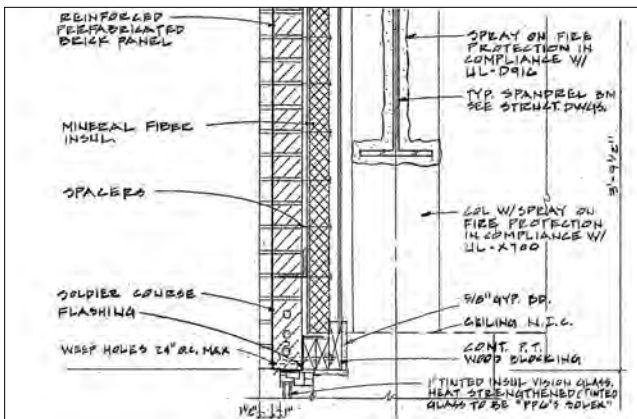
Interior water damage appears to be the result of improperly placed wall flashing and weep holes above windows.

Detail of the wall section from the original construction document shows intended location of weep holes.

Water damage is evident at window heads and jambs throughout the facility. Occupants report that water enters the building in these areas when there is a heavy rain event, especially if it is accompanied by wind. An examination of the construction documents and site conditions revealed that there may be an inherent detailing problem with the curtain wall assembly. It appears that the positioning of wall flashing and weep holes prevents water that has entered the wall cavity from being wicked away through the weep holes. As a result, this water is entering the building above the window assembly and damaging interior finishes. It is also possible that the mineral fiber insulation located adjacent to the prefabricated brick wall panels is absorbing water. This could lead to its deterioration and provide conditions favorable to the growth of mold, which could adversely affect indoor air quality in the building.

- It will be necessary to selectively demolish a representative interior wall area to discover exactly what is occurring within the wall cavity and to determine how this condition might best be corrected. However, it appears that the problem is ubiquitous and will probably be difficult and costly to repair.

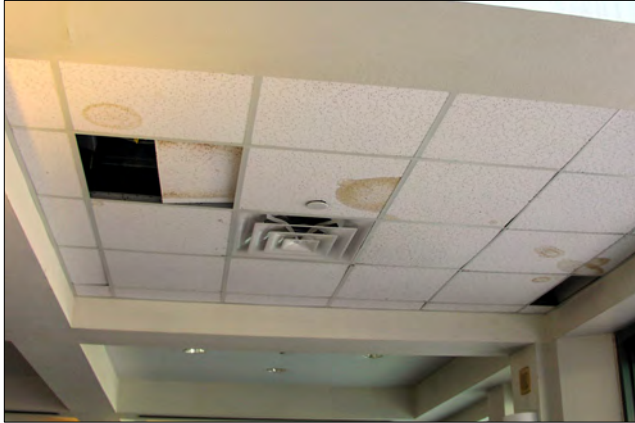
- Many ceiling tiles show signs of water damage. Facilities personnel believe heat pumps above the ceiling are the source of the water leaks. However, it may be that condensate drain lines are clogged, resulting in overflowing drip pans. The drains and drip pans should be examined as part of the next heat pump maintenance cycle to ensure they are functioning properly.

Damaged ceiling tiles should be replaced.

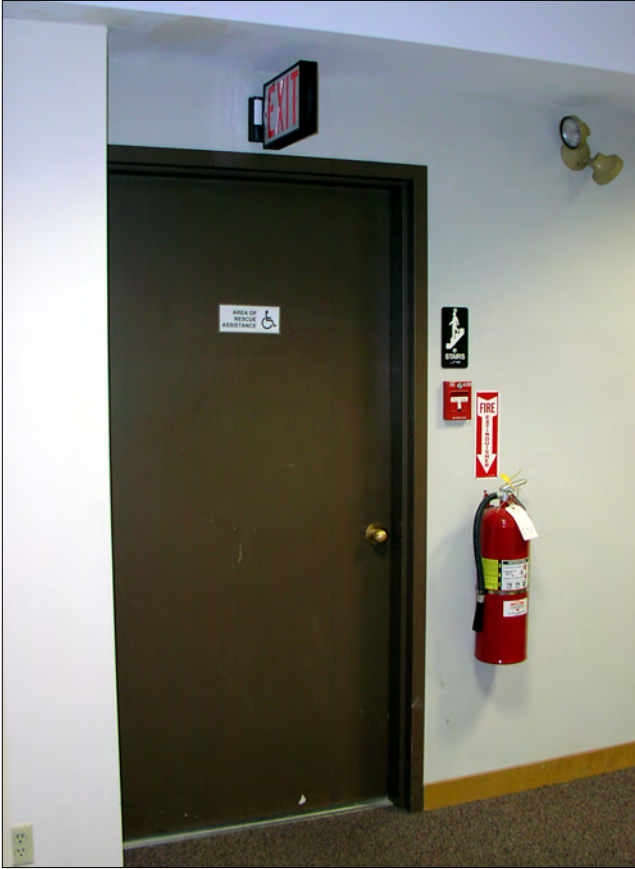
- Most of the exit stair doors are equipped with knob hardware. Lever door hardware should be installed at all exit stair doors, except the exit door on the second floor that is already equipped with panic hardware.
- Areas of rescue assistance are identified at some stair exit doors, but these areas do not meet the necessary requirements to function in this capacity. In addition, they are not required under the current code because the building is fully sprinklered.

Lever door hardware should be installed at all exit stair doors.

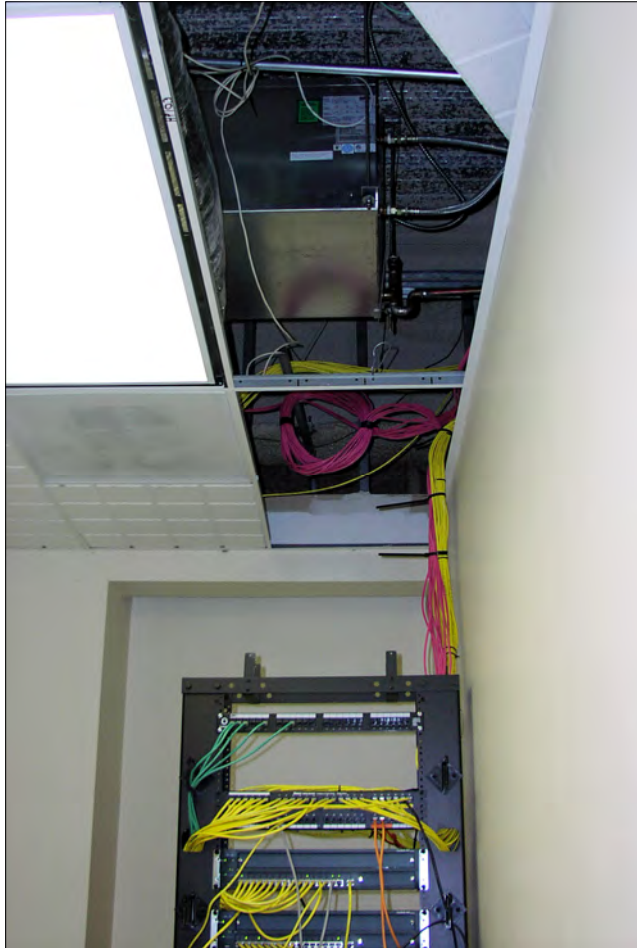
Water-source heat pumps are located above the suspended acoustic tile ceilings.

- The majority of the heat pumps appear to be original to the building and are nearing the end of their anticipated 20 year useful life. Condensate pans reportedly overflow when drains clog and water damage could be seen on ceiling tiles throughout the facility. The locations of the heat pumps do not adequately serve the present layout and the proposed use for community college space. Although the heat pumps are not presently in a condition that requires replacement, many revisions will be required regarding the size, location, and distribution of the units. Therefore, the heat pumps should be replaced with new units that are properly zoned for the new space layout.

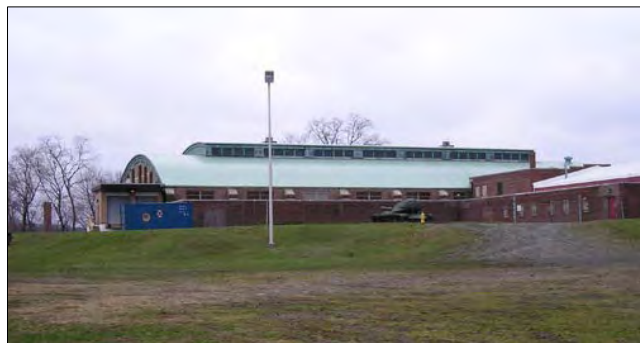
The barrel-vaulted drill shed has an interesting structure, but the configuration of the building does not lend itself to conversion for college use.

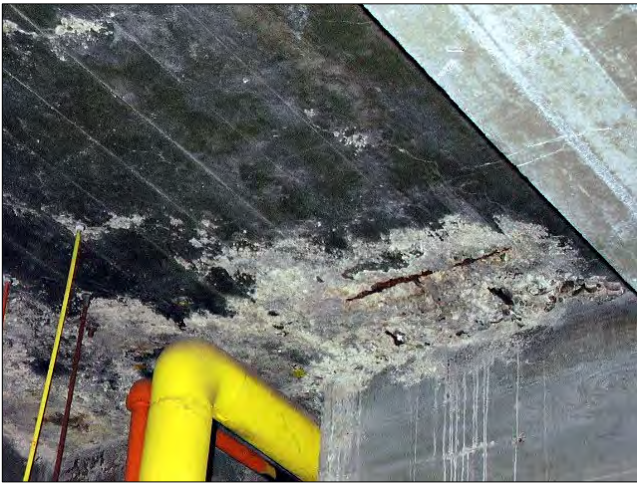
The ramp to the lower level of the building cannot be used by anything heavier than a pick-up truck, according to maintenance personnel. The concrete ceiling structure of the basement below the ramp (originally the coal storage room) is showing signs of deterioration due to water infiltration. Evidently, asphalt sealer on the parking area above has deteriorated, permitting water to enter the basement during periods of heavy rain.

Water infiltration in basement below the ramp is resulting in deterioration of the concrete structure.

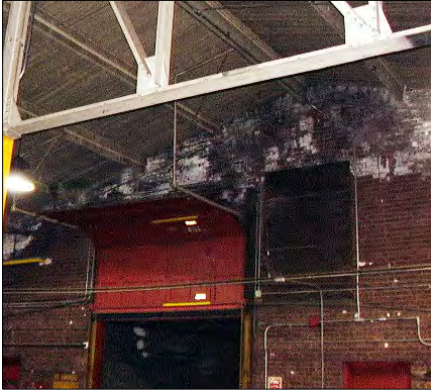
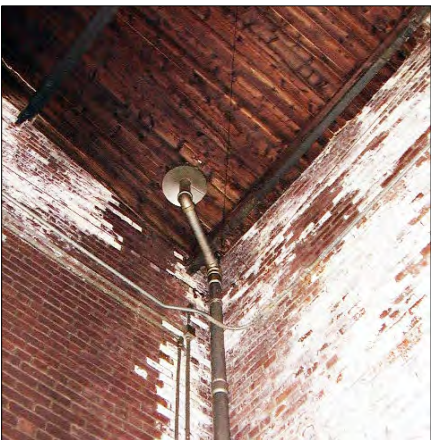
Efflorescence, the result of roof leaks, is visible on the brick walls of the drill shed above, and the gym shown below.

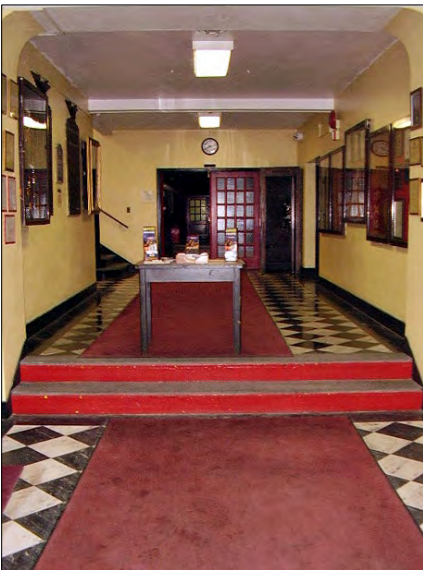
Steps in the front entry hallway are but one building element limiting building accessibility.

There is no elevator. Stairs in the entry hallway and throughout the building make the facility inaccessible. Toilet rooms are not designed to accommodate individuals in wheelchairs and doors are primarily fitted with knob hardware. Signage is not ADA compliant.

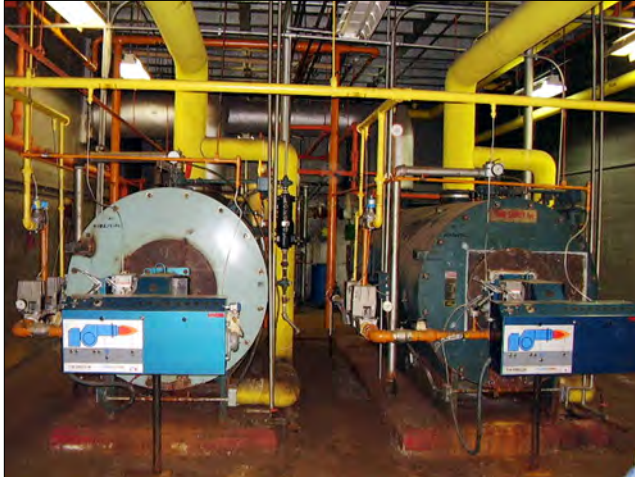
The two fire-tube boilers would need to be replaced if the building was to remain in use.

- Two fire-tube boilers, installed in 1969, generate low pressure steam to heat the building. They were converted from oil to gas in 2001. Both boilers, inefficient and past their useful life, should be replaced. If the building is retained for college use, condensing hot water boilers should be considered.

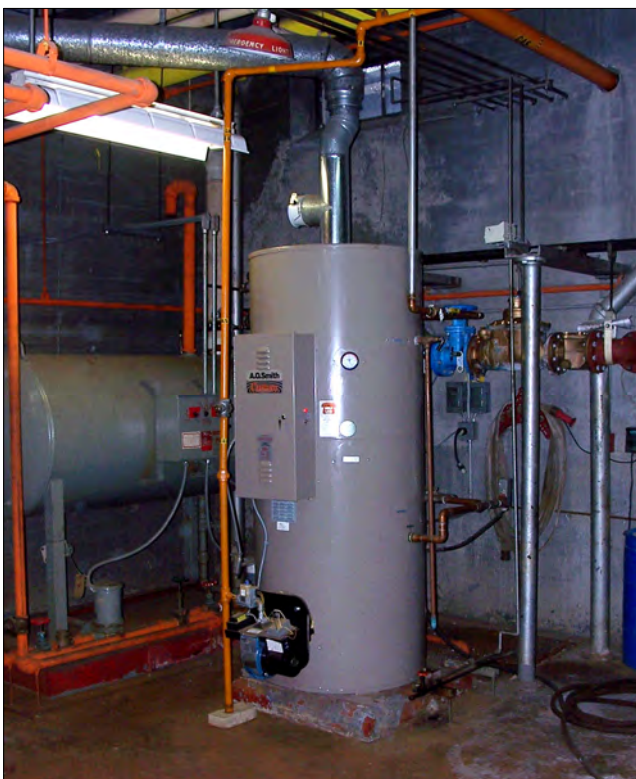
A new natural gas-fired domestic water heater was installed in 2001.

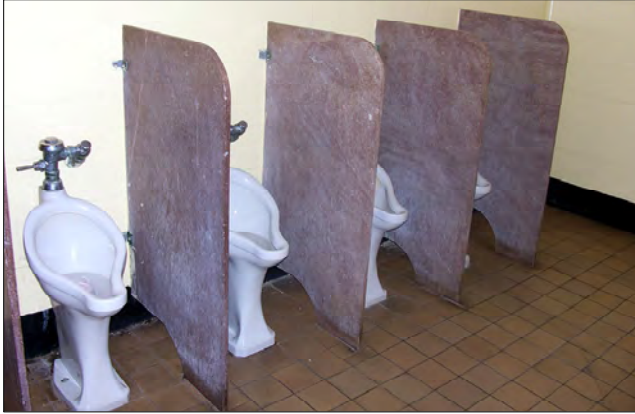
Existing toilet fixtures, including urinals, would need to be replaced with low flow fixtures.

- All of the urinals, water closets, and lavatories in the toilet rooms are old but appear to be operable. The flush valves are not low flow 1.6 gallons per flush valves required by today's codes. If the College intends to use this facility, all of the toilet fixtures should be replaced with low flow units.

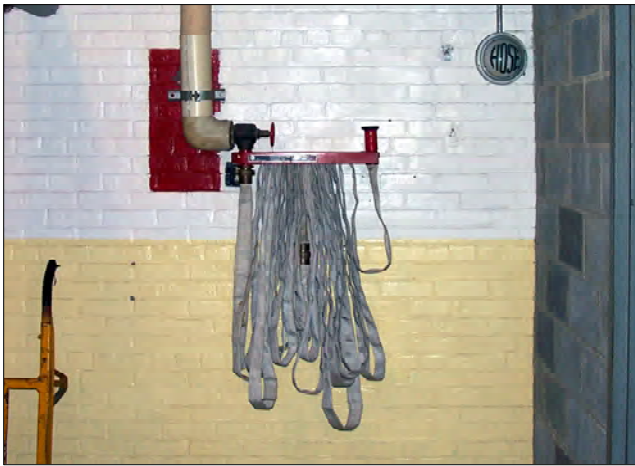
The building fire protection system consists of hose stations fed from the domestic water service.
