## 2006 Master Plan Update

# SUNY ORANGE

# Master Plan Update

Presented to the OCCC Board of Trustees on 8 May 2006

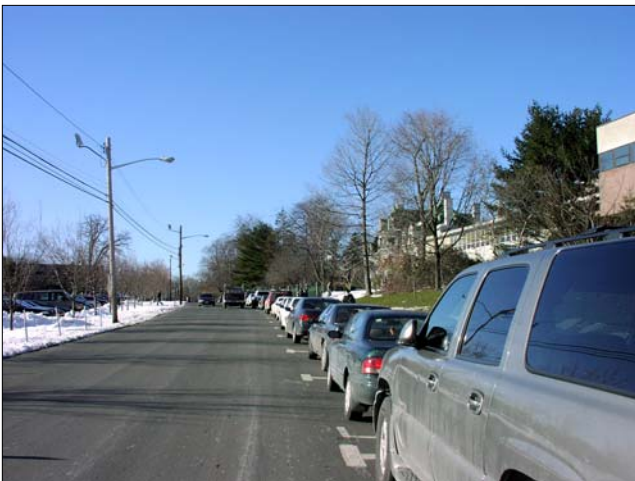
College personnel report that several times a year students are hit by cars on South Street.

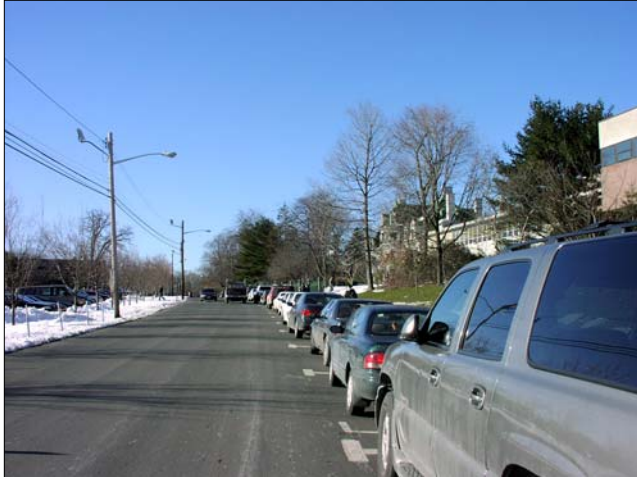
Reportedly, several students are hit by cars each year as they cross South Street.

- **Improvements to South Street.** The pedestrian/vehicular conflicts that occur along South Street are a significant issue that will be addressed by this Master Plan. While improvements such as creating well-defined crosswalks and road edges, improving site lighting and signage, burying overhead wiring and introducing trees, banners, and raised planters would all help to “calm” traffic and reduce the number of accidents, additional issues must be addressed. For example, the main pedestrian entry route to the campus is also used by vehicles. This Master Plan will examine ways to separate these two to improve pedestrian safety. In addition, there is a need to create a better connection between the two sides of the campus and clearly signal to drivers that they have arrived on the Middletown Campus.

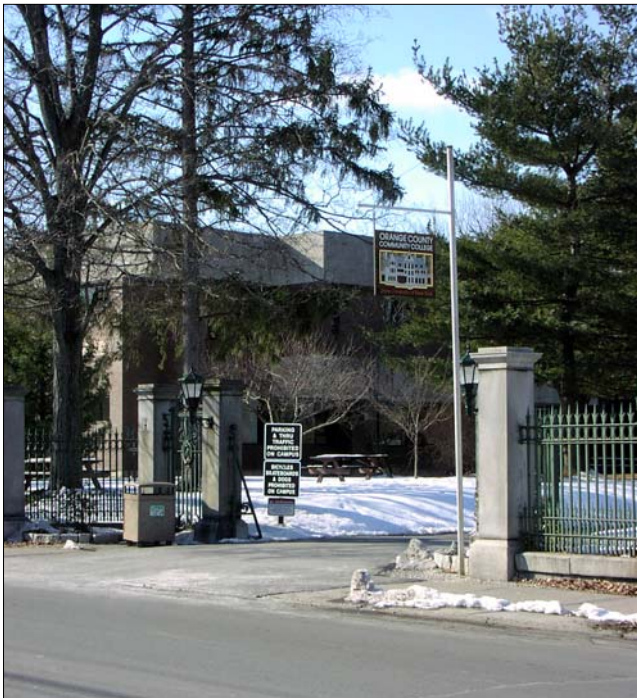
The primary vehicle entry to the campus core is also the primary pedestrian entry point. These two should be separated from each other.

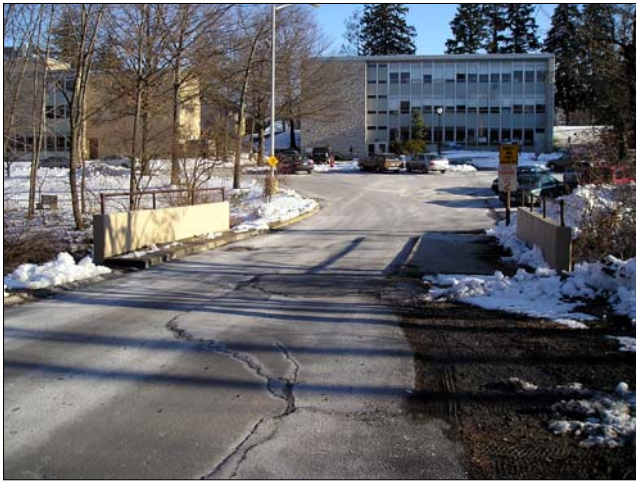
The College should consider widening the road and bridge at the entry to the Harriman Hall parking lot.

- **Widen the entrance road and bridge at the Harriman Hall parking lot.** The existing entry road and bridge are quite narrow, making it tight for two cars to cross the bridge at the same time. The College should consider widening the roadway to improve traffic flow in this area.

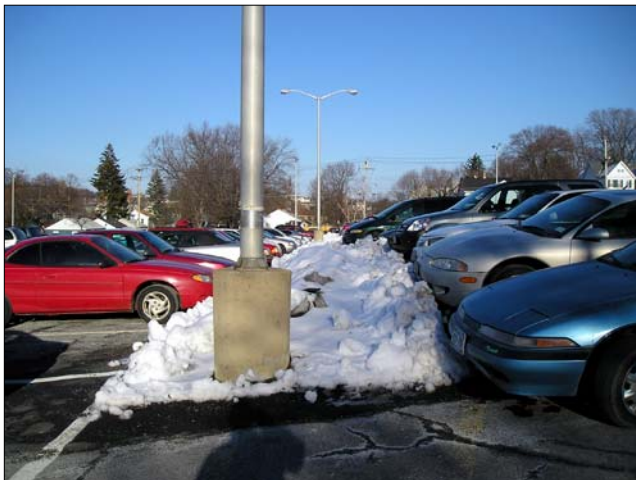
Regrading and reconfiguring the Orange Hall parking lot could result in the creation of additional parking capacity.

- **Reconfigure the Orange Hall parking lot.** The College plans to resurface the Orange Hall parking lot in 2006. The lot currently contains some awkwardly positioned parking spaces. In addition, grade changes between parking rows consume a fair amount of space. Additional spaces may be created by regrading and reconfiguring the entire lot in conjunction with the planned repaving and restriping project.
- **Resurface the tennis court parking lot.** The parking lot adjacent to the tennis courts is in poor condition and should be resurfaced.

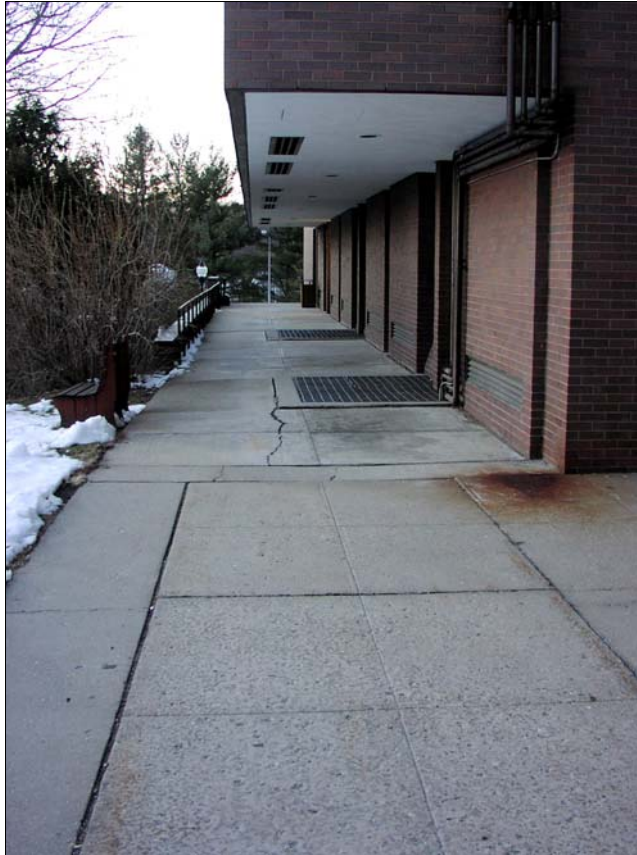
The sidewalk northwest of the Bio-Tech Building is in poor condition and should be replaced.

- **Continue to replace substandard sidewalks and site stairs.** Among the concrete sidewalks that should be replaced, those northwest of the Bio-Tech Building remain in the poorest overall condition. The walks have settled at building entrances, creating tripping hazards, and uneven settling, cracking, and spalling plague the walk and plaza areas. Among the asphalt-paved

- **Redesign the plaza and walkways north/northwest of the Bio-Technology Building.** As mentioned previously, the plaza and sidewalks north/northwest of the Bio-Technology Building are in poor condition. The College should consider redesigning the area and reducing the amount of paved surface around the building. A portion of the concrete plaza could be replaced with landscaped beds to improve the appearance of this well-traveled area.

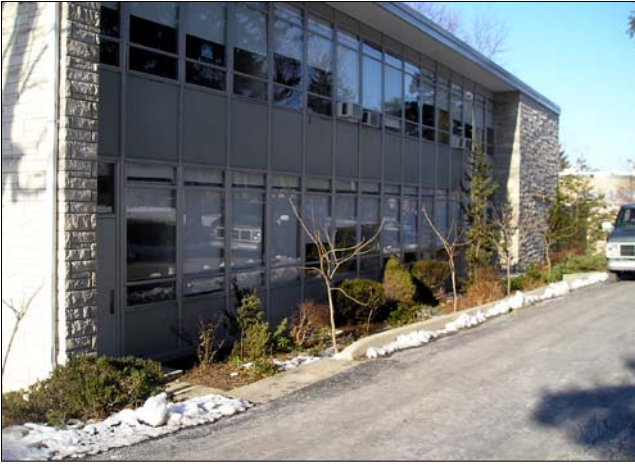
An access ramp is needed at Sarah Wells to make at least the quad level floor accessible.

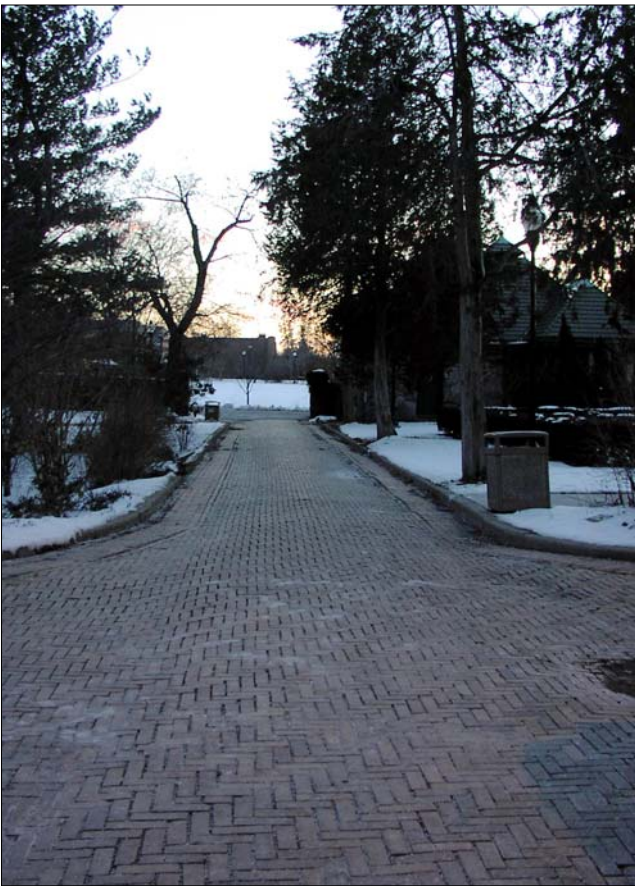
The paved road west of Horton Hall has settled above the utility tunnel that runs between Horton Hall and the Ice House. The pavers should be removed; the area should be regraded; and the pavers should be reinstalled.

- **Repair the plaza and roadway at Horton Hall.** Remove the brick paving and sub-base from the garden/greenhouse area (west of Horton Hall) all the way to the garden wall at the central quad. The paving has settled over the service tunnel, creating an uneven walking surface. The area should be regraded and a new sub-base should be installed. Repave the entire area with salvaged bricks.

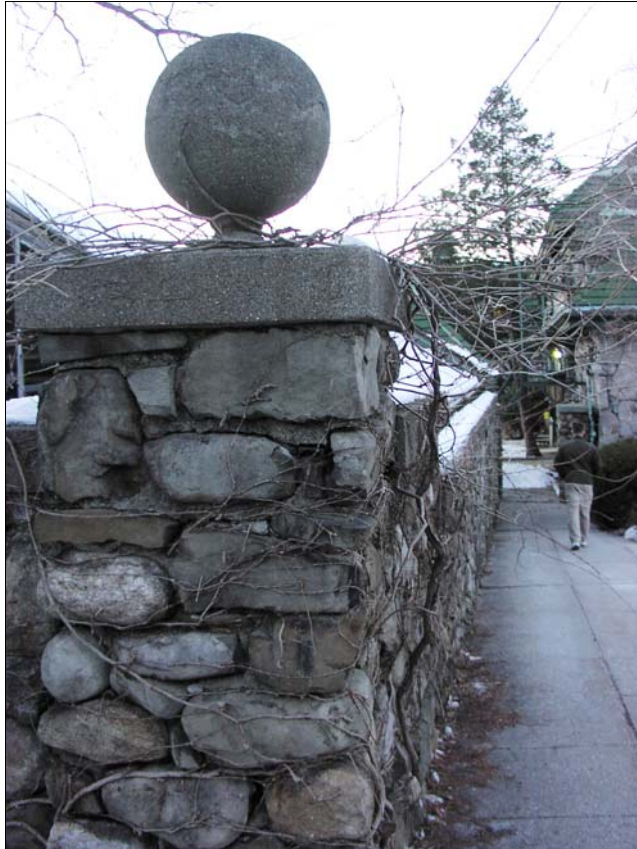
The stone site wall, a portion of which serves as the east wall of Greenhouse A, should be repointed.

- **Repoint the stone site wall around the Horton Hall gardens and greenhouses.** The stone walls should be repaired to prevent further deterioration of the mortar.
- **Repair the campus site wall/fence.** The concrete wall that supports the fence that surrounds the campus is cracked and crumbling in some areas.
- **Repair the Bio-Technology site wall.** The site wall and stair at the southeast corner of the Bio-Technology Building are beginning to deteriorate and should be repaired to prevent further damage.

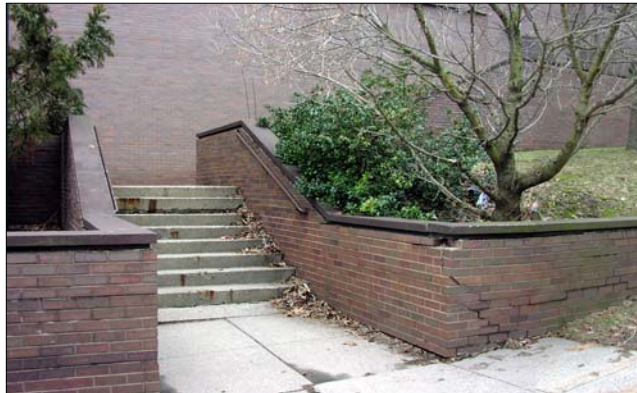
The site wall and stair at the southeast corner of the Bio-Technology Building are beginning to deteriorate.

- **Repair southeast exterior stair and site wall.** The exterior stair and site wall at the southeast corner of the building is beginning to deteriorate. Repairs should be made to prevent further deterioration.

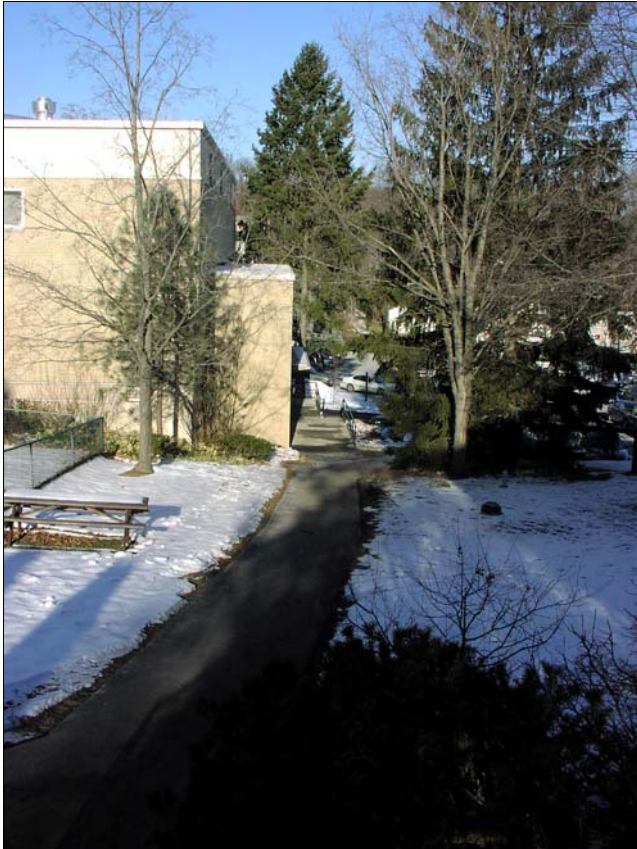
Additional site lighting should be installed along the walkway between Orange and Horton Halls.

- **Install site lighting fixtures.** Additional lighting fixtures should be installed at the perimeter of parking lots and along walkways that are not well illuminated, such as the walkway between Orange and Horton Halls.
- **Continue upgrading parking lot lighting fixtures.** As parking lots are repaved/reconfigured, older lighting fixtures should be replaced with units that provide adequate light levels while avoiding night light pollution.

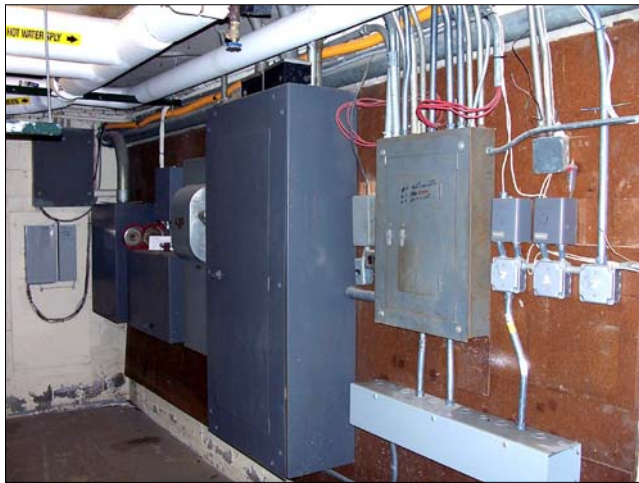
The distribution switch gear and main disconnect switch for the campus are located in the basement of Hudson Hall. The draw-out fuse boxes (shown below) can be pulled out while still under a live electrical load, presenting a possibly hazardous condition. The distribution equipment should be replaced.

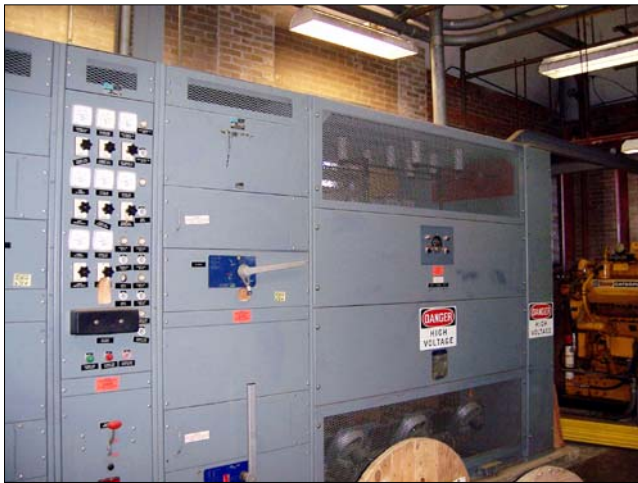
The main switchgear equipment and transformer in the Ice House are past their useful life and should be replaced.

- **Replace the main switchgear equipment.** The 13.2 kV switchgear is over 40-years old and past its useful life. The switchgear equipment and the transformer should be replaced. Prior to the replacement of the switchgear. A study should be completed to determine the most appropriate switchgear and distribution system for the College. The study should evaluate reliability, constructability, first cost and maintenance costs. The design will need to be compatible with the new emergency generator system installed approximately five years ago.

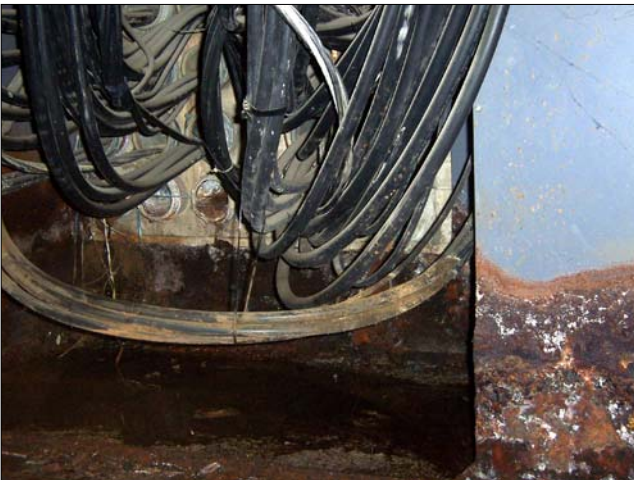
The tunnels beneath the Ice House expose the existing secondary distribution system to a deleterious environment for electrical equipment and conductors. The tunnel/basement area beneath the Ice House is constantly infiltrated with flowing

ground water. This has resulted in extensive damage to the existing junction boxes and conduit, exposing conductors to possible water damage, as well. If allowed to continue, this condition could lead to an electrical failure.

The electrical junction box in the basement of the Ice House is severely deteriorated because of water infiltration through the conduits.

- **Construct a new underground ductbank system.** Install a new 480-volt secondary underground ductbank electrical distribution system to serve the entire campus. The ductbank should originate either from the Ice House, or from wherever the new switchgear equipment is located. The ductbank should run to all campus buildings on the north side of South Street. Underdrains should be installed to prevent water infiltration in the new ductbank.

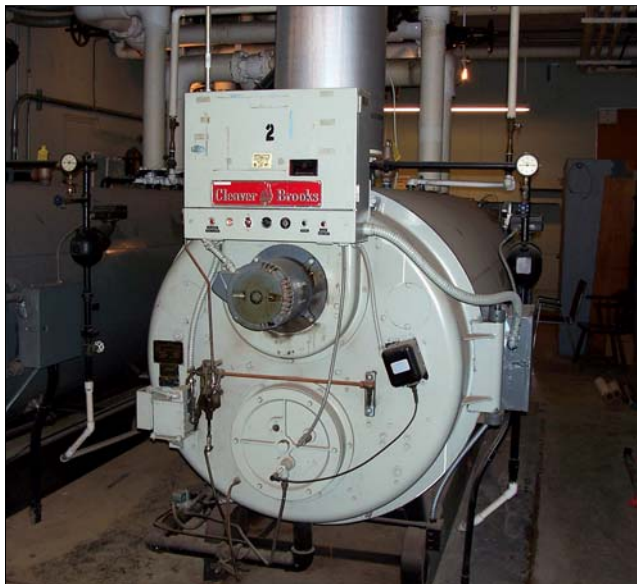
The old boiler in Harriman Hall should be replaced within the next 10 years.

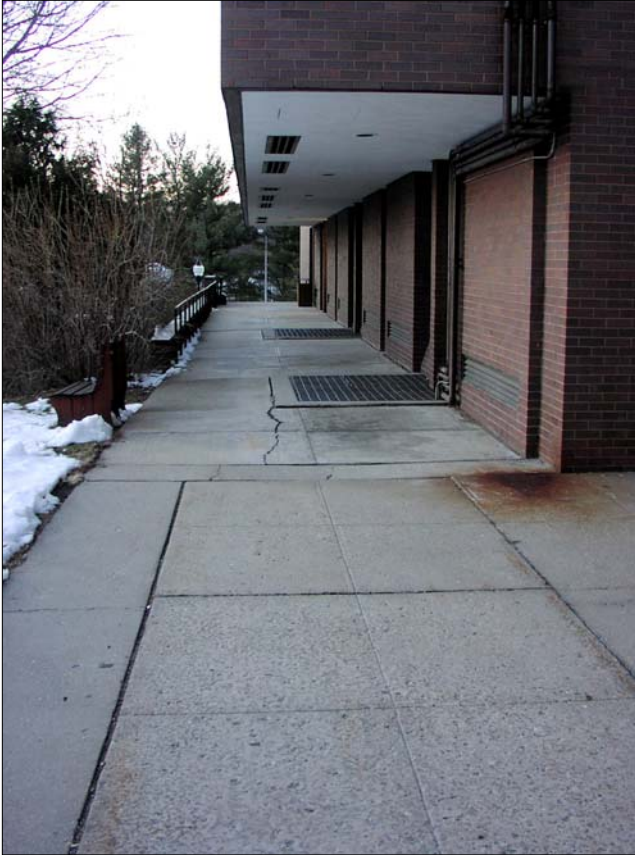
Deteriorating plazas to the north/northeast of the building should be repaired. The retaining wall at the southeast site stair (below) is also in need of repair.

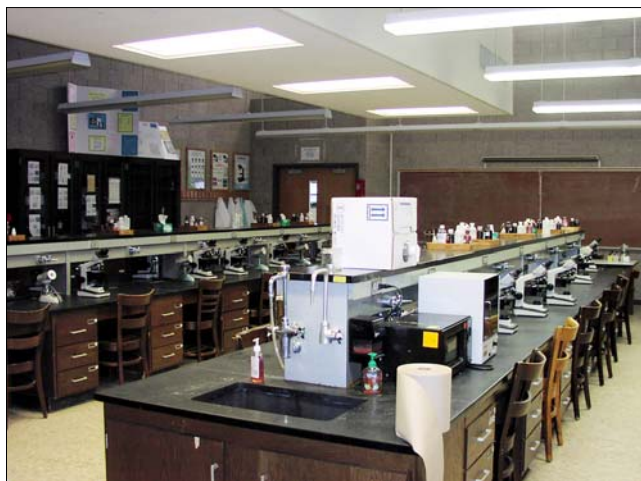
Faculty report that the risers on the lab tables in BT315 interfere with teaching.

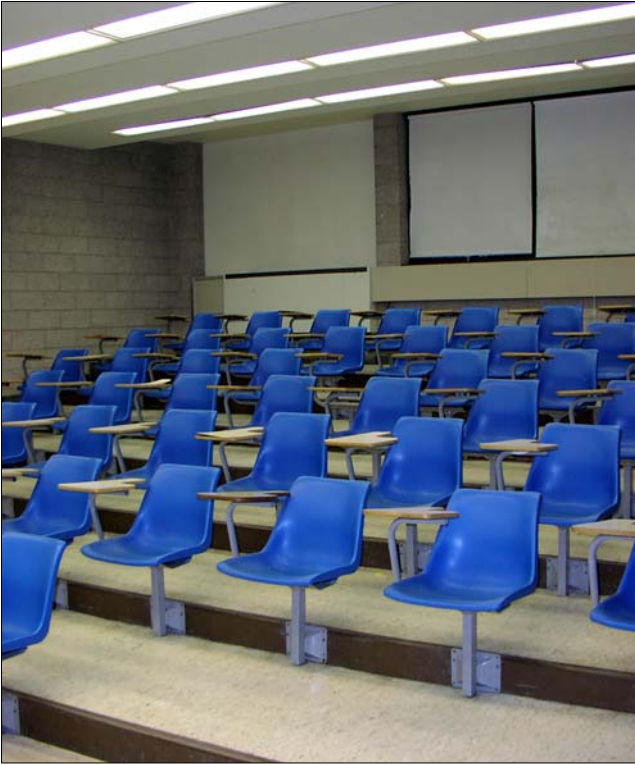
Tiered classrooms should be updated with seating that is more appropriate for today's students.

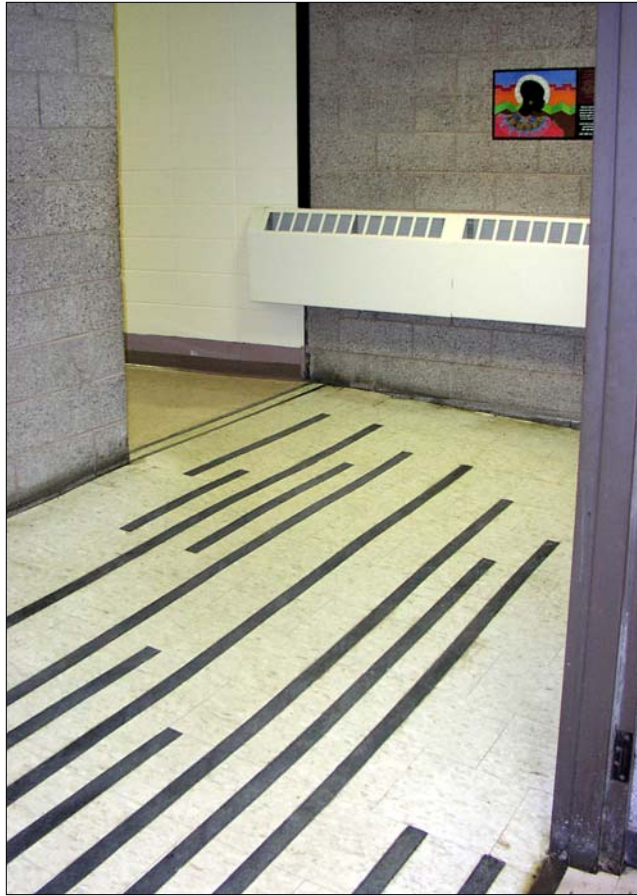
Disability Services reports that several disabled individuals have fallen at the cross ramp in the connector between the Bio-Technology Building and Hudson Hall. Hand rails should be provided to improve accessibility in this area.

- **Install hand rails in the connector between Hudson Hall and the Bio-Tech Building.** The cross-sloping connector between both levels of the Bio-Tech Building and Hudson Hall is difficult to navigate for individuals using canes, walkers and wheelchairs. Reportedly, an individual using a walker fell in this area in the fall of 2005. The College should install hand rails to improve accessibility.
- **Upgrade seating in tiered classrooms.** The swivel, tablet-arm seating in several of the building's tiered classrooms does not comfortably accommodate many of today's students. The College should consider replacing seats in BT201, 203, 301 and 303 with seats and tables similar to those found in BT311.
- **Install ADA-compliant signage.**

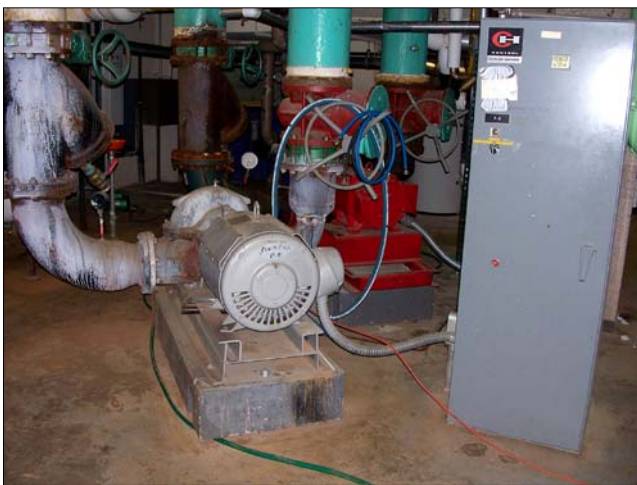
The existing tower pumps should be replaced.

- Replace the cooling tower. The cooling tower, tower pumps, and associated valves are all past their useful lives and should be replaced.
- Replace the remaining exhaust fans.
- Replace the remaining fan coil units.
- Install direct digital controls. The existing controls appear to be pneumatic. They should be upgraded to a direct digital controls (DDC) system.
- Install new boilers. The two boilers are nearing the end of their useful life. They will need to be replaced within the next several years.
- Commission the HVAC system. Temperature control issues persist. As a first step, the existing system should be commissioned to verify that the HVAC system is functioning as intended. This should include air balancing. Further steps, if necessary, should be evident from the commissioning process and report.

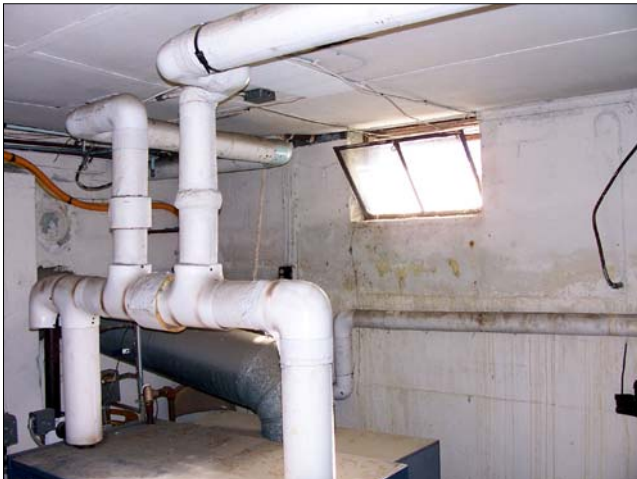
The boiler piping should be reworked to comply with manufacturer's recommendations.

- **Provide a dedicated outdoor air/ventilation system.** The house currently does not have a ventilation system that delivers fresh air to occupied spaces, as required by the NYS Building Code. A dedicated outdoor air system should be installed.
- **Modify the boiler piping.** The steam boiler should be re-piped so the piping is in accordance with manufacturer's recommendations. Also install a reduced-pressure zone backflow preventer.
- **Provide adequate combustion air for the boiler.**
- **Update the fire alarm system.**
- **Install public address and master clock systems.**

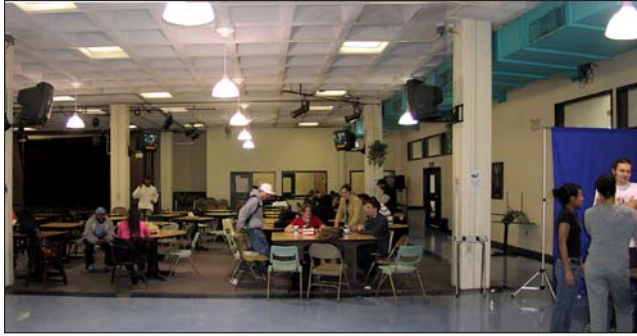
The cafeteria should be renovated to make it more appealing to students and the rest of the College community.

- **Upgrade interior finishes and improve lighting.** Upgrade the interior finishes and lighting throughout the building in conjunction with a Master Plan project to reconfigure and renovate the Commons.
- **Renovate the cafeteria.** The high school-type cafeteria should be updated. The existing kitchen equipment is 32-years old and should be replaced. Instead of duplicating the existing cafeteria set-up, however, the College should consider creating a food court where the cooking is done in front of the customers, not hidden in

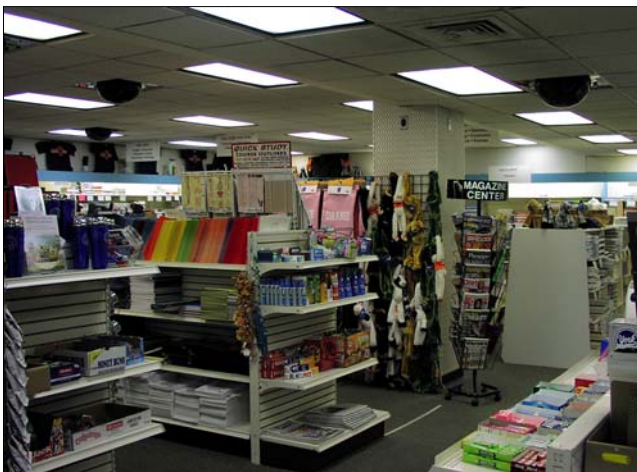
The bookstore should be updated.

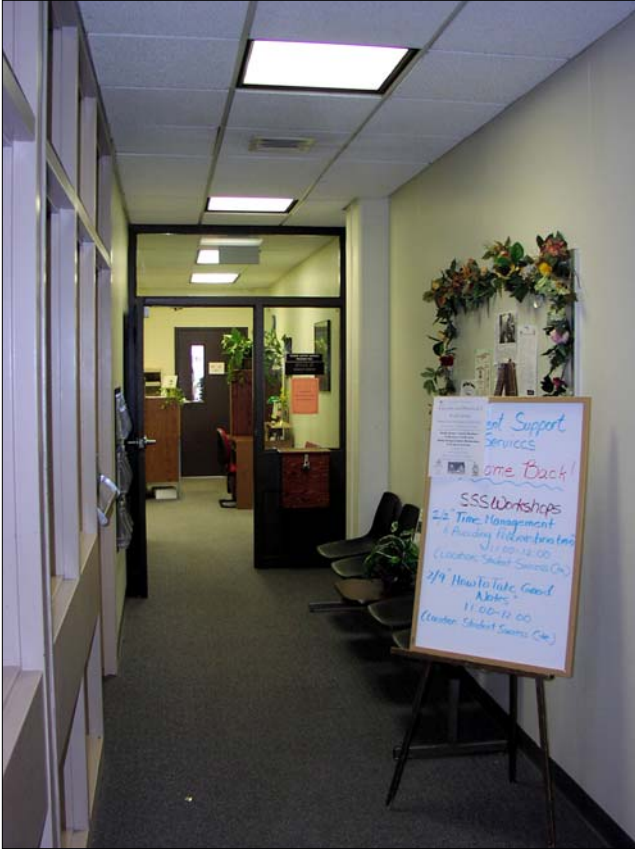
Staff report that some disabled students have had difficulty maneuvering around the cramped Disability Services office area.

- **Improve access to Disability Services offices.** As part of the renovation of the third floor, improve accessibility to the office of Disability Services. Staff report that disabled individuals have had difficulty moving around the existing office.

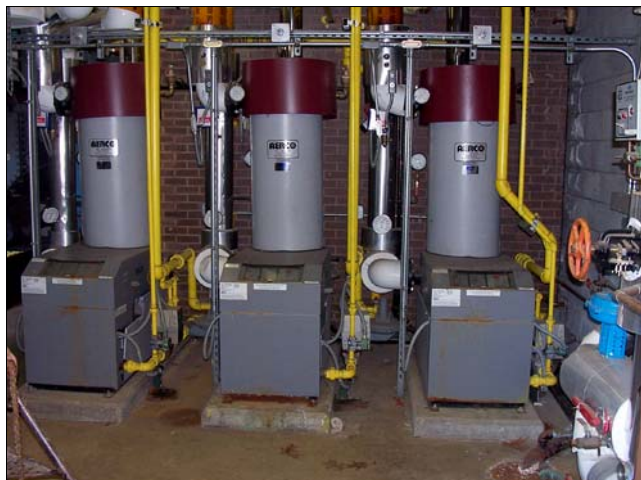
The boilers were recently replaced.

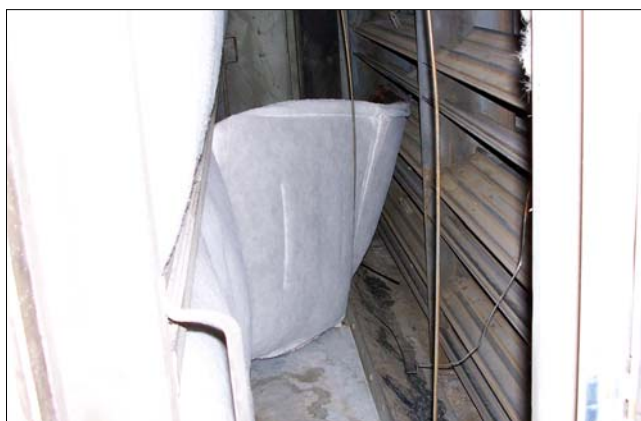
A displaced filter on an air-handling unit should be put back in place to improve indoor air quality in the Commons.

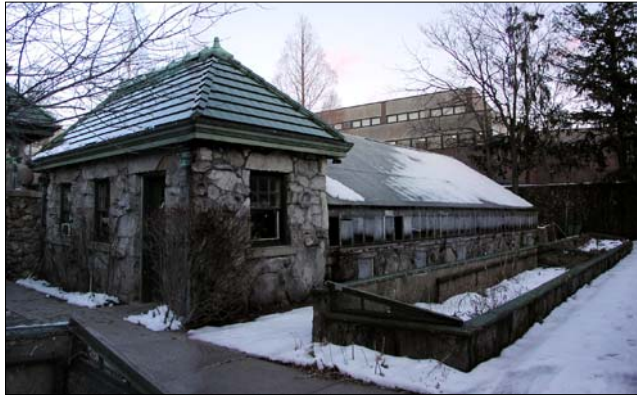
Built in 1908, both greenhouses are in need of repair. The front portion of Greenhouse A received a new clay tile roof in 1995, but the remaining roof and all of the glazing is in poor condition and should be replaced. In addition, its stone walls need to be repointed. Greenhouse B's wood frame and glazing are also in poor condition and should be replaced.

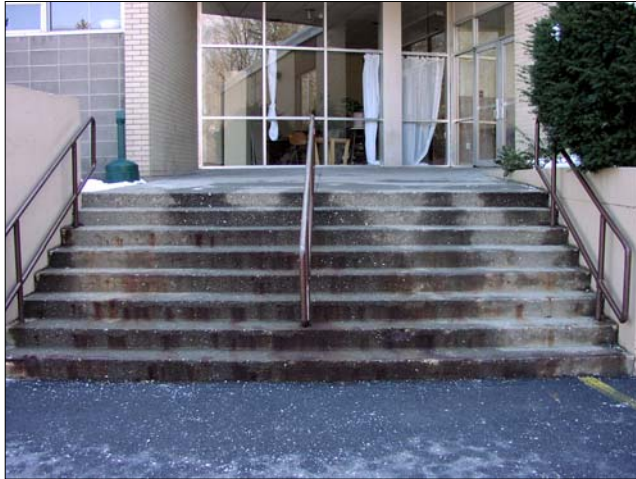
The exterior north stair is beginning to deteriorate and should be monitored.

- The exterior concrete stair at the north entrance plaza is showing signs of deterioration. It should be monitored and repaired, when necessary.

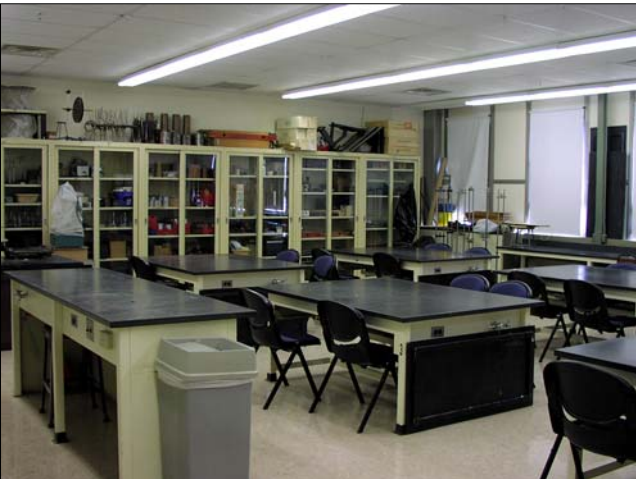
Science labs and lecture halls should be updated.

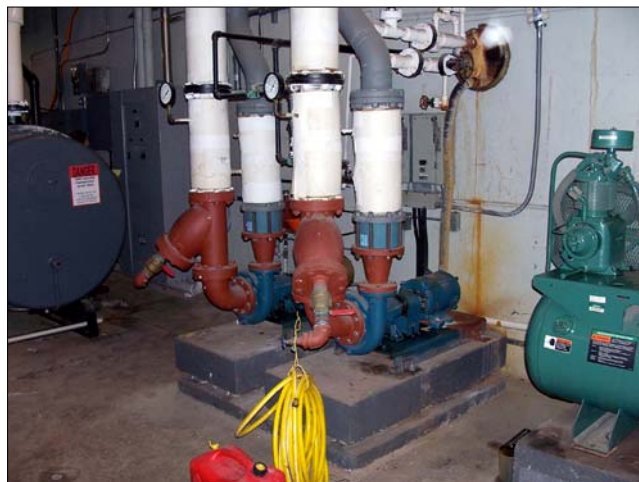
New control valves, dampers and suction diffusers should be installed.

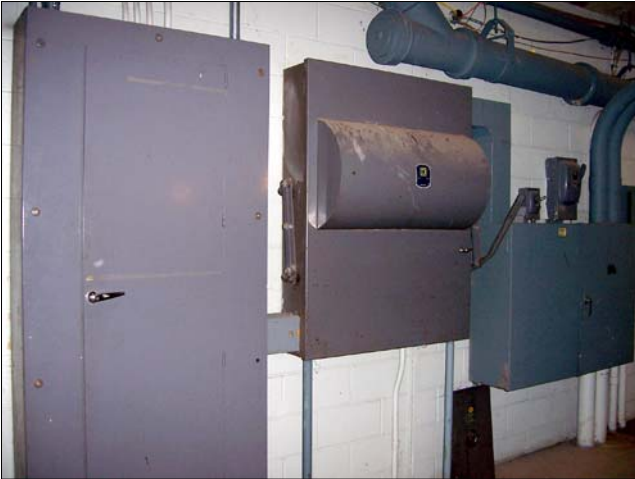
The building's main electrical disconnect switch and main distribution panel is located directly below an 8-inch sanitary line and clean-out. If modifications are made to either of these systems, it would be prudent to separate these two non-compatible systems.

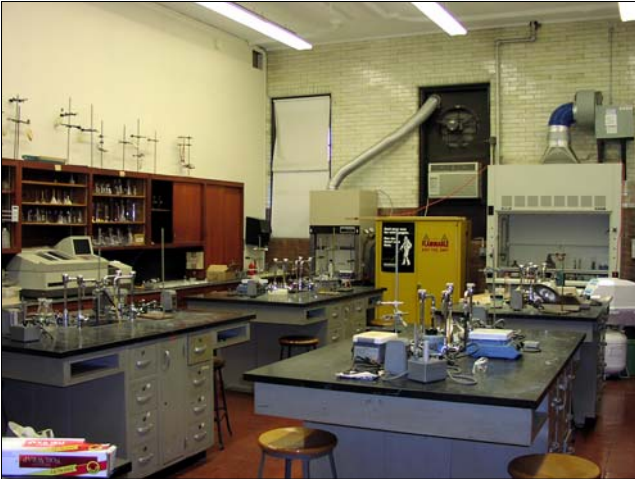
The science labs and tiered lecture hall should be completely renovated to provide more appropriate learning environments.

- **Renovate science labs.** Completely renovate labs HO102, 107, 108, 112 and 113. Install new furnishings and provide new technology to transform these spaces into smart classrooms.

- **Upgrade tiered classroom HO101.** The swivel, tablet-arm seating does not comfortably accommodate many of today's students. The College should consider replacing the rooms furnishings with seats and tables similar to those found in BT311.

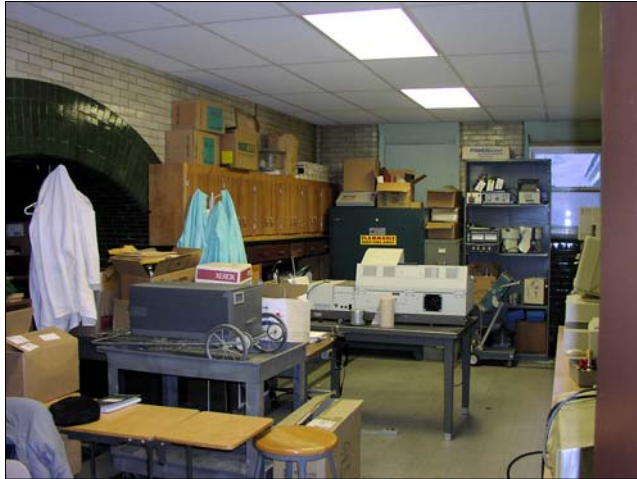
This space is used as a faculty office and for storage.

- **Renovate faculty offices.** Some faculty offices are also storage rooms, which is inappropriate.
- **Address water infiltration issue in the basement.** A portion of the basement is currently being used for storage, but only certain items can be kept in this space due to the continuing water infiltration problem. Water enters the basement via the service tunnel. (See a discussion of the tunnel in the Site and Campus Infrastructure section of this report.) Water also weeps up from around the floor in some areas. Once the water infiltration in the tunnel has been eliminated, the basement should be monitored carefully to determine whether the problem continues. If it does, a site drainage system may need to be installed around the building to eliminate the water problem.

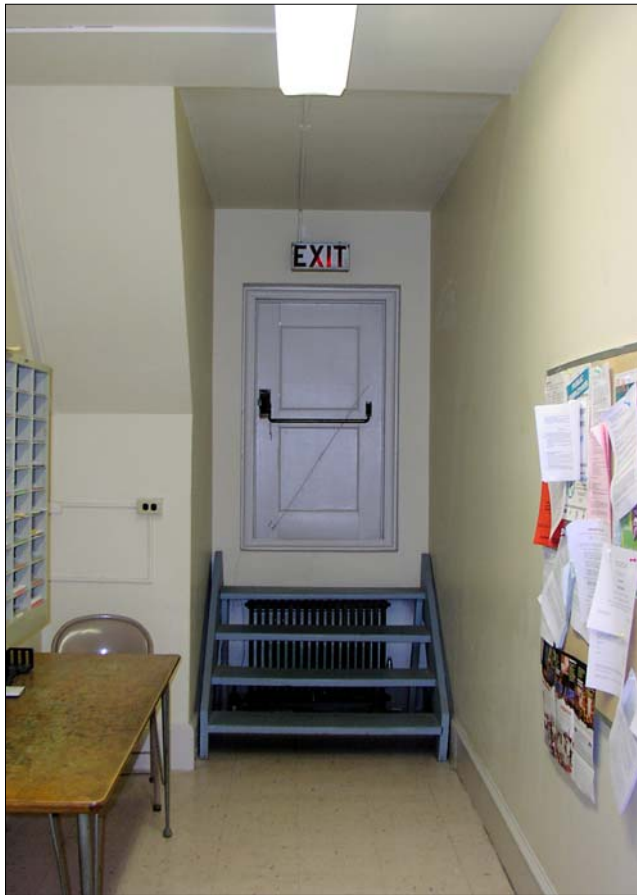
The second means of egress from the upper floor is via a 57" high door that leads to a fire escape. The College should construct an additional, code-compliant means of egress to serve the upper floor when the building is renovated.

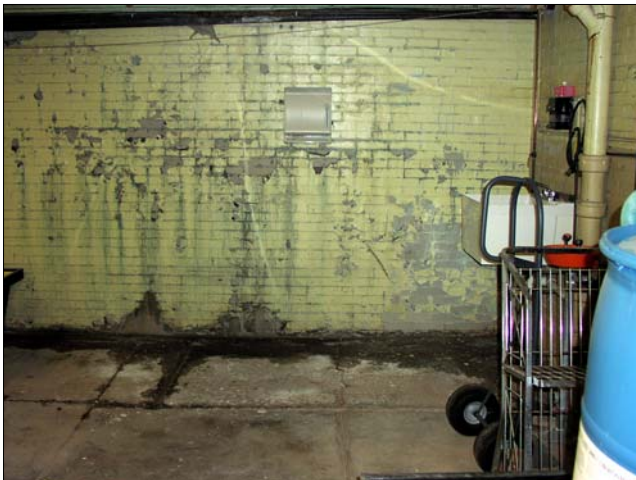
Water can be seen seeping into the basement of Horton Hall at the base of the service tunnel door, shown above. Water infiltration also occurs at the base of the basement wall, as shown below.

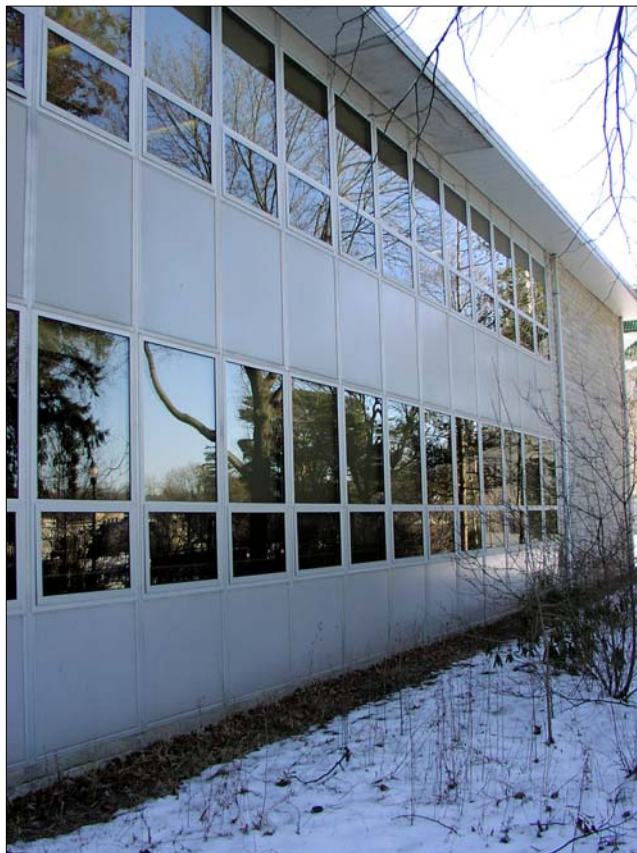
New windows were installed to improve energy efficiency and occupant comfort.

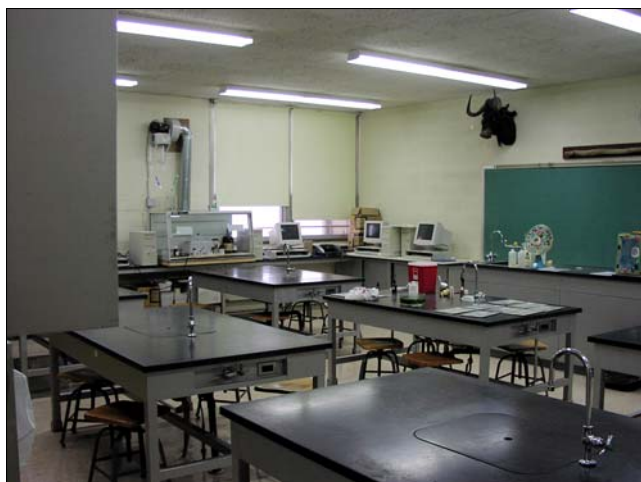
All four science labs should be renovated.

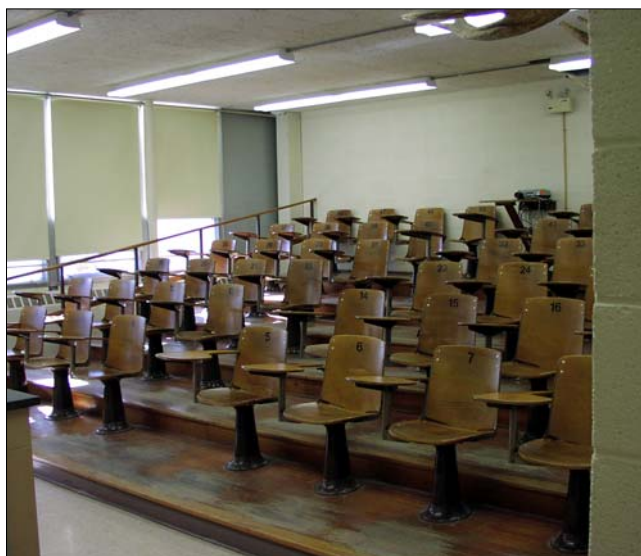
Both lecture halls should be transformed into smart classrooms with improved lighting and seating. ADA-compliant viewing stations should also be provided.

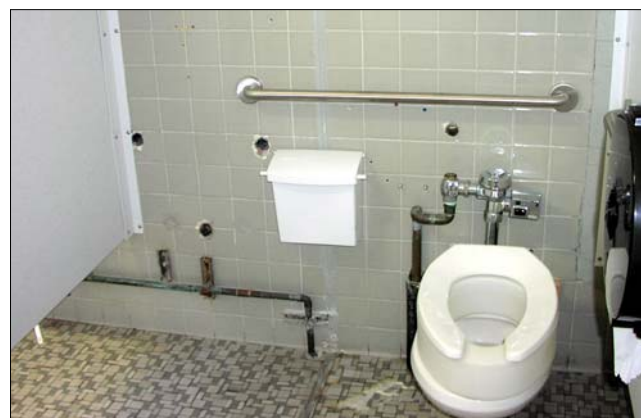
Modifications to the toilet rooms have made them more accessible, but aesthetic improvements are still needed.

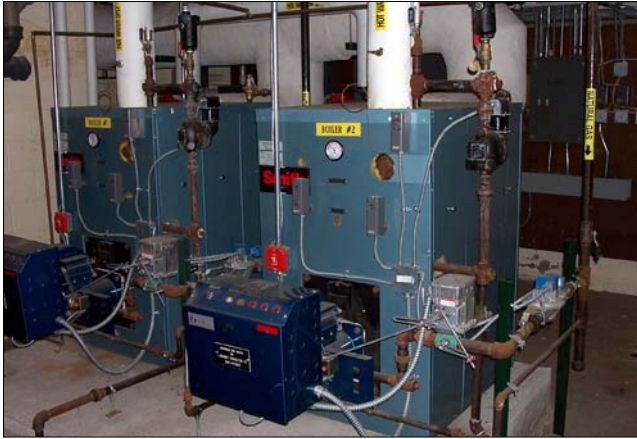
New boilers were recently installed.

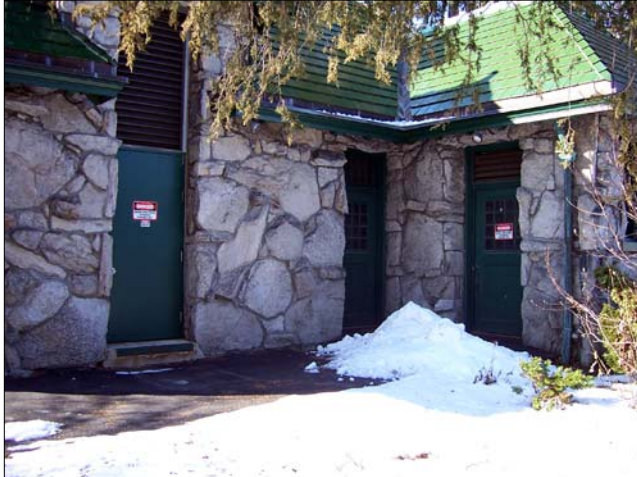
Snow falls from the roof and piles up in front of the building's two secondary doors. The main door to the upper floor is seen on the left.

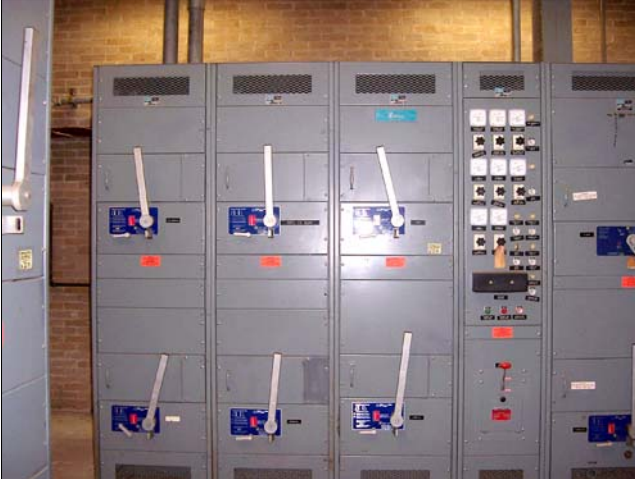
The switchgear equipment is well past its useful life and should be replaced.

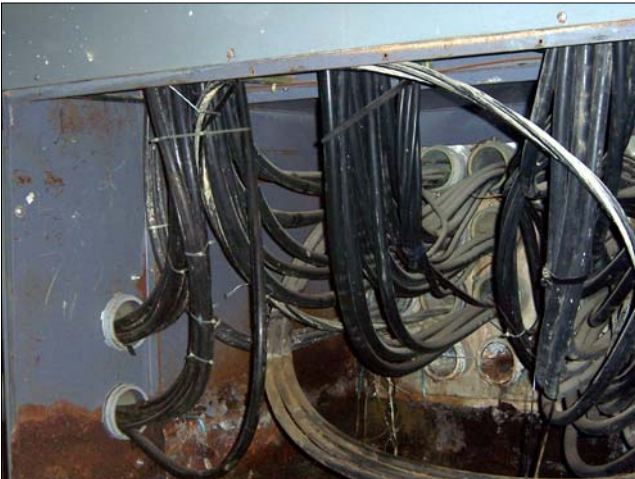
There is no internal connection between the upper floor and the basement. Electrical cables run from the switchgear equipment through the floor to a junction box in the basement. From there the cables run underground in conduits to the various campus buildings. There is an ongoing problem with water infiltration in the basement that has caused extensive damage to the junction box.

Water infiltration in the basement has caused the junction box to deteriorate. See the Site and Campus Infrastructure section of this report for a more detailed discussion of this problem.

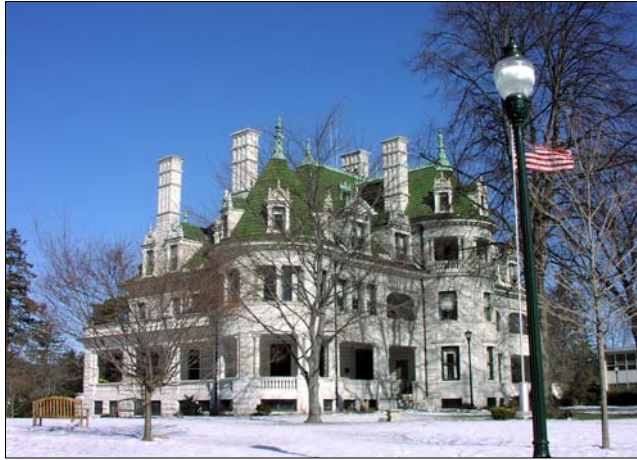
Snow and ice falling from the roof pose a potential hazard to pedestrians below.

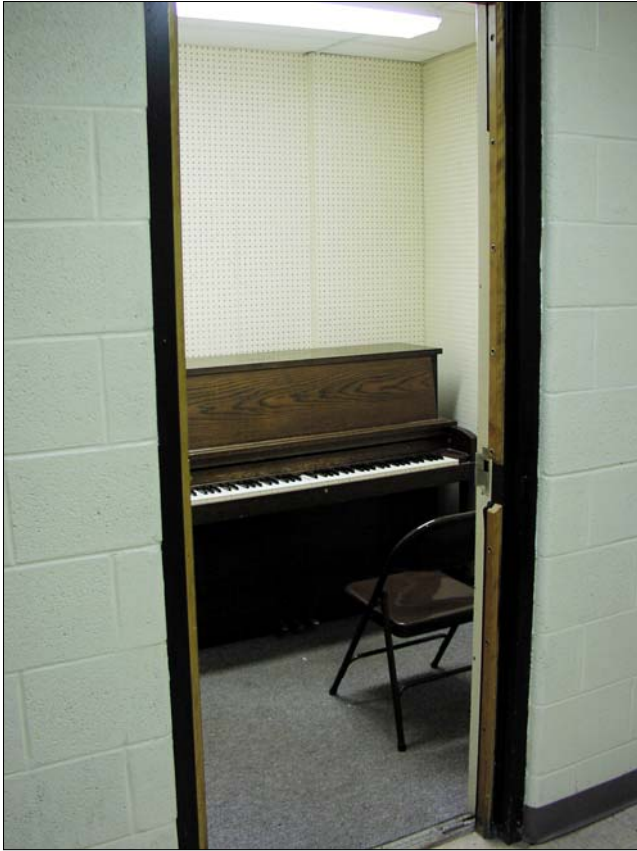
Music practice rooms are small and acoustical separation is poor.

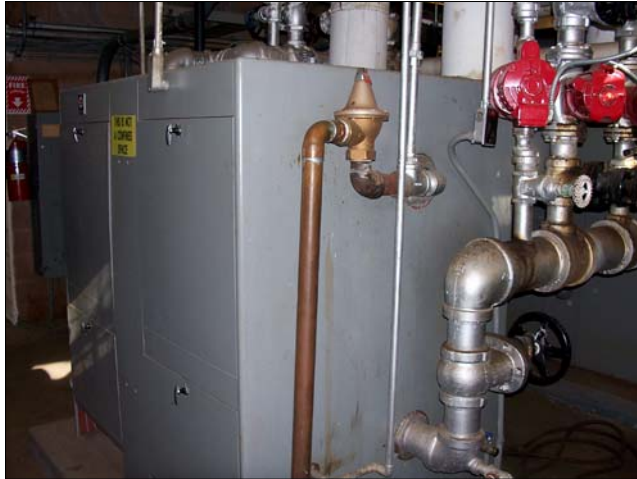
The two old boilers should be replaced.

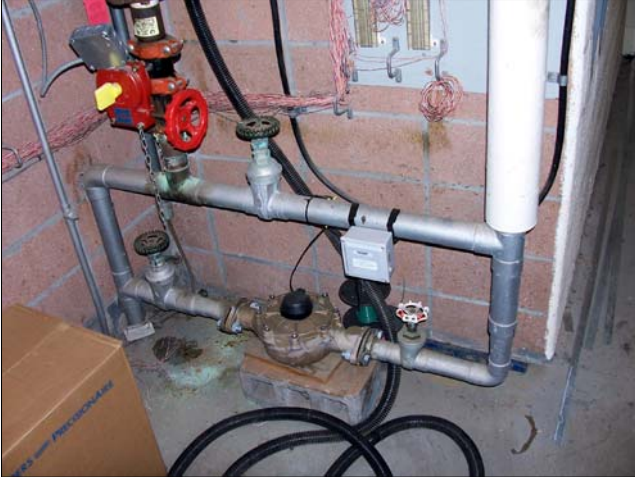
A backflow preventer should be installed at the boiler connection to protect the domestic cold water system.

- **Replace deteriorating pipes.** Oxidation of the copper and galvanized cold water piping and the galvanized drainage piping has caused many leaks in the system. Deteriorating pipes should be replaced, as needed.
- **Install a backflow preventer.**

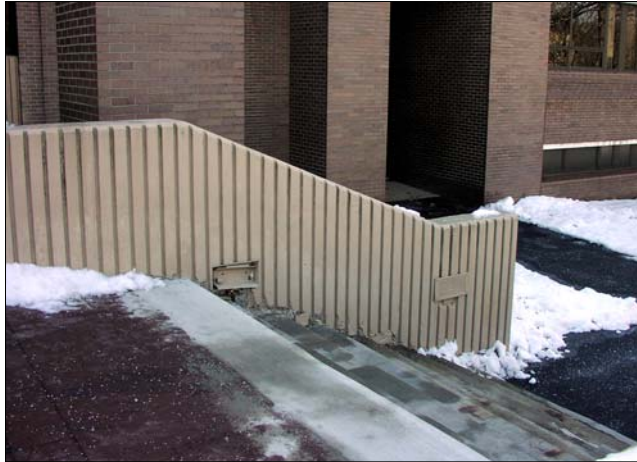
Damaged site stair lighting fixtures should be replaced.

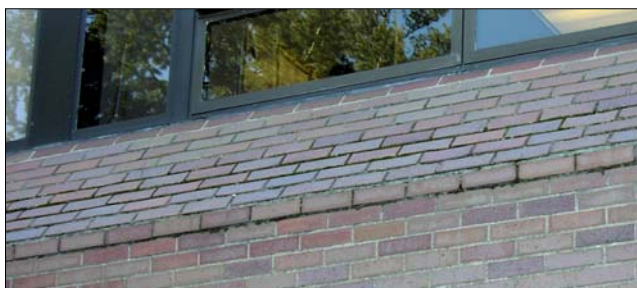
Deteriorating mortar joints should be raked and repointed to prevent further damage to the wall system.

- **Repoint deteriorating mortar joints.** Mortar joints are showing signs of deterioration at several locations around the building, particularly at the sloped sills beneath windows. All deteriorating joints should be raked and repointed to prevent further deterioration of the exterior wall system.
- **Recoat/resurface the roof.** The roof warranty expires in 2009. Therefore, the College should be prepared to recoat the roof within the next ten years.

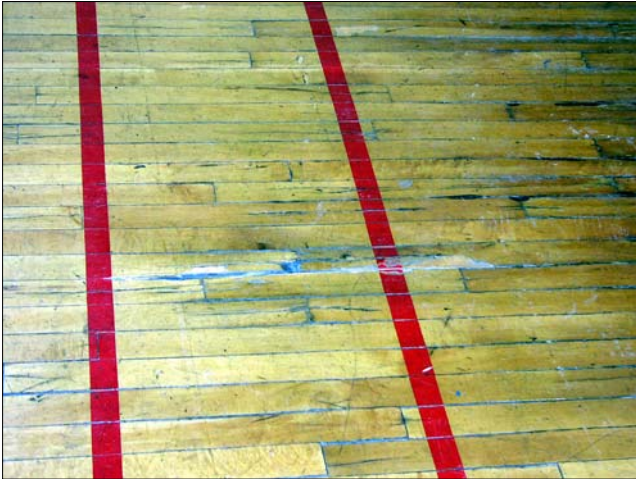
The gymnasium floor is in poor condition. It should be replaced and new bleachers and partitions should be installed.

potential tripping hazard. The bleachers are in failing condition and they damage the gym floor when opened and closed. The partitions do not work properly. The flooring, bleachers and partitions should all be replaced. Faculty would like to maintain at least one solid partition in the gym. The second partition could be replaced with netting.

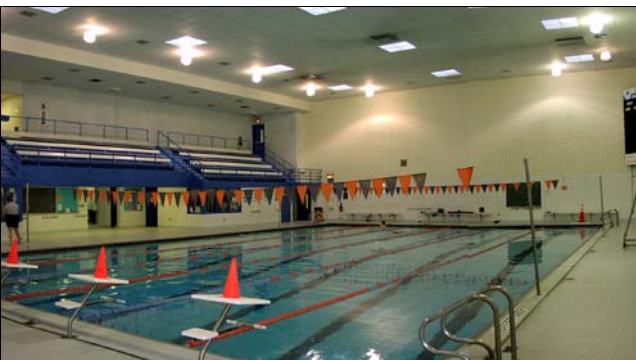
The suspended ceiling above the pool should be removed and the lighting fixtures should be replaced.
