## 2006 Master Plan Update

# SUNY ORANGE

# Master Plan Update

Presented to the OCCC Board of Trustees on 8 May 2006

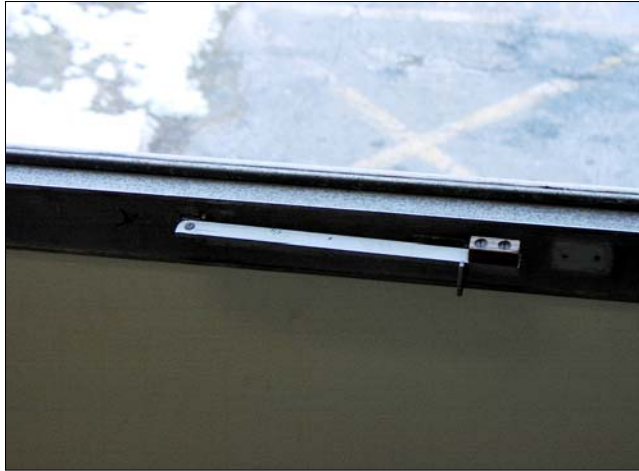
The College has devised a mechanism to replace damaged window operators, but the entire curtainwall system is in poor condition and should be replaced.

- **Install a new curtainwall system.** The curtainwall system, composed of single-glazed windows and uninsulated panels, is in poor condition and should be replaced.
- **Recoat the roof.** The roof warranty expired in 2002, but there are no reported problems at this time. The College plans to recoat the roof in 2007.
- **Replace all entry doors.** The heavy exterior doors are in poor condition and should be replaced.

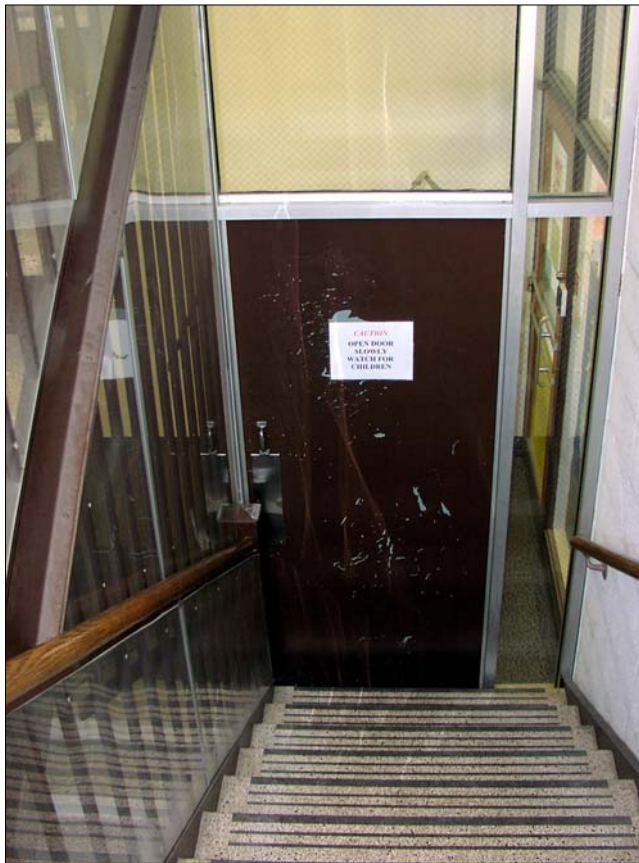
If the Kindercollege remains in Sarah Wells, the entry should be reconfigured to provide code compliant space in front of the entry door.

- **Repair damaged stair treads.** Some of the damaged terrazzo stair treads have been replaced with concrete, but there are still areas where pieces of terrazzo nosings have broken off. These areas should be repaired.
- **Eliminate the code violation at the entry to the Kindercollege.** There is no landing at the base of the stair that leads to the Kindercollege. This is a building code violation and presents a potential hazard. If the Kindercollege remains in this building, the entry should be reconfigured.

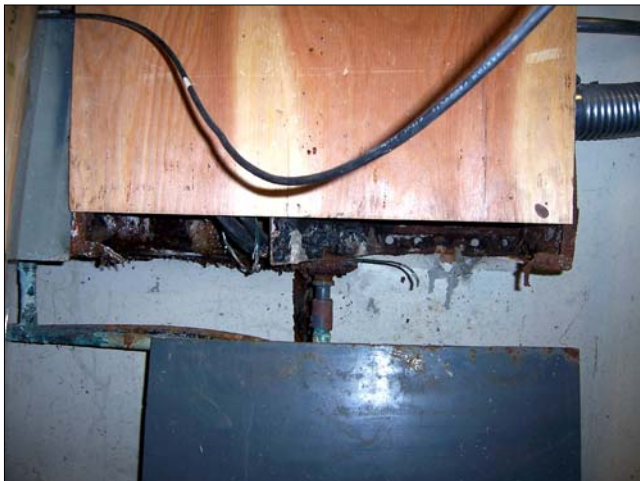
The rusted cover of an electrical panel has been replaced with a piece of wood. The building's entire electrical distribution system should be replaced.

- **Installation of a new electrical distribution system.** This Master Plan recommends the replacement of the entire electrical distribution system to provide both 480/277 and 120/208 volts.
- **Upgrade the lighting system.** Replace the existing lighting system with new energy efficient lighting fixtures that use T-8 fluorescent lamps or compact fluorescent lamps and electronic ballasts and a 277 volt system. Many of the existing fixtures are old and are not energy efficient.
- **Update the fire alarm system.**
- **Install public address and master clock systems.**

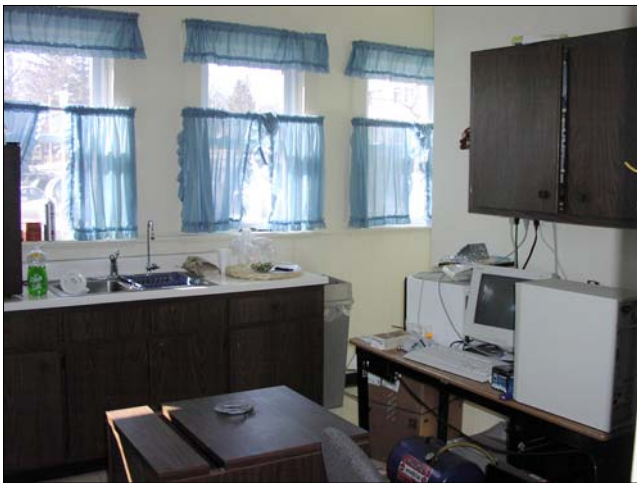
IT department offices are set up in spaces such as the kitchen and former bedrooms.

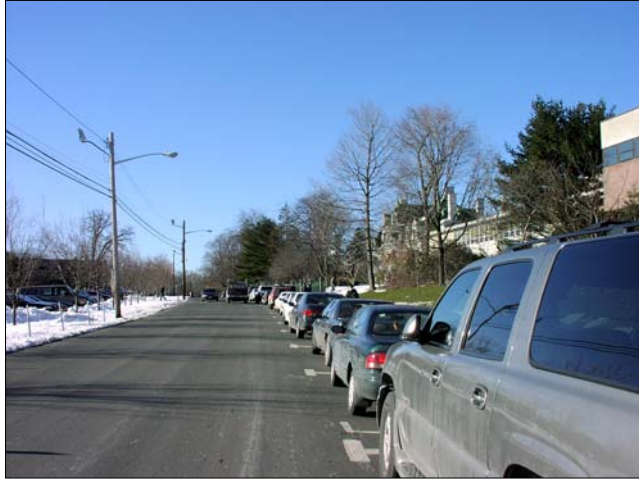
Reportedly, South Street is the site of several pedestrian/vehicle accidents each year.

South Street is a busy thoroughfare that divides the Middletown Campus, positioning the College Commons and a large college parking lot on the south side of the street and the remainder of the campus to the north. Parked cars along one side of the road and the speed at which vehicles travel create a potentially dangerous situation. Each year several students are reportedly hit by cars as they cross South Street at designated crosswalks. In addition to creating an unsafe condition for pedestrians, South Street creates a physical and psychological barrier between academic and student life components of the College. It also undercuts the viability of constructing a new academic building on the land currently used for parking.

This Master Plan recommends that South Street be closed to all but emergency vehicles between East Conkling Avenue and Grandview Avenue. The road in this area should be narrowed and textured paving should be installed to create a recognizable pedestrian zone. Overhead utilities should be buried, and new trees, site lighting and banners should be installed to create one the sense of being on a college campus.

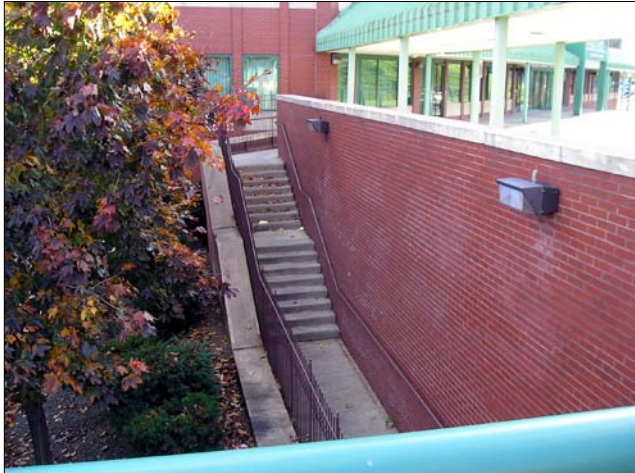
The site stair between the Key Bank and Maple Buildings collects wind-blown trash and leaves and is difficult to maintain.

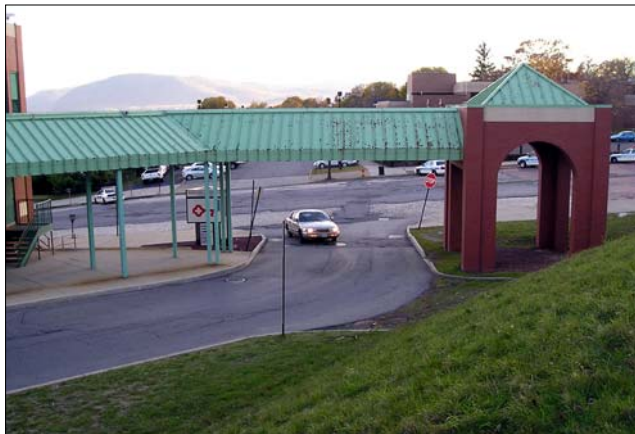
Widening the narrow main entry drive would involve reworking the entry canopy.

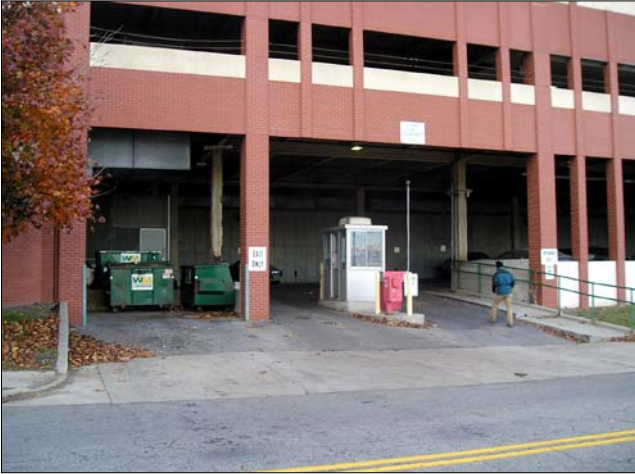
Refuse containers located adjacent to the garage entrance are an eyesore.

Campus trash receptacles are located adjacent to the garage entrance in plain view from the street, which is an eyesore.

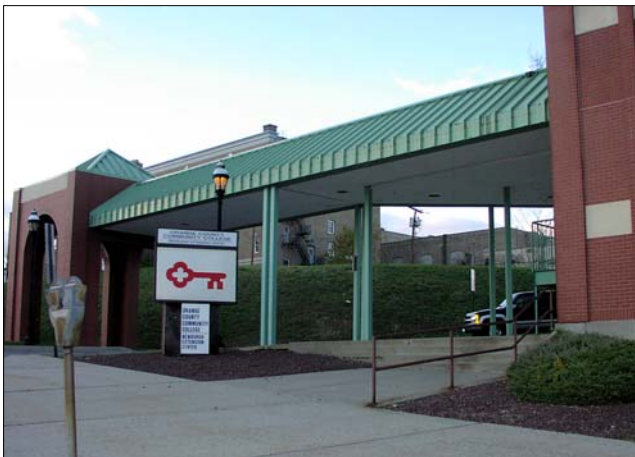
The College's name should be featured more prominently on the main entry sign.

The only vehicular signage observed on campus is located at the corner of Broadway and the main entrance drive. The most prominent feature of the sign is the Key Bank symbol. Orange County Community College lettering appears to have been added to the existing Key Bank sign and is somewhat difficult to read. There is no other signage to direct vehicles to parking or service areas and, consequently, it is difficult for drivers to tell where they are allowed to park.

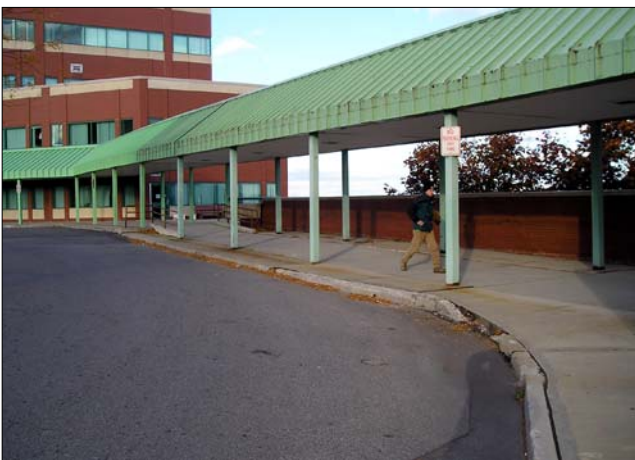
Signage should be installed to direct pedestrians to the College entrance at the Key Bank Building. Additional curb cuts should be created, especially at the main building entrance.

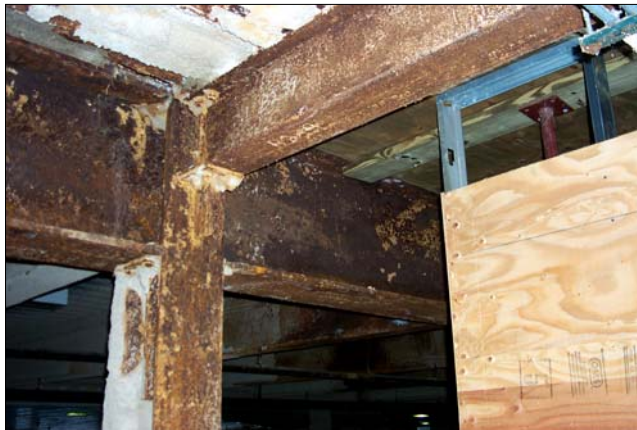
Water damage is evident in the parking garage beneath the Maple Building.

As previously mentioned, 75 parking spaces are available to the College in the public parking garage located under the Maple Building. At the time of the consultant’s site visit it appeared work was in progress to deal with water damage. College personnel report that security issues keep many people from taking advantage of the garage.

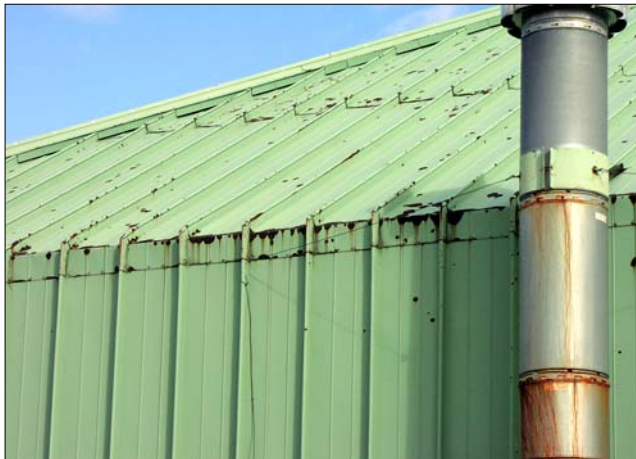
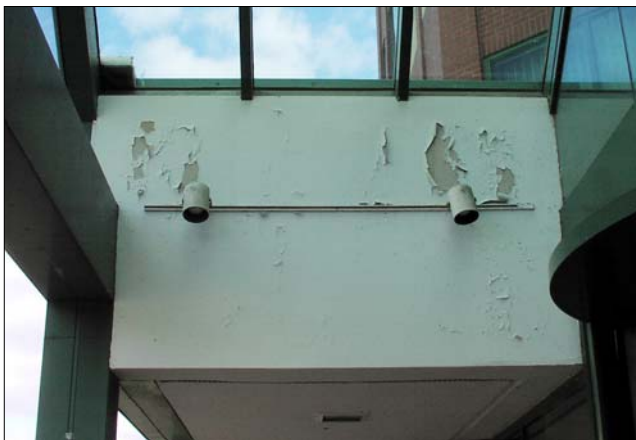
Exterior soffits need to be repainted.

- The ballasted, single-membrane roof underwent some repairs in August 2005. Occupants report, however, that leaks continue. In addition, there are some areas of the sixteen-year old roof where water is ponding. Given the fact that recent repairs have not eliminated the leaks and that it is the original roof system, the College should anticipate the need to replace the roof within the next five years.
- The standing-seam metal roof is marked with rust spots over its entire surface. The rust should be removed and the entire metal roof system should be properly prepared and repainted.
- Paint on the exterior soffits along the front of the building is deteriorating. All of these surfaces should be scraped, properly prepared and repainted.

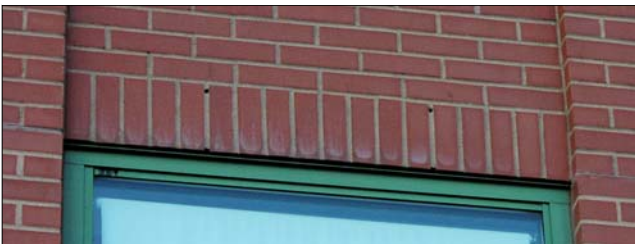
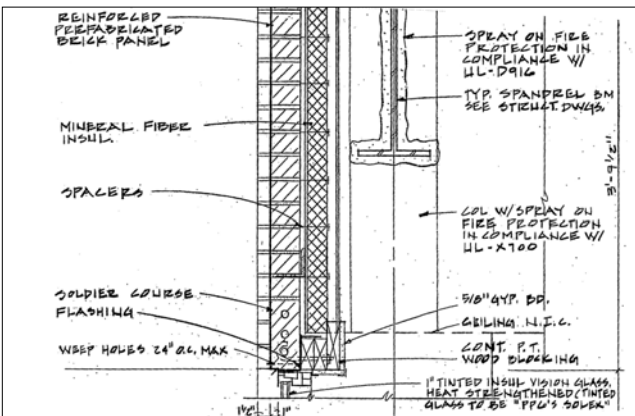
Interior water damage appears to be the result of improperly placed wall flashing and weep holes above windows.

Detail of the wall section from the original construction document shows intended location of weep holes.

Water damage is evident at window heads and jambs throughout the facility. Occupants report that water enters the building in these areas when there is a heavy rain event, especially if it is accompanied by wind. An examination of the construction documents and site conditions revealed that there may be an inherent detailing problem with the curtain wall assembly. It appears that the positioning of wall flashing and weep holes prevents water that has entered the wall cavity from being wicked away through the weep holes. As a result, this water is entering the building above the window assembly and damaging interior finishes. It is also possible that the mineral fiber insulation located adjacent to the prefabricated brick wall panels is absorbing water. This could lead to its deterioration and provide conditions favorable to the growth of mold, which could adversely affect indoor air quality in the building.

- It will be necessary to selectively demolish a representative interior wall area to discover exactly what is occurring within the wall cavity and to determine how this condition might best be corrected. However, it appears that the problem is ubiquitous and will probably be difficult and costly to repair.

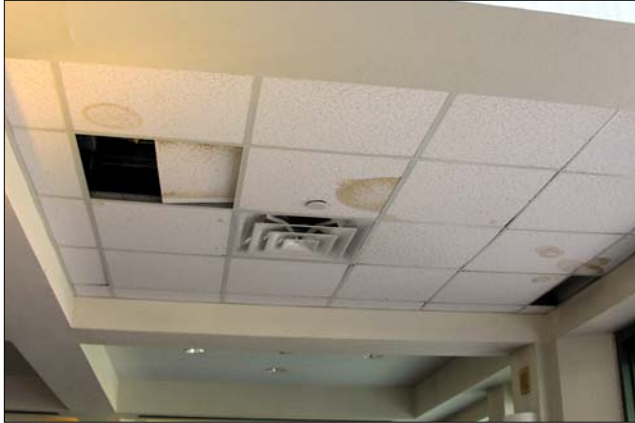
Damaged ceiling tiles should be replaced.

- Many ceiling tiles show signs of water damage. Facilities personnel believe heat pumps above the ceiling are the source of the water leaks. However, it may be that condensate drain lines are clogged, resulting in overflowing drip pans. The drains and drip pans should be examined as part of the next heat pump maintenance cycle to ensure they are functioning properly.

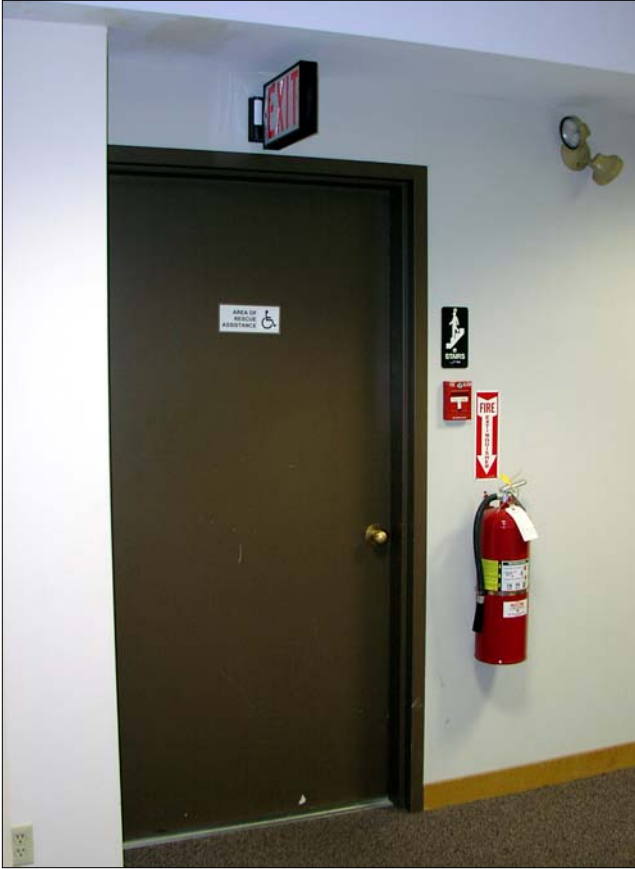
- All of the toilet rooms are equipped with an alternate stall, with the exception of the accessible unisex toilet room on the second floor, which meets current ADA requirements. While there is sufficient maneuvering space for a wheelchair within each toilet room, all but the unisex toilet room has knob hardware on doors that are heavy and difficult to open. The doors and door hardware should be replaced. Insulation should be installed on exposed lavatory pipes and soap dispensers should be moved so they are accessible.

Lever door hardware should be installed at all exit stair doors.

- Most of the exit stair doors are equipped with knob hardware. Lever door hardware should be installed at all exit stair doors, except the exit door on the second floor that is already equipped with panic hardware.
- Areas of rescue assistance are identified at some stair exit doors, but these areas do not meet the necessary requirements to function in this capacity. In addition, they are not required under the current code because the building is fully sprinklered.

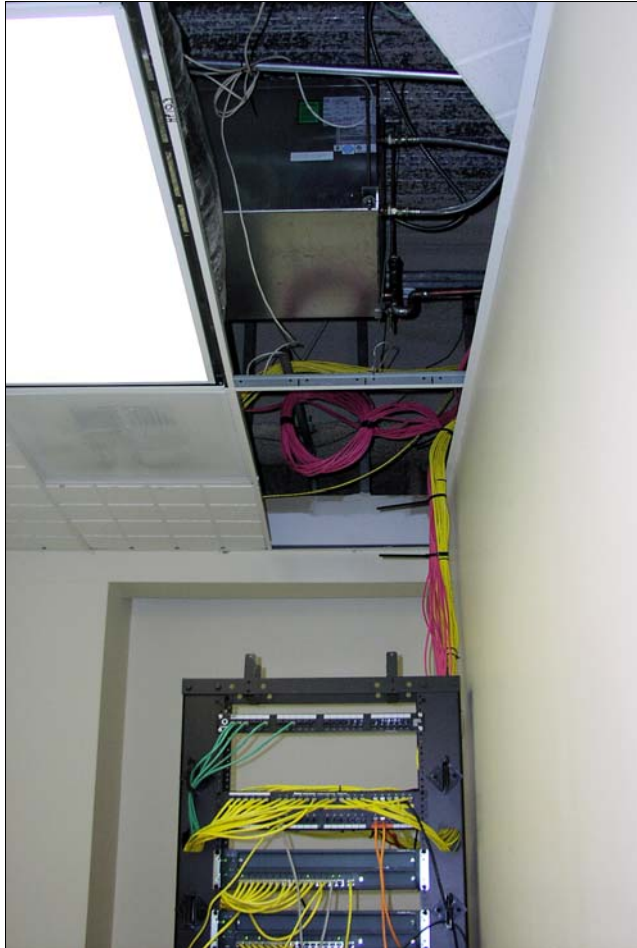
Water-source heat pumps are located above the suspended acoustic tile ceilings.

- The majority of the heat pumps appear to be original to the building and are nearing the end of their anticipated 20 year useful life. Condensate pans reportedly overflow when drains clog and water damage could be seen on ceiling tiles throughout the facility. The locations of the heat pumps do not adequately serve the present layout and the proposed use for community college space. Although the heat pumps are not presently in a condition that requires replacement, many revisions will be required regarding the size, location, and distribution of the units. Therefore, the heat pumps should be replaced with new units that are properly zoned for the new space layout.

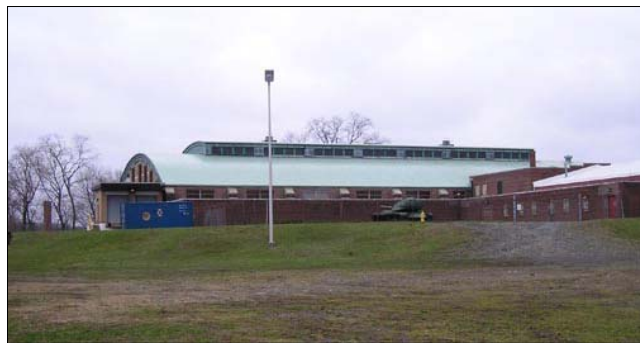
The barrel-vaulted drill shed has an interesting structure, but the configuration of the building does not lend itself to conversion for college use.

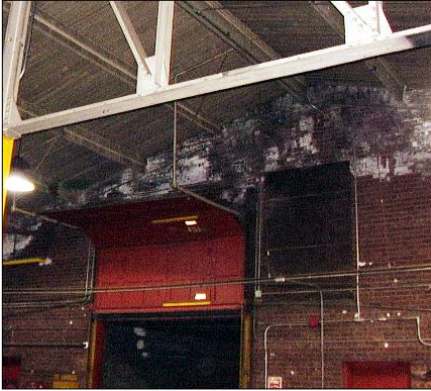
Efflorescence, the result of roof leaks, is visible on the brick walls of the drill shed above, and the gym shown below.

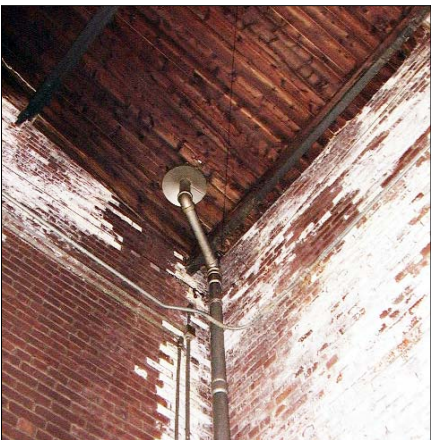
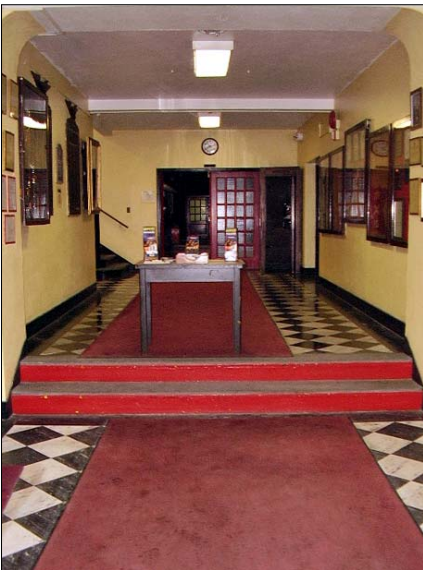
Steps in the front entry hallway are but one building element limiting building accessibility.

There is no elevator. Stairs in the entry hallway and throughout the building make the facility inaccessible. Toilet rooms are not designed to accommodate individuals in wheelchairs and doors are primarily fitted with knob hardware. Signage is not ADA compliant.

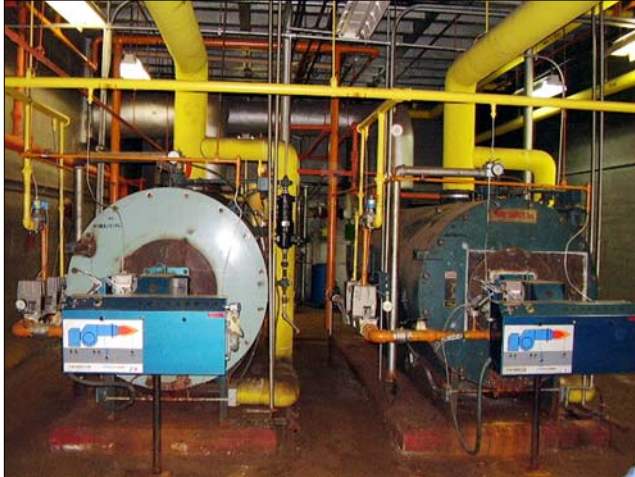
The two fire-tube boilers would need to be replaced if the building was to remain in use.

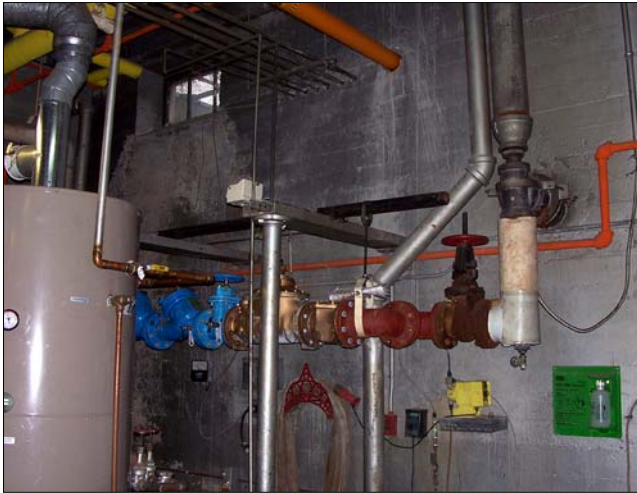
Water service entrance.

- The existing domestic cold water service appears to be original. It is split between domestic water and fire protection. A new double-check valve was installed on the domestic system in the last few years. An RPZ backflow preventor installed on the make-up water to the steam system. Occasional leaks from the domestic piping system have been reported. Some of these leaks were due to pipes located in exterior walls that froze due to the lack of insulation. These leaks have been repaired. The entire system is should be replaced.

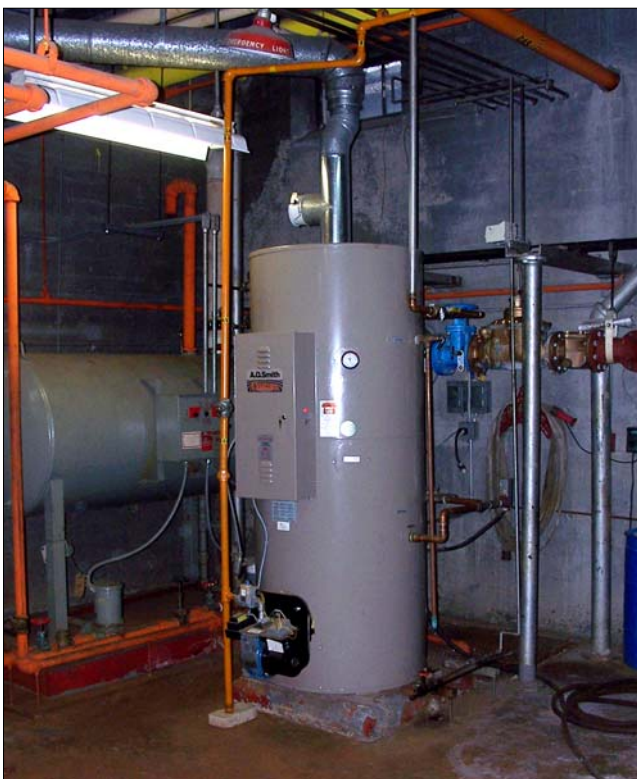
A new natural gas-fired domestic water heater was installed in 2001.

- A natural gas-fired domestic water heater, installed in 2001, serves the building. A domestic hot water recirculation pump is installed on the water heater. The extent of this

recirculation system in the building was not apparent. The domestic hot water system is also old and deteriorating. It should be replaced.

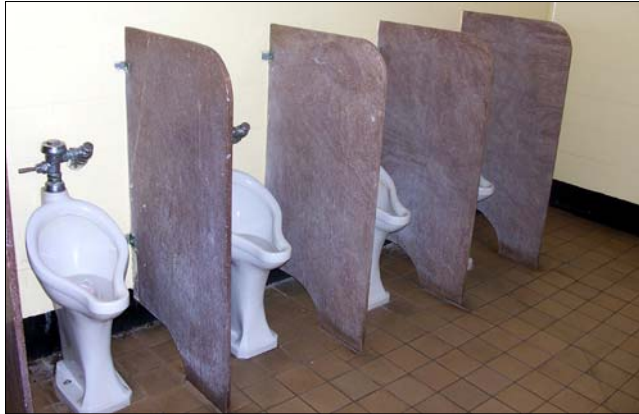
Existing toilet fixtures, including urinals, would need to be replaced with low flow fixtures.

- All of the urinals, water closets, and lavatories in the toilet rooms are old but appear to be operable. The flush valves are not low flow 1.6 gallons per flush valves required by today's codes. If the College intends to use this facility, all of the toilet fixtures should be replaced with low flow units.

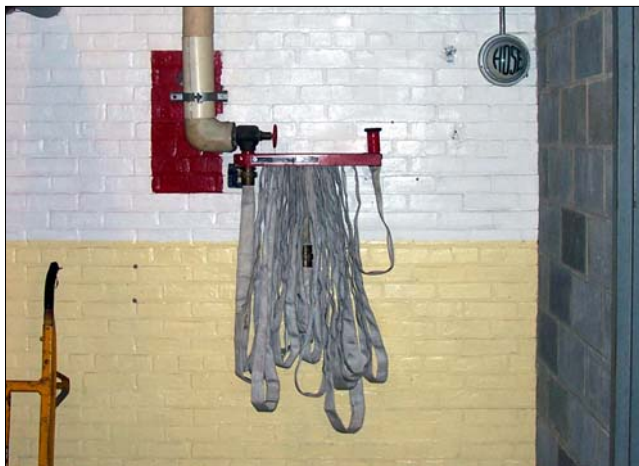
The building fire protection system consists of hose stations fed from the domestic water service.

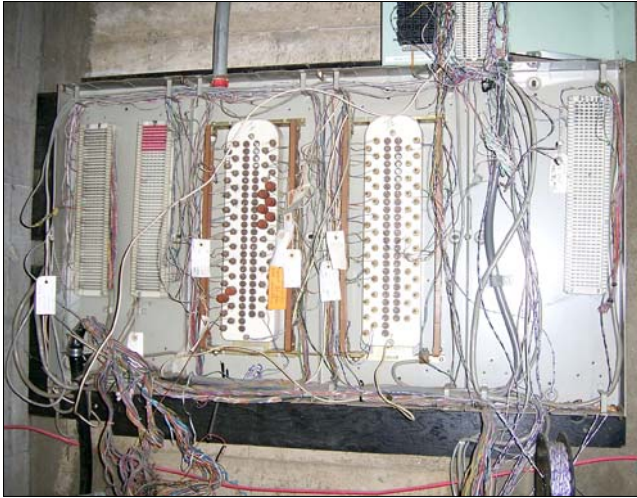
The existing telephone and data distribution system would need to be replaced.
